Staying on the right track

When the Ash Grove Cement plant in Chanute, Kansas, USA, experienced involuntary shutdowns and rising costs due to belt drifts, the solution came in the form of modern belt tracking technology. The upgrade has reduced belt damage, spillage and downtime.

■ by **Cory Goldbeck**, *Martin Engineering, USA*

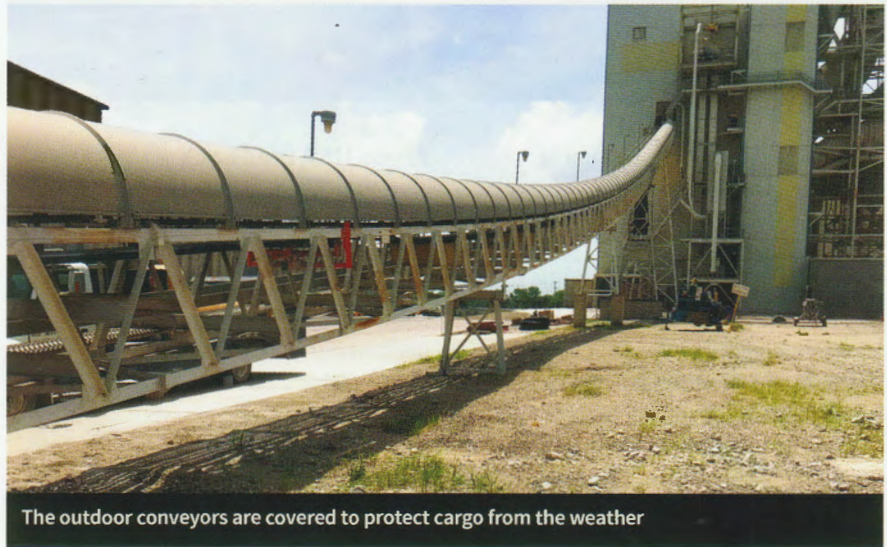
The outdoor conveyors are covered to protect cargo from the weather

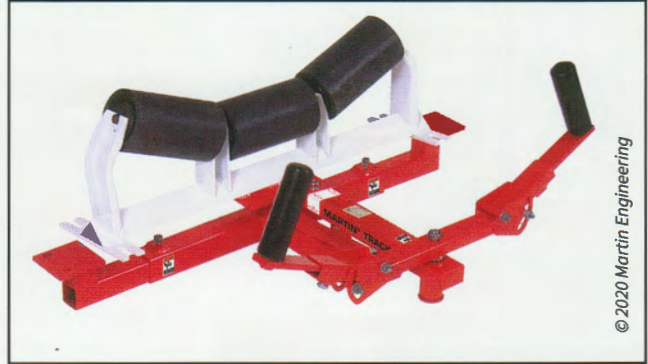
The Martin Tracker™ for the carrying side adjusts to fit the system’s trough angle

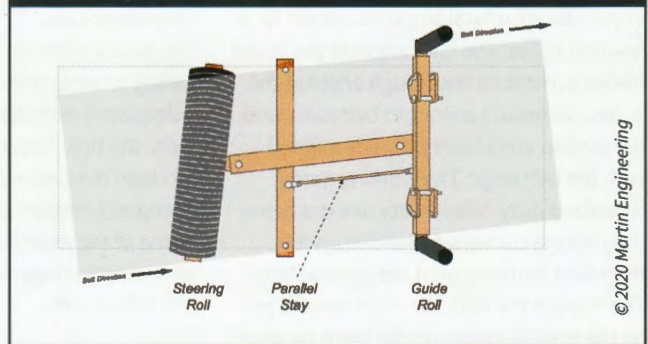
Figure 2: the tracker pivots against the mistracking, using the force and weight of the belt to redirect it

rollers at the tip, which smoothly ride the edges of the belt. The sensing arms detect slight variations in alignment and use the force of the belt to immediately pivot the position of the troughed idlers against the misalignment with equal force, thus returning the belt to its intended path (see Figure 2).

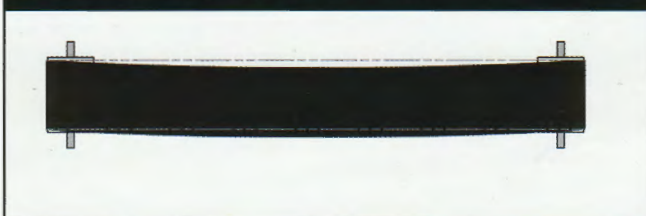
Secondly, technicians suspected some potential manufacturing flaws of the belt attached to the limestone conveyor. If the belt is not precisely engineered or properly stored, it can bow or camber (see Figure 1). This might have contributed to the tracking and belt damage issues.

Figure 1: camber happens in the manufacturing process, and belts should be inspected prior to installation

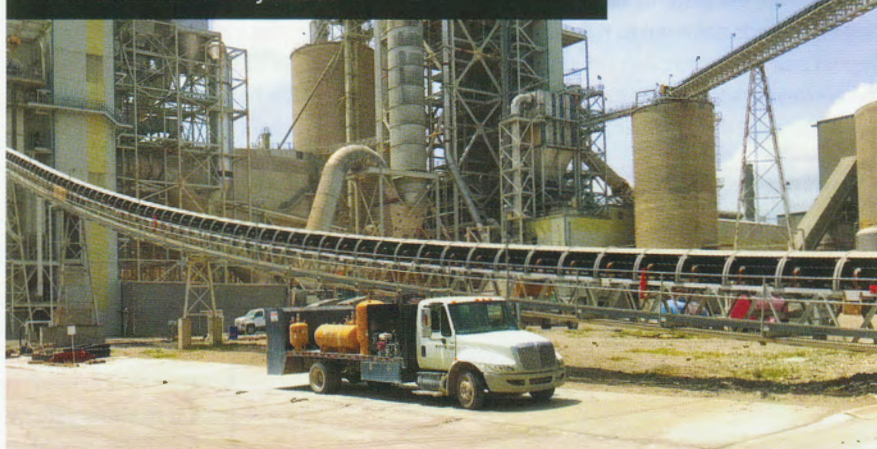
With the discharge so close to the belt entrance, the tracker had to be installed immediately outside
