# PROBLEM SOLVED™ PAPER

**SOLUTION:** Martin® Modular Tracker

**TITLE:** Martin® Tracker™ Eliminates Belt Mistracking in the Chrome Industry

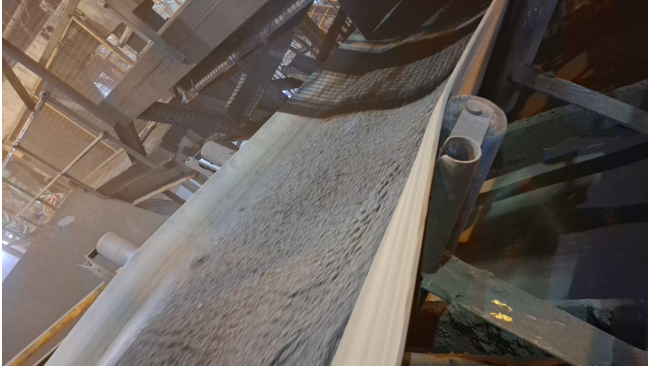
Mistracking of conveyor belt

One of the largest single ferrochrome producers in the Western world faced significant challenges due to mistracking of a 25-metre-long, 1200 mm-wide conveyor belt. Belt edge damage resulted from the conveyor belt running off the centreline and travelling along a rough path, where constant friction gradually wore down the belt. This type of damage typically develops over time and may not show visible signs immediately. Mistracking caused structural damage and spillage issues, further posing risks to equipment integrity, productivity, and safety. These conditions led to potential downtime and increased maintenance costs. The company needed to correct the issue promptly to prevent further damage and minimise fugitive material.

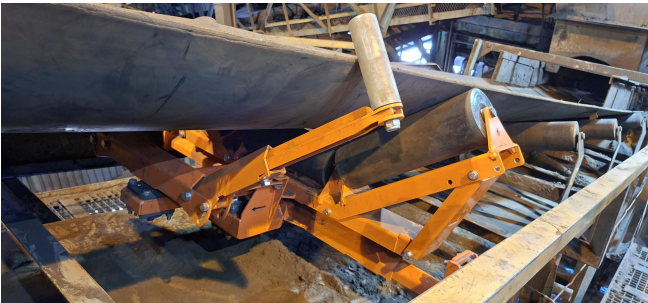
Martin® Tracker™ installed on the carrying side of 1200 mm wide conveyor belt

Martin's Sales Engineer conducted a thorough audit of the conveyor system to identify and address the root cause before implementing corrective actions. A comprehensive Walk the Belt™ conveyor audit was performed, and the installation of a 1200 mm Martin® Tracker™ on the carrying side of the affected conveyor belt was recommended. This product was selected for its proven ability to correct mistracking efficiently, ensuring smooth belt alignment without requiring major structural changes. The Martin® Tracker™ features sensing rollers and lever arms on both sides of the unit. A stainless-steel paddle wheel is used to detect the direction of belt travel and activate the sensing rollers at the appropriate end of the unit.

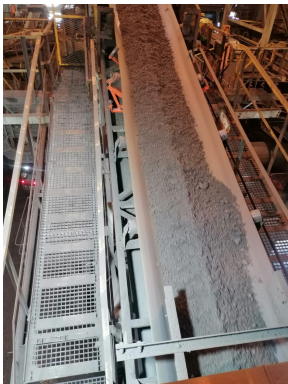
The belt misalignment problem was resolved.

The Martin® Tracker™ proved to be a complete success, providing immediate, powerful, and continuous steering to correct the belt path. This prevented spillage, equipment damage, and the need for repairs, while also resulting in increased uptime and productivity. The customer expressed high satisfaction with the performance of the Martin® Tracker™, as well as with the prompt and efficient service provided by the Sales Engineer.
