PROBLEM SOLVED™ PAPER

SOLUTION: Martin® QC1™ Cleaner HD STS

INDUSTRY: Recycling

LOCATION: Salzgitter, Germany

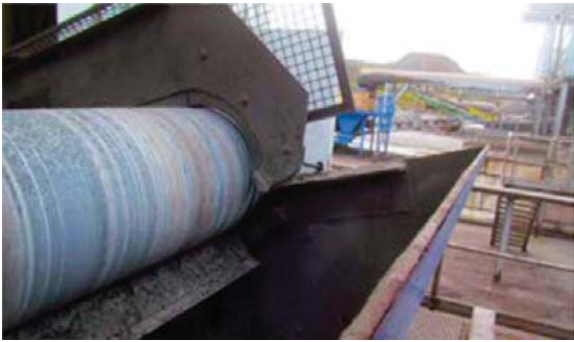
The existing metal blade delivered poor cleaning performance, while damaging the belt and splice.

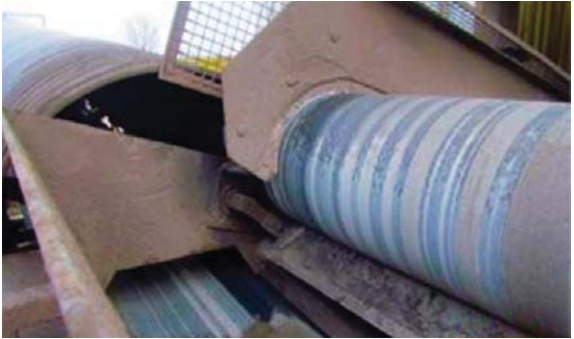
Inadequate cleaning reduced system productivity and increased maintenance costs.

After a thorough inspection that included a Walk the Belt assessment, Martin Engineering Germany representatives determined that a QC1™ Cleaner HD STS was better suited to clear the belt of adhered carryback. Using the patented Martin® Tensioner HD STS with a polyurethane blade formed in the "CARP" (Constant Angle Radial Pressure) design, the blade creates a tight seal on the belt, flows easily over the splice and maintains cleaning performance through all stages of blade life. Mounted on a sturdy stainless steel mandrel, the blade cartridge is serviced without confined space entry with a simple one-pin operation, making replacement a safe and simple procedure.

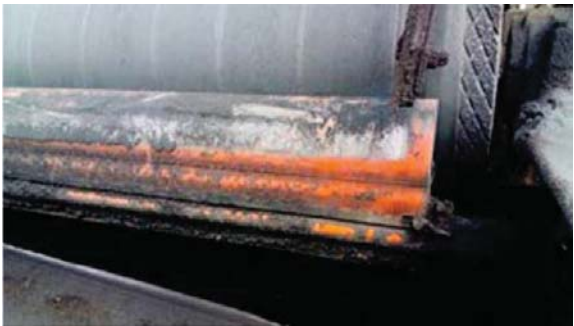
Improved belt cleaning increased efficiency and reduced airborne dust.

Upon installation, operators discovered considerably more material was discharging into the chute with less carryback. Due to the reduction of material adhered to cracks and divots on the return side of the belt, less dust adhered to the belt, leading to an immediate improvement in plant air quality. Spillage along the belt path was also significantly reduced, leading to fewer workers taking less time to clean along the belt path, improving safety and reducing the cost of operation. "We have not had to replace the belt once since installing the QC1™," said an operator close to the project. "We are now assessing the effectiveness of other cleaning systems compared to this one."
