# PROBLEM SOLVED™ PAPER

**SOLUTION:** Martin® Tracker™

**LOCATION:** Huaibei Mining Group, Luling Plant, Auhui, China

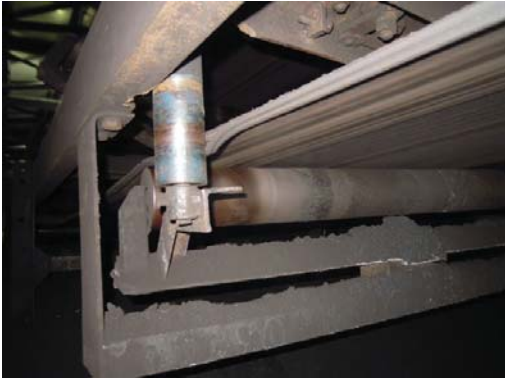
One of the conveyor at the Luling mine of Huaibei Coal Mining Group, carrying coal 50 meters, started experiencing problems. The belt became loose, ran askew and material was adhering to the corrective roller. This misalignment caused the belt edges to wear, reduced the life of the belt and increased spillage along the conveyor. These problems not only impacted the material handling efficiency but also increased the labor intensity, and created serious environmental pollution.

*The Luling mine was experiencing belt misalignment on one of their conveyors resulting in heavy damage to the belt edge.*

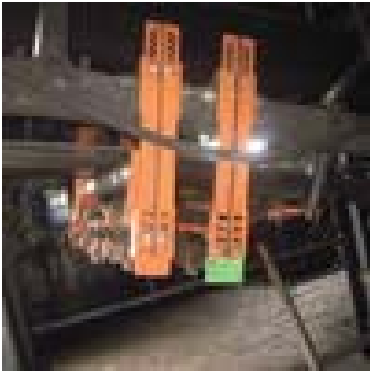
*Martin Engineering installed Martin® upper Tracker™ & Martin® lower Tracker™ to correct the problem.*

Martin technicians observed the misalignment and then selected the most suitable location to install a Martin® upper Tracker™ & Martin® lower Tracker™. The Martin® Tracker™ provides immediate, continuous precision adjustment of wandering conveyor belts, reducing edge damage, preventing spillage and extending the life of the belt.

As the belt contacts the guide rolls, the torque are pivots the steering roll, causing the belt to track to the center of the conveyor structure.

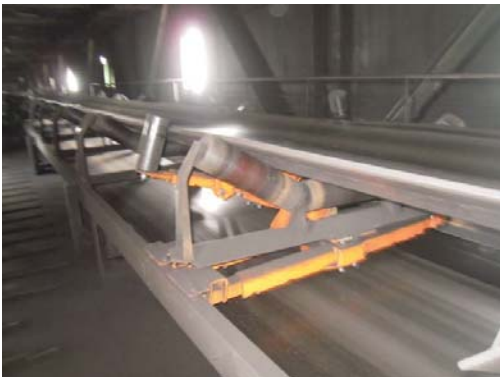
After installing the Martin® Trackers™, the belt is now aligned. The edge of the belt is no longer worn, extending the life of belt. The spillage problem has disappeared on both sides of the belt and the workers are spending less time adjusting the belt and cleaning up around the belt. The material build up is greatly reduced, and the environmental concerns are gone. The plant has significantly reduced its amount of unplanned downtime, while ensuring safe production and improved plant efficiency.

*The Martin® Trackers™ have corrected the alignment issues and have increase plant efficiency.*
