# PROBLEM SOLVED™ PAPER

**SOLUTION:** Martin® QC1™ Cleaner HD and Martin® SC16 Cleaner

**INDUSTRY:** Cement

**LOCATION:** Siam City Cement Co. Ltd (SCCC), Saraburi Province, Thailand

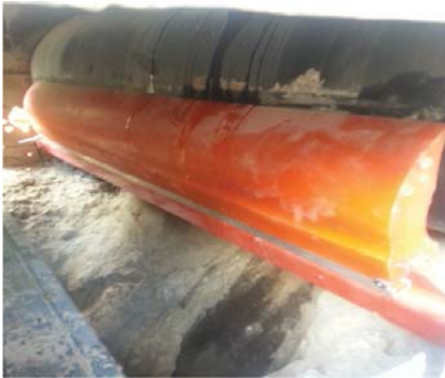
*The Patented "CARP" Constant Angle Radial Pressure design keeps a tight seal on the belt.*

Technicians from CNS Thailand, a Martin distributor, and Martin Engineering Thailand examined the issue and determined that the best option was to replace the existing equipment with a Martin® QC1™ Cleaner HD and a Martin® SC16 Cleaner. Using the standard orange blade for heavy-duty applications, the Martin® QC1™ Cleaner HD is set on a mandrel connected to a spring tensioner. This allows the blade curved in the Patented "CARP" Constant Angle Radial Pressure design to keep a tight seal without damaging the belt's surface or splice. The Martin® SC16 Cleaner backs up the Martin® QC1™ Cleaner HD designed to remove dust and fines from high-speed belts with high-tonnage loads under punishing conditions.

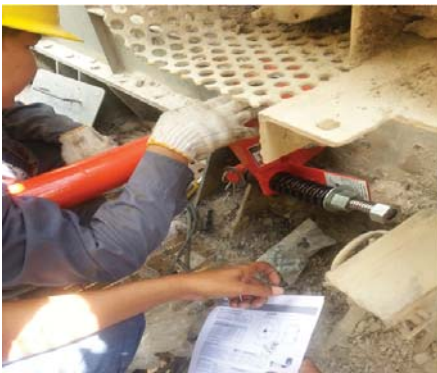
*Martin Engineering technicians install the Martin® QC1™ HD cleaner on the underside of the head pulley.*

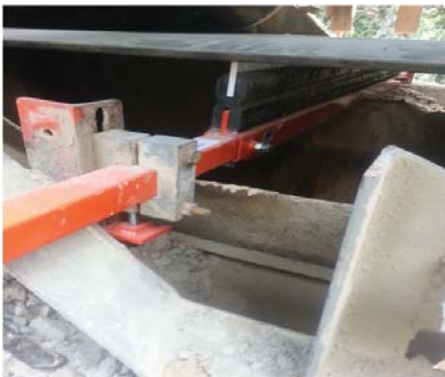
*Martin® SC16 Cleaner uses a tungsten blade to dislodge adhered material.*
