PROBLEM SOLVED™ PAPER

SOLUTION: Martin® Hurrican Air Cannons

INDUSTRY: Cement

LOCATION: Cement Plant in Texas, US

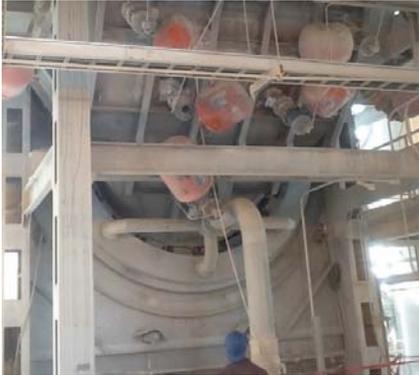
After only seven months, the plant quickly realized they had a problem with the air cannons on the feed shelf leading to the clinker. There was no access to the air cannons and they were in need of constant repair. To reach them, employees had to place scaffolding around the clinker.

Before - The plant could not easily reach the air cannons to service them.

After reviewing the problem, Martin Engineering recommended installing blow pipes to extend to the next floor for easier access. Additionally, 7-70ml Martin® Hurricane Air Cannons were installed with Martin's supervision.

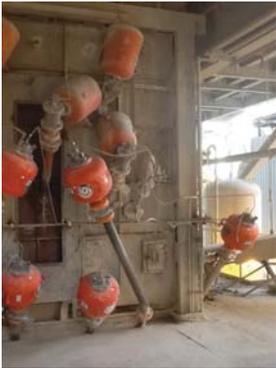
After - Martin installed blow pipes up through the ceiling to the floor above, making access easier.

The maintenance manager at the plant stated "cannons are working great!" Because the air cannons are easier to reach for service, and because they are located in a location better suited for maintenance, the plant has not had to stop production to service them. The scaffolding has been removed and production has been restored to full capacity.

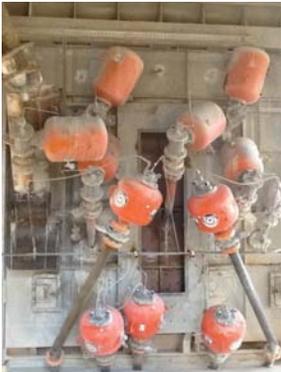
The Martin® Air Cannons were designed to fit in smaller places, providing more power from less air.

The Martin® Hurricane Air Cannons were designed for simple maintenance. The complete valve assembly can be removed in one easy step, working from one side of the tank. It can be replaced within minutes to keep your process running. There is no need to ever remove the tank from the vessel for service, making them ideal for this application.
