# PROBLEM SOLVED™ PAPER

**SOLUTION:** Martin® ApronSeal™ Skirting

**LOCATION:** Platte Generating Station, Grand Island, NE

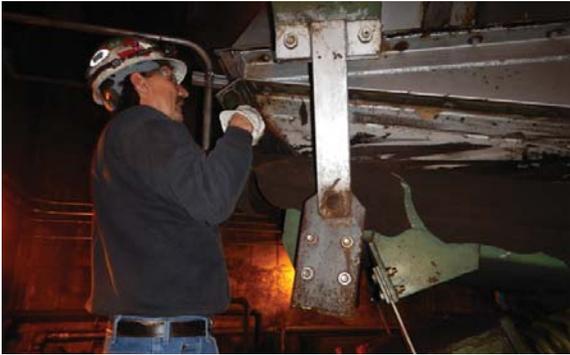
Platte Generating Station (PGS), a coal-fired power plant located in Nebraska handling a volume of approximately 30,000 tons per month of PRB coal, was experiencing failures of the rubber/fabric seals at the top of the chute wall on its Train Unload Vibratory Feeder. Unable to handle the powerful vibration, the thin rubber seals allowed dust and fines to spill from the chute, creating a potential workplace hazard. Workers had to clean up at least once per month, and the spillage created a potential workplace hazard.

*Platte was experiencing failures of the rubber/fabric seals at the top of the chute wall on its train unload feeder.*

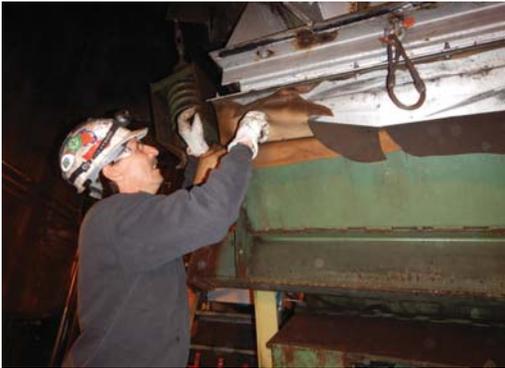
*Martin came up with an innovative solution and performed a custom installation of a Martin® ApronSeal™ Skirting.*

Martin technicians inspected the issue and came up with an innovative solution. After removing the original seal, a highly experienced technician performed a custom installation of a Martin® ApronSeal™ Skirting on the chute wall. Designed originally for sealing the bottom of high volume conveyor chutes, the EPDM rubber composite skirt offers excellent rigidity and stands up well to constant vibration. Utilizing a specially engineered single strip unistrut system that holds the rubber composite strips firmly into place, the assembly facilitates replacement of the seal safely from outside the chute.

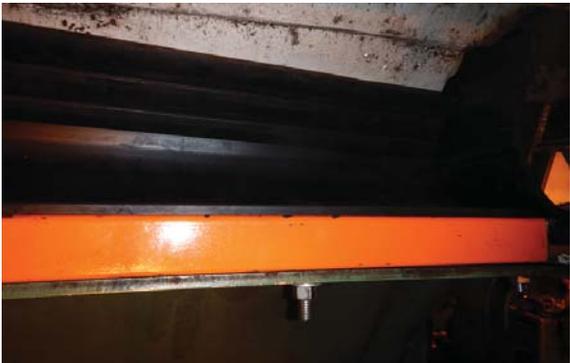
After a months-long trial period running several tons of coal, the Martin® ApronSeal™ Skirting has yet to require replacement. There has been a considerable reduction in spillage and maintenance labor. "The new Martin® ApronSeal™ Skirting holds up to the rigors of the vibratory feeder significantly better than any other type of seal we have tried," commented Ryan Schmitz, Production Engineer at PGS. Due to the rigidity and longevity of the Martin® ApronSeal™ Skirting experienced to date, and the associated reduction in airborne dust, plant managers have initiated the proposal process for another three units to be installed in other areas of the facility.

*After a trial period running several tons of coal, the Martin® ApronSeal™ Skirting has yet to require replacement.*
