# PROBLEM SOLVED™ PAPER

**SOLUTION:** Martin® Hurricane Air Cannons

**TITLE:** Martin® Air Cannons improved material flow & reduced manual intervention

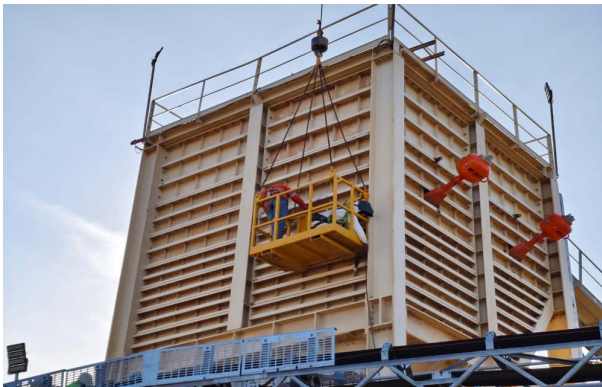
Martin® Hurricane Air Cannons Installation in progress

Martin Engineering Africa assessed the application and recommended the installation of a comprehensive flow enhancement system using 70-litre Hurricane Air Cannons, strategically positioned across the affected bin. A total of fourteen air cannons were installed to ensure adequate coverage and effectively address the scale of the blockage problem. The solution was designed to deliver powerful air bursts to dislodge material buildup and maintain continuous flow. By increasing the number of air cannons and optimizing their placement, the system provided consistent performance and prevented the recurrence of blockages that had previously hindered operations.
