# PROBLEM SOLVED™ PAPER

**SOLUTION:** CleanScrape® Belt Cleaners

**INDUSTRY:** Steel

**LOCATION:** ArcelorMittal, Fos Sur Mer, France

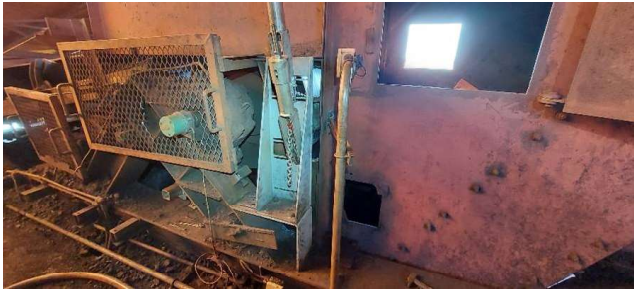
The damp, dense cargo contributed to adhered material clinging to the belt.

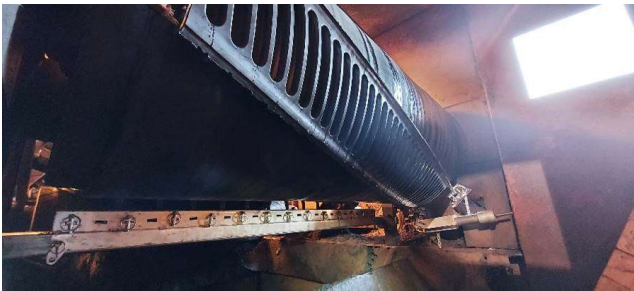
The unique design of the CleanScrape Primary Cleaner contributes to its effectiveness and long service life.

Technicians from Martin Engineering France examined the system and recommended a CleanScrape® Primary Cleaner HD (heavy-duty) and a CleanScrape® Secondary Cleaner. Installed at an angle across the discharge pulley, the primary cleaner is designed for the most punishing bulk handling environments. It is equipped with tungsten carbide tips that are safe for use on mechanical splices due to the minimal pressure on the belt. After initial tests and a single re-tensioning, it requires no further adjustment and lasts up to 4x longer than standard polyurethane blades. The CleanScrape Secondary Cleaner features a stainless steel assembly and carbide tipped blades. The unit removes leftover fines on the belt to further reduce carryback.

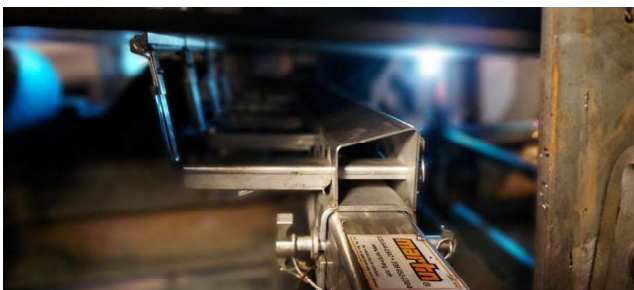
The CleanScrape Secondary Cleaners also significantly reduce dust emissions on the return path.
