# PROBLEM SOLVED™ PAPER

**SOLUTION:** CleanScrape

**INDUSTRY:** Coal

**LOCATION:** Bharat Aluminium Company Limited (BALCO), Korba, Chhattisgarh, India

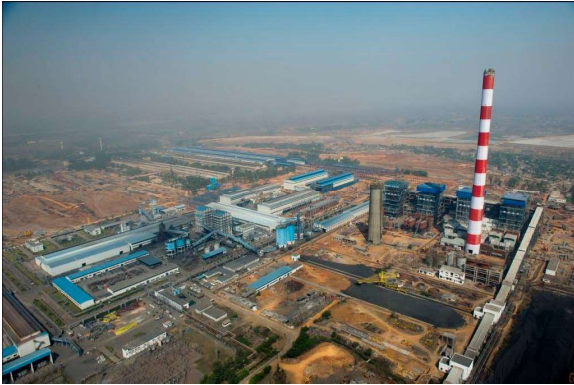
The Balco plant has miles of conveyor belting that it depends on for system efficiency.

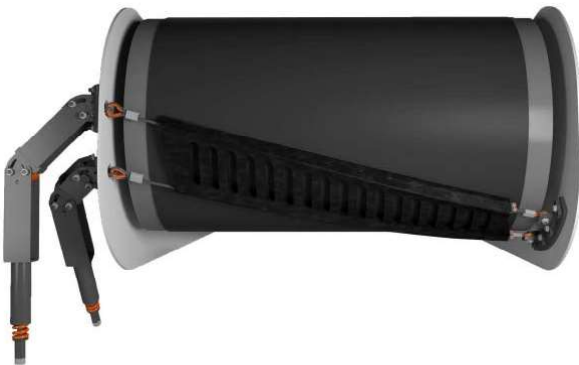
The CleanScrape® Primary Cleaner's innovative design spans the width of the belt.

The Martin Engineering India team visited the site and performed an assessment. After showing the Martin® CleanScrape® Primary Cleaner to operators, they scheduled an installation. Designed for the heaviest applications, it features a matrix of rugged tungsten carbide scrapers that are easy on mechanical splices and provide better cleaning efficiency throughout the blade's life than most traditional blade designs. The CleanScrape was installed diagonally to form a 3-dimensional curve around the head pulley at 17-19 degrees using double tensioners. Field testing has revealed the blade typically delivers up to 4x the service life of urethane primary cleaners, without ever needing re-tensioning after adjustments following a performance review.

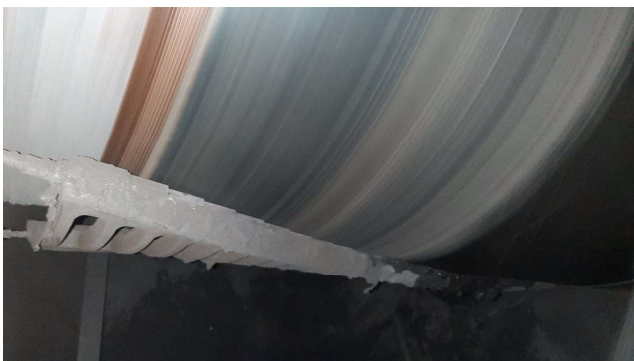
The time and money saved on tensioning and blade replacement adds to the ROI from the unique design. +
