# PROBLEM SOLVED™ PAPER

**SOLUTION:** CleanScape®, Martin® Impact Cradle, Martin® ApronSeal™ Skirting

**INDUSTRY:** Steel

**TITLE:** CleanScape® Belt Cleaner Eliminates Carryback at a Large Steel Plant

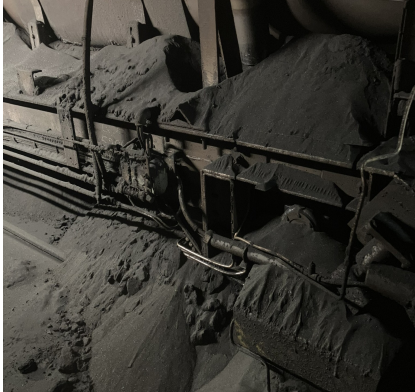
Material loss causing safety hazards and production loss

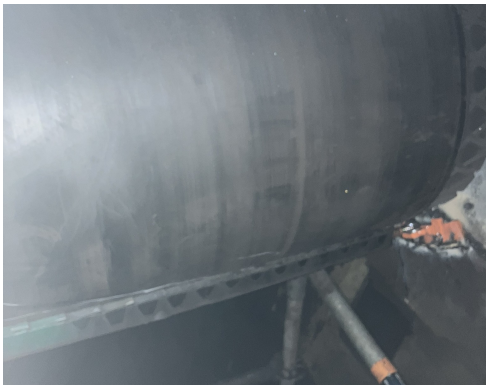
The CleanScape® Cleaner is the latest innovation in belt cleaning technology.

Following a detailed on-site inspection, our Sales Engineering team, together with our partner Netco13, recommended the installation of a CleanScape® belt cleaner and a Martin® Impact Cradle. The impact cradle was installed at the loading zone to stabilize the belt, absorb impact energy, and prevent belt sag. In addition, Martin® ApronSeal™ Skirting was installed to provide a dual-sealing system that effectively controls fugitive material and dust along the skirtboard area. The CleanScape® belt cleaner was selected because it is highly suitable for applications with limited installation space, as the chute area was restricted. Its design requires minimal tensioner adjustment, easy to maintain in confined spaces & supports reliable low-maintenance operation.

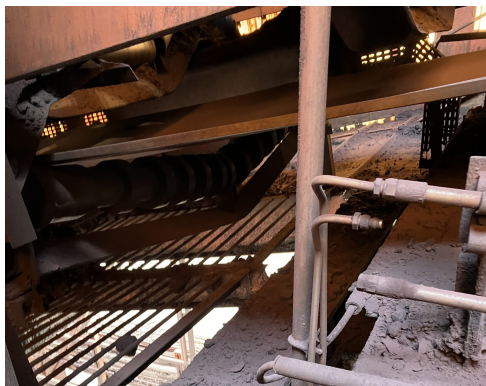
Elimination of material loss underneath the belt

After 6 months of installation, the conveyor system delivered consistent and measurable improvements. Product loss beneath the belt was eliminated, significantly reducing the need for manual cleanup and ongoing maintenance intervention. Housekeeping conditions improved noticeably, creating a cleaner and safer working environment around the conveyor structure. At the same time, overall conveyor reliability increased, supporting uninterrupted coke handling and contributing to stable, continuous production. The customer expressed a high level of satisfaction with the long-term performance of the installed solution.
