# PROBLEM SOLVED™ PAPER

**SOLUTION:** Total Solution™ Conveyor Retrofit

**INDUSTRY:** Sodium Carbonate

**LOCATION:** Kazan Soda Elektrik Uretim A.S., Ankara, Turkey

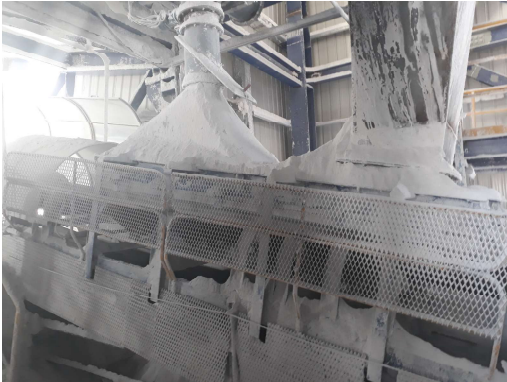
Fine dust would easily escape through openings in the enclosure, filling the area and settling on surfaces.

Representatives from Martin Engineering Turkey examined the area to offer a solution. In the transfer point, technicians installed a Martin® Impact Cradle, ApronSeal™ Skirting, and a Torsion Arm V-Plow. The cradle has smooth energy-absorbing impact bars in a sealed enclosure, rather than rollers, reducing dust. The plow system cleared fugitive material from the return side of the belt. At the discharge zone, the old equipment was replaced by a QC1 HD Primary Cleaner with Twist Tensioner, a secondary Brush Cleaner, a Vibrating Dribble Chute, and Upper & Lower Belt Trackers™. The primary cleaner's modern curved design cleared the belt while the brush dislodged fines from cracks. The trackers kept the belt in line and the dribble chute ensured flow.

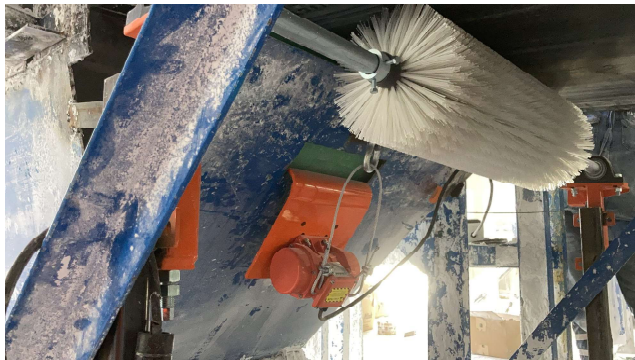
A brush cleaner controls any fines trapped in cracks and divots in the belt from carryback, reducing dust.

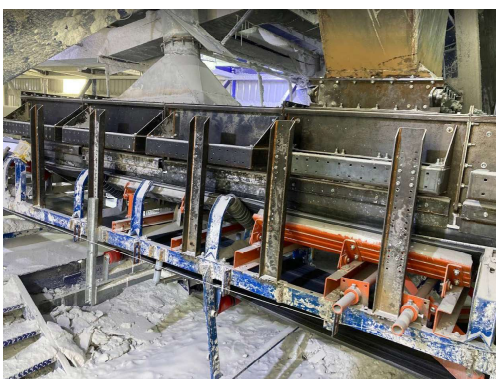
The impact cradle ensures material a soft landing and centered settling, with less dust-causing shifting.
