# PROBLEM SOLVED™ PAPER

**SOLUTION:** Martin® Typhoon Air Cannon

**TITLE:** Martin® Typhoon Air Cannon solved bridging issues in fly ash hoppers

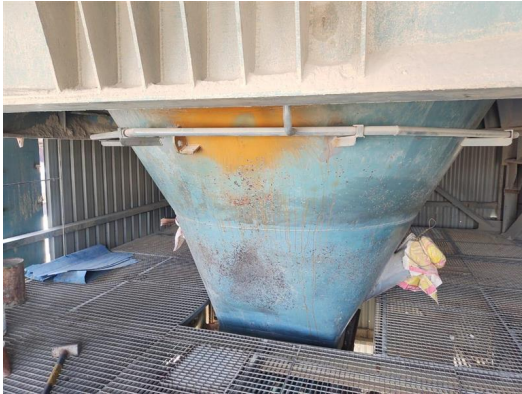
Fly ash hoppers faced frequent blockages. Vibrators and hammering proved to be unsafe and inefficient.

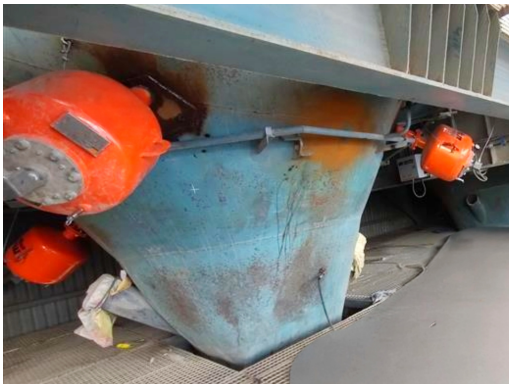
Improved flow and reduced manual intervention led to enhanced operational efficiency and workplace safety.
