PROBLEM SOLVED™ PAPER

SOLUTION: Martin® Hurricane Air Cannon

TITLE: Air Cannons Tackle Material Build-Up in DRC's Largest Copper Mine

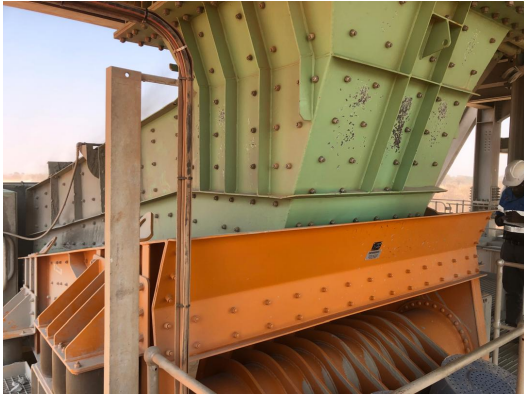
Material build-up in hoppers and chutes often led to manual hammering, causing damage & safety concerns

One of Africa's largest copper producers, located in the DRC, was experiencing material build-up issues in hoppers and chutes, causing significant operational challenges. The high moisture content of the material leads to clumping, resulting in blockages that disrupt material flow and reduce efficiency. Producing approximately 400,000 tonnes of copper per year, it is critical for the mine to maintain optimal production levels—making it essential to address these material flow issues to optimize productivity and minimize downtime. Employees often rely on hammers to dislodge stuck material, creating visible hammer rash on hoppers and chutes. This damage not only increases maintenance costs but also raises safety concerns.

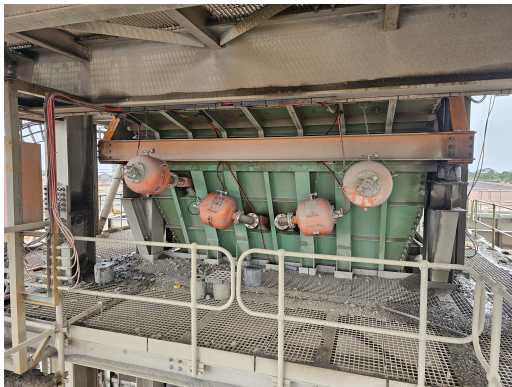
15 numbers of 70-Ltr Martin® Hurricane Air Cannons were strategically installed across critical chutes

After conducting an audit at the mine, our Sales Engineer proposed installing 15 numbers of 70-Ltr capacity Martin® Hurricane Air Cannons across four chutes. This solution is ideal given the chute structures and the challenges posed by materials that retain moisture and become sticky, such as copper, coal, cement, and aggregate. The Martin® Hurricane Air Cannon's design allows for straightforward maintenance, with the complete valve assembly removable in one easy step from one side of the tank. This enables quick replacement within minutes, ensuring minimal disruption to operations. This efficient solution will help tackling material build-ups, improve flow, and enhance overall productivity at the mine.

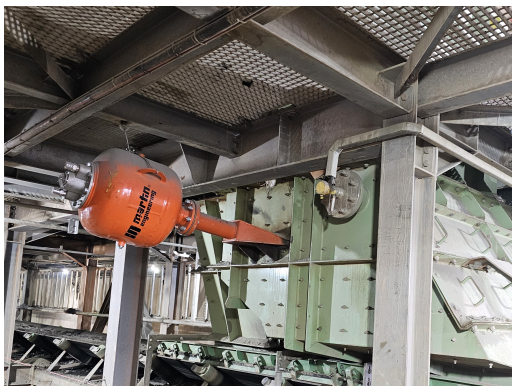
Martin® Hurricane Air Cannons improved material flow, minimized downtime, and boosted overall productivity.

The installation of 15 Martin® Hurricane Air Cannons strategically placed across critical chutes has significantly improved material flow, reducing downtime associated with manual cleaning. Sticky materials that once caused blockages are now effectively dislodged, ensuring smoother, more efficient operation. This has minimized labor-intensive cleaning and allowed employees to focus on productive tasks. As a result, overall productivity has increased, enabling the mine to operate at optimal levels. The user-friendly design also enables quick maintenance, supporting sustained efficiency.
