PROBLEM SOLVED™ PAPER

SOLUTION: CleanScape®, Dual SC16, V Plough, Bias Plough, Belt Support, Sealing

TITLE: Optimizing Efficiency in Underground Mining Operations

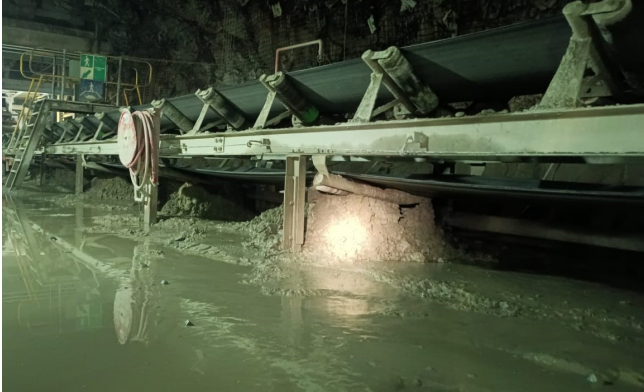
Underground belt conveyors faced carryback issues, resulting in unplanned downtime & potential safety risks.

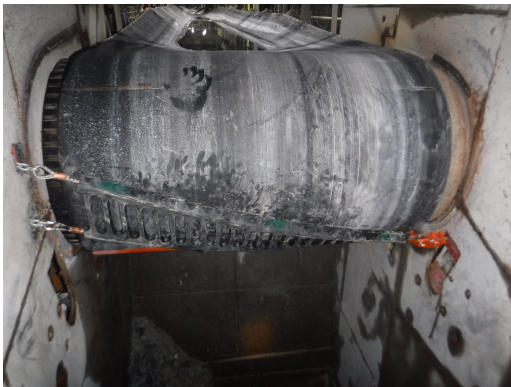
Efficient CleanScape® Primary Cleaner are installed in minimal space and is safe for use on clip joints.

Following a thorough conveyor belt audit conducted by our Partner Manager, a comprehensive solution was recommended to address carryback and material spillage challenges. The proposed setup included the installation of 12 CleanScape® Primary Cleaners—safe for use on conveyor belts with clip joints—alongside 22 Martin® SC16 as Dual Secondary Cleaners for enhanced cleaning efficiency. To further protect the system, Martin® V-Plough and Bias Plough units were installed at the tail pulleys to prevent material buildup and potential belt damage. Additionally, proper belt support was ensured with 14 Martin® High Speed Impact Cradles (HSIC), and effective sealing was achieved using Martin® ApronSeal™ skirting.

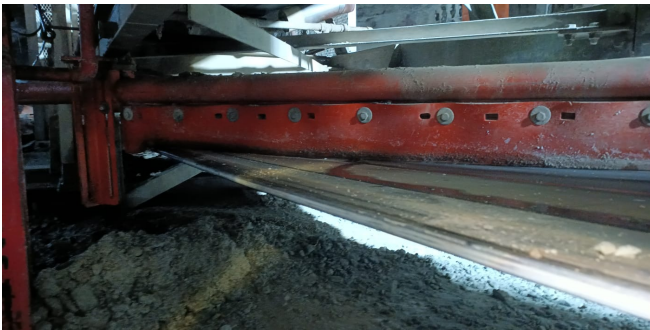
Bias Plough installed to protect the tail pulley.
