# PROBLEM SOLVED™ PAPER

**SOLUTION:** Martin® Hurricane Air Cannons

**INDUSTRY:** Coal-Fired Power

**LOCATION:** Coal-Fired Power Plant in Turkey

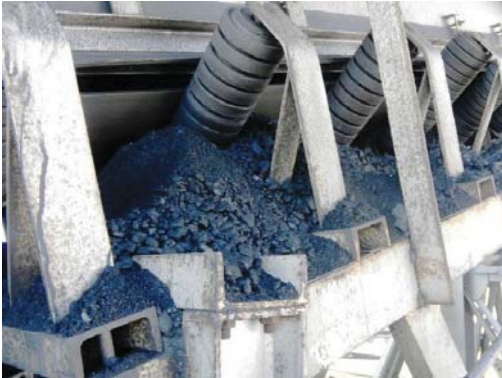
A coal-fired power plant in Turkey produces over 300,000 tons per day, making them the largest manufacturing plant in business with the highest production capacity in Turkey. Imported coal is used to meet the electricity needs of the plant and is used as fuel in the production plant. The plant was having trouble with dust and spillage at the conveyor transfer loading point in addition to excessive spillage and piles of fugitive materials under the conveyor belt. The problem led to manual cleaning and an increase in maintenance costs, resulting in regular and costly down-time and man-hours.

*A coal-fired power plant in Turkey was having trouble with dust and spillage at a conveyor transfer loading point.*

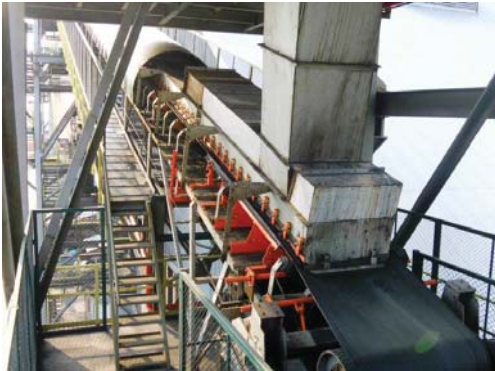
*After assessing the design, Martin Engineering determined several areas for improvements.*

After assessing the design, Martin Engineering determined several areas for improvements. Martin installed Martin® Slider Cradles to support the edges of the belt to eliminate sag and Martin® Impact Cradles to absorb the force of falling material to prevent damage to the belt and structure and to help eliminate spillage. While Martin® ApronSeal™ Skirting was added to prevent spillage without requiring service to maintain an effective seal.

Additionally, a Martin® QC1™ Cleaner XHD was installed to provide a durable belt cleaning performance in this challenging applications with a Martin® SQCS™ Cleaner in the secondary position which allows installation in close quarters and helps resist material buildup.

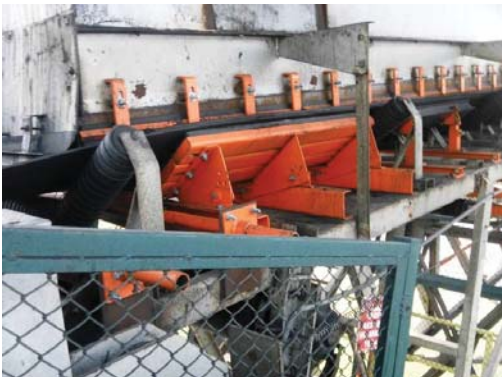
The transfer point upgrades have eliminated the dust and spillage problems and the plant has been running at full capacity since.

*The plant has been running at full capacity since.*
