PROBLEM SOLVED™ PAPER

SOLUTION: Martin® Conveyor Products

INDUSTRY: Mining

LOCATION: Mazapil, Zacatecas, Mexico

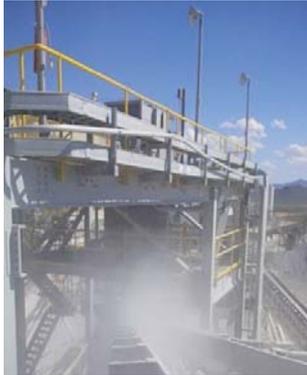
A mine in north central Mexico was experiencing dangerous spillage at the loading zone of its tower mounted conveyor.

Martin Engineering drafted a total solution plan that addressed all of their concerns, reducing spillage and safety.

After conducting a Walk the Belt™ assessment of the system, Martin technicians drafted a total solution plan. It addressed all aspects of the bulk handling process for properly guiding the cargo through the transfer chute, centering the material using impact and slider cradles and containing potential spillage throughout the settling zone. The plan also included chute skirts and dust bags, alignment along the entire path and belt cleaning at the discharge zone. Designed with innovative safety features and ease of maintenance in mind, the entire system of Martin components works to deliver a comprehensive bulk handling solution that reduces spillage, promotes system health and creates a safer workplace.

Following installation, fugitive material was significantly reduced and spillage no longer blocks access to the area. The air around the transfer point and throughout the tower is much clearer. "We no longer need to allocate staff for cleaning during scheduled shutdowns," said an operational manager. "We're very happy with the work done by Martin Engineering." The customer cited the expert service, a thorough understanding of the mine's needs and the quality of the equipment for choosing Martin, and intends to continue the relationship.
