PROBLEM SOLVED™ PAPER

SOLUTION: Foundations™ Workshop, Martin® Belt Cleaners & V-Plow

INDUSTRY: Cement

LOCATION: Ibague, Colombia

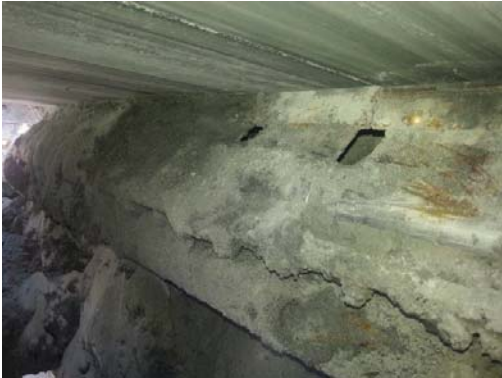
A cement plant in Colombia was experiencing severe spillage issues on several of its conveyors, causing belt misalignment and damage to the belt and rolling components. On conveyor 312-04, which receives limestone from the primary crusher, carryback resulted in a crusty accumulation on the return rollers and underside of the belt. Conveyors 4125 and 4130, used for handling cement additives, experienced spillage along the entire return run, as well as encrusted material in the return rollers. The situation increased maintenance costs, due to premature replacement of the belt and conveyor components, as well as the labor expense of three people for a full shift each. These employees were also exposed to the inherent risk of having to work around moving conveyors.

At a cement plant in Colombia, limestone was accumulating on the return roller and the underside of the belt.

At the end of the workshop attendees were able to identify the primary issues and prioritize the most pressing needs. The Martin solution was recommended in several stages to suit the plant's budget. First the team installed primary and secondary belt cleaners to eliminate carryback, significantly reducing material spillages as well as material on rolling components. Martin® V-Plows were also installed conveyors 4125 and 4130 to protect the tail pulley. The customer is very satisfied, "The solution has improved the condition of the belt, eliminating material spillages caused by accumulation of material and allowing proper functionality of the equipment." The company has requested a quote for another workshop for different personnel from the cement plant, as well as additional equipment for the rest of the conveyors.
