# PROBLEM SOLVED™ PAPER

**SOLUTION:** Martin® Hurricane Air Cannons

**INDUSTRY:** Port Terminal

**TITLE:** Air Cannon System Upgrade and Maintenance Training Deliver Lasting Results

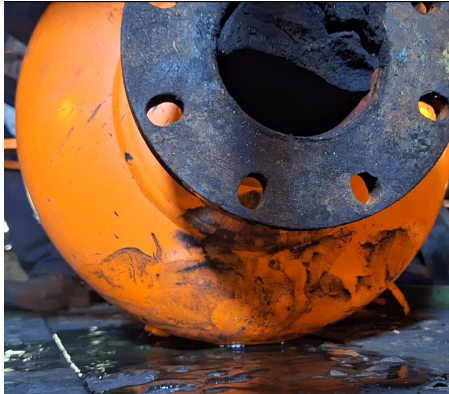
Old Air Cannon has been removed and damaged due to lack of maintenance

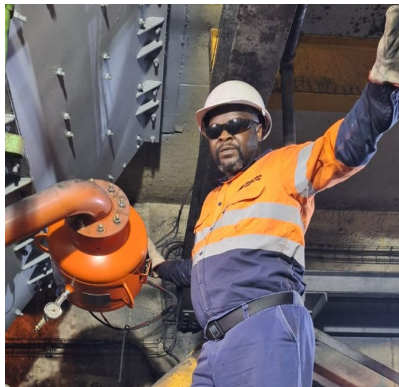
Hurricane® Air Cannon upgrade supported by practical maintenance training to improve reliability and safety.

The solution included the installation of 12 Martin® Hurricane 35L Air Cannons and 2 new control panels across the affected tippler systems. In addition to the equipment upgrade, Martin Engineering provided practical maintenance training for the customer's artisans and operators. The training focused on correct inspection procedures, preventative maintenance practices and troubleshooting techniques. This combination of equipment replacement and knowledge transfer ensured that the customer received both an immediate operational improvement and a sustainable long-term solution.

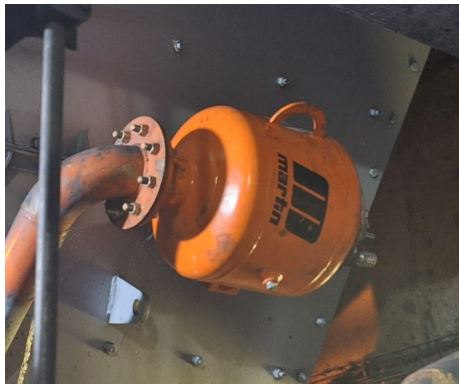
Martin® Hurricane Air Cannon improve the flow of bulk materials
