# PROBLEM SOLVED™ PAPER

**SOLUTION:** Martin® Chevron Cleaner

**LOCATION:** KC Cottrell, Ngodwana Biomass Power Station, South-Africa

**TITLE:** Martin Chevron Cleaner: Protecting Every "Step" Beneath the Conveyor

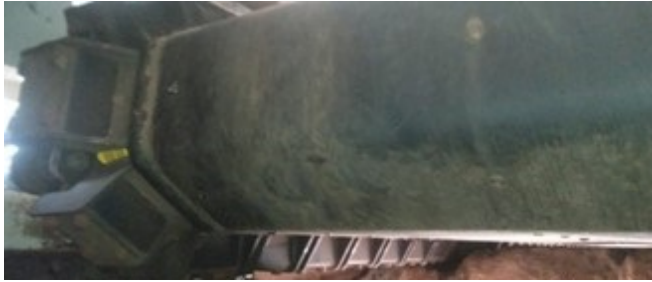
The wing pulley design means space is limited.

An energy biomass power plant faced a persistent issue with woodfibre spillage accumulating under the Buffalo Feeder conveyor. This spillage was largely due to the 'wing pulley' design, which made it challenging to find a compatible cleaning solution that could fit within the confined space around the conveyor. The excessive build-up of fine woodfibre not only interfered with operations but also created a serious safety hazard, as the area directly beneath the conveyor serves as a walkway for employees. The spillage posed significant risks of slips, trips, and falls, threatening the safety of the workforce navigating this pathway daily.

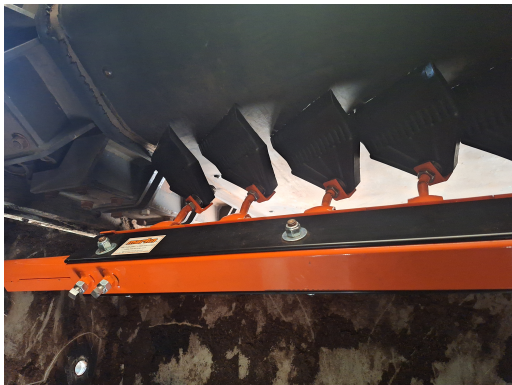
The Chevron Cleaner is ideal where space is limited.

A Martin Engineering sales engineer conducted a site visit to assess the Buffalo Feeder conveyor and its spillage issues. Due to the conveyor's space constraints and design, the engineer recommended the Martin® Chevron Cleaner as the optimal solution. The Chevron Cleaner's design allows it to handle fine wood fiber material effectively, preventing spillage while working efficiently within the system's limitations. This solution significantly reduced wood fiber spillage, creating a safer environment for employees who use the area as a walkway.

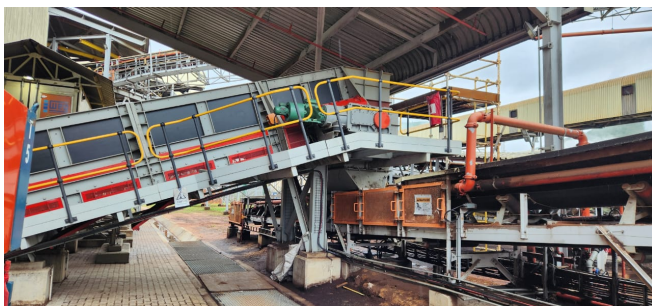
No more spillage on the walkway beneath the Buffalo Feeder!

The significant reduction in spillage has minimized the need for frequent manual clean-up, enhancing operational efficiency and reducing maintenance requirements. The reduced spillage also greatly improves safety, as it minimizes slip, trip, and fall hazards for employees who regularly traverse the area beneath the conveyor. The customer expressed satisfaction, stating, "Less spillage translates to less downtime needed for cleaning and has improved overall workflow and productivity. The support we received from the Sales Engineer, along with his recommendation of a specialized cleaner, truly came to our rescue."
