# PROBLEM SOLVED™ PAPER

**SOLUTION:** CleanScrape® Primary Belt Cleaner

**LOCATION:** Yeniköy-Kemerköy Energy, Kemerköy Power Plant, Muğla, Turkey

**TITLE:** CleanScrape® - High Cleaning Efficiency with Low Maintenance Costs

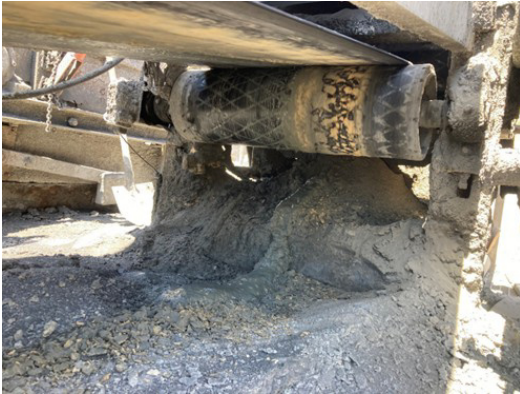
Poor belt cleaner performance was resulting in carryback, spillage and excessive maintenance.

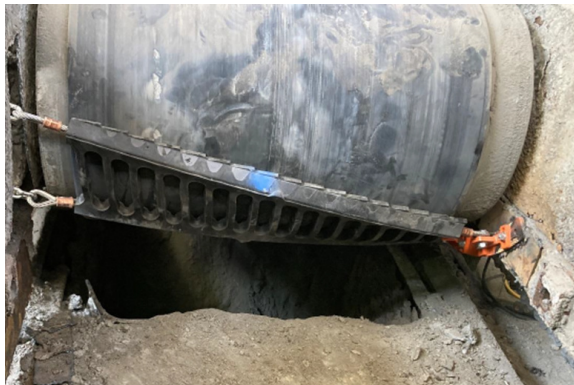
The next-generation CleanScrape® belt cleaner was selected thanks to its many advantages.

Seeking a permanent, effective and low maintenance solution, plant management consulted with Martin's experts and conducted a detailed on-site inspection. The next-generation CleanScrape® belt cleaner was selected thanks to its many advantages:

1. Specially engineered for abrasive materials
2. Very low contact pressure leading to extended belt life
3. Performs better than traditional primary and secondary cleaner
4. Curved design for maximum surface contact area
5. Easy installation and virtually zero maintenance requirement,
6. Cleaner tip service life up to 12 months (for this application)
7. Reduced conveyor downtime due to low-tension operation.

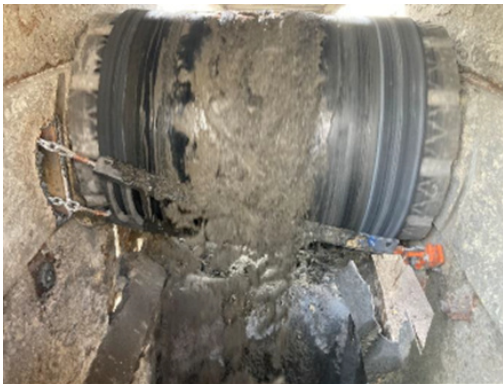
With outstanding performance and durability, CleanScrape® delivered a definitive solution.

Clear and measurable gains were achieved in terms of cleaning, maintenance and labor with a 75% reduction in maintenance and inspection time. Daily cleaning was reduced to once per week and replacement went from every 20 days to every 12 months. Ultimately, plant downtime was significantly reduced and thanks to the high level of satisfaction and clear performance improvement at Kemerköy, another thermal power plant in the region also invested in CleanScrape®. CleanScrape® delivered a definitive solution at Kemerköy by reducing maintenance workload, providing stand-alone belt cleaning performance, and eliminating chronic issues caused by polyurethane belt cleaners.
