# PROBLEM SOLVED™ PAPER

**SOLUTION:** Martin® MultiPort and Hurricane Air Cannon

**INDUSTRY:** Cement

**TITLE:** Martin® MultiPort & Hurricane Air Cannons Improved Preheater Reliability

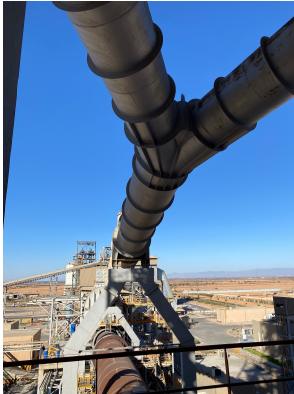
The preheater tower at the cement plant was experiencing severe material build-up and concretion.

A large cement production facility in Morocco, producing approximately 1.6 million tonnes per year, began experiencing significant operational challenges in its preheater tower. As one of the organization's newest plants in the country, it operates a single production line from the preheater tower to the clinker cooler, making system reliability critical to safe and stable operation. Increased use of alternative Carbonized Solid Recovered (CSR) fuels led to severe material build-up and concretion inside the preheater tower, restricting material flow and gas circulation. This resulted in frequent blockages and unplanned shutdowns. The build-up also increased safety risks due to manual cleaning in high-temperature areas and caused ongoing productivity losses.

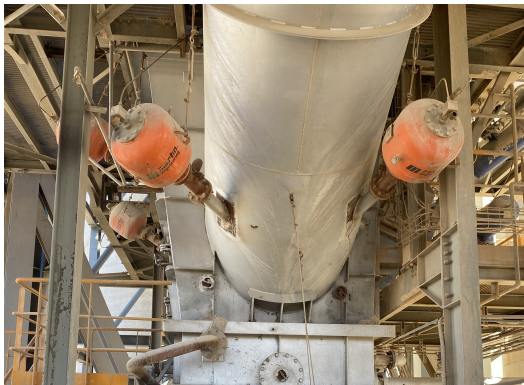
29 Martin® Hurricane Air Cannons were installed in strategic locations.

Martin Engineering France proposed a targeted flow-aid solution designed specifically for the harsh conditions of the preheater tower. The recommended system consisted of a combination of Martin® MultiPorts and Hurricane® Air Cannons, selected for their proven performance in cement and high-temperature process environments. In total, two MultiPorts and thirty Hurricane Air Cannons were installed at strategic locations along the preheater tower where material build-up was most severe. The robust construction of the Hurricane Air Cannon makes it particularly well suited to the extreme conditions found in cement preheaters, including high temperatures, abrasive dust, and continuous operation.

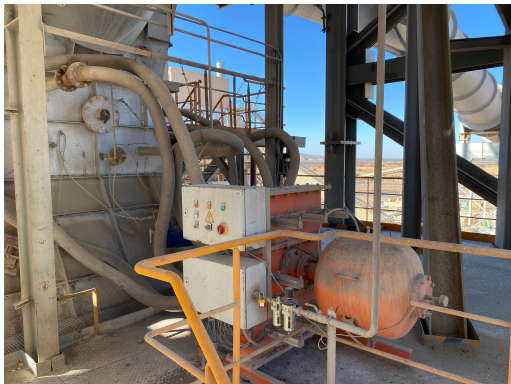
The plant reported an immediate increase in production

Within a few months of installation, the combined solution delivered clear and measurable improvements. Material build-up inside the preheater tower was significantly reduced, and blockages that previously caused unplanned shutdowns were eliminated. Maintenance interventions decreased, reducing personnel exposure to hazardous environments and lowering overall operational risk. The customer confirmed that the Martin Engineering solution completely resolved the problem and expressed high satisfaction with both the product performance and the technical support provided.
