PROBLEM SOLVED™ PAPER

SOLUTION: Martin® Rotary Brush Cleaner

TITLE: A customized mounting bracket for cleaner saves time & increase safety

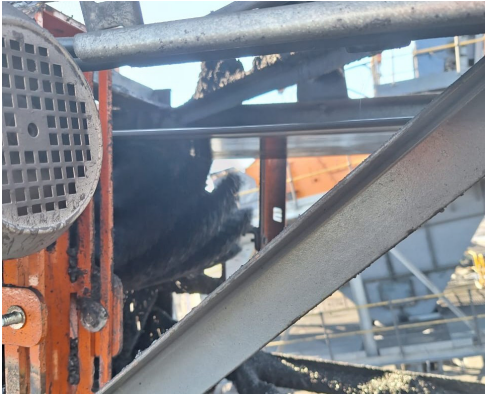
Unsafe, time consuming Brush Cleaner maintenance with restricted one-sided walkway access

At an anthracite mine producing more than 300,000 tonnes per annum, a Martin® Rotary Brush Cleaner was installed to prevent material carryback and maintain conveyor belt cleanliness. However, during the maintenance schedules for the brush cleaner, the adjustment process to ensure the cleaner's contact level with the belt became challenging due to the restricted access caused by a one-sided walkway. To level the brush cleaner, workers had to manually lift it from the center, which created two significant issues: manual lifting in a confined space posed a serious safety risk for the team, and the process was time-consuming, leading to increased downtime and reduced overall productivity.

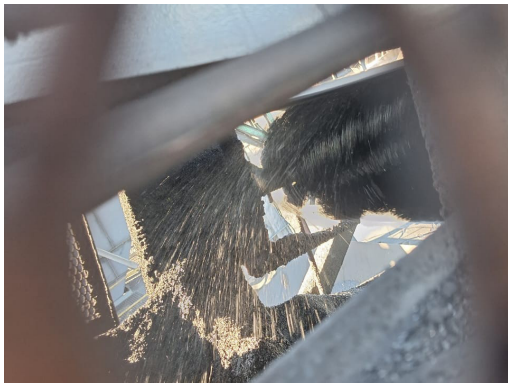
Customizing the rotary brush adjustment bracket was recommended to ensure safe, easy maintenance.

Martin® Rotary Brush Cleaner was the ideal choice due to its consistent cleaning performance with abrasive anthracite material and lower maintenance requirements. However, to address the maintenance-related accessibility, safety and downtime concerns, Martin's expert service technicians conducted a site visit and recommended customizing the rotary brush adjustment bracket to make it more accessible and user-friendly. The custom-made mounting bracket design and installation directly resolved the core accessibility challenge, ensuring safer and efficient adjustments. This case demonstrates how the Martin Engineering understands customer pain points and responds with engineered solutions that deliver cleaner, safer and more productive performance.

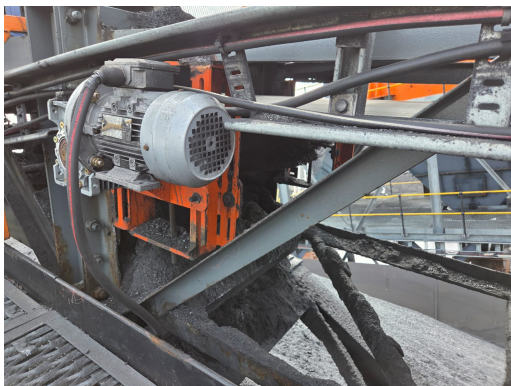
The customised bracket now allows quick, simple access, making maintenance safer and more efficient.

A targeted design upgrade to the Brush Cleaner focused on safety and ease of maintenance, resulting in a complete operational improvement. By eliminating hazardous lifting tasks, simplifying adjustments to minimize downtime, and ensuring reliable conveyor performance in a demanding coal mining environment, Martin Engineering effectively solved the maintenance challenge. The customised bracket now allows quick, simple access, even with only one walkway, making maintenance safer and more efficient. The customer confirmed their satisfaction with the improved adjustment process and expressed confidence in the cleaner's overall performance.
