# PROBLEM SOLVED™ PAPER

**SOLUTION:** Martin® QC1+™ Cleaner HD

**TITLE:** Martin® QC1+™ Cleaner HD Eliminated Carryback at Chrome plant

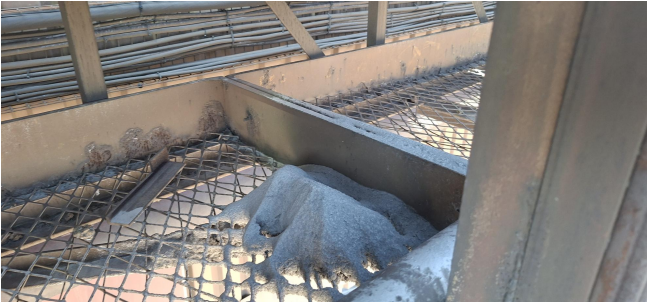
A major ferrochrome production facility with an annual production capacity of approximately 285,000 tonnes relies on its crusher plant to process raw and recycled materials to the correct size for efficient production and optimal chrome recovery. The 750 mm conveyor system depended on a secondary belt cleaner that was unable to effectively control carryback. As a result, material accumulated on the return side of the belt, causing spillage along the conveyor, increasing housekeeping requirements, creating potential slip, trip, and fall hazards for personnel, and negatively impacting conveyor efficiency and reliability.

Spillage due to ineffective belt cleaning causing safety hazards

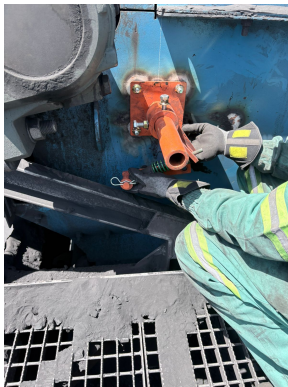
Installation of Martin® QC1+™ Cleaner HD

Following a thorough Walk the Belt™ inspection, our expert Sales Engineer recommended the installation of the Martin® QC1+™ Cleaner HD. This CEMA-recommended (Conveyor Equipment Manufacturers Association) cleaning arrangement removes the bulk of carryback at the head pulley, allowing the secondary cleaner to effectively remove the remaining residue and improve overall belt-cleaning performance. Featuring patented Constant Angle Radial Pressure (CARP) technology, Martin® QC1+™ Cleaner HD maintains consistent blade-to-belt contact and cleaning pressure, delivering superior cleaning performance, reduced carryback, and extended blade life.

Within two weeks of installation, carryback was effectively eliminated, significantly improving belt cleanliness and reducing fugitive material along the conveyor. Lower spillage levels reduced housekeeping requirements and helped create a safer working environment by minimizing slip, trip, and fall hazards. The improved cleaning performance increased conveyor efficiency, reduced material loss, and contributed to more reliable plant operation. The customer expressed satisfaction with both the solution and installation process, noting measurable improvements in conveyor performance, operational efficiency, and workplace safety.

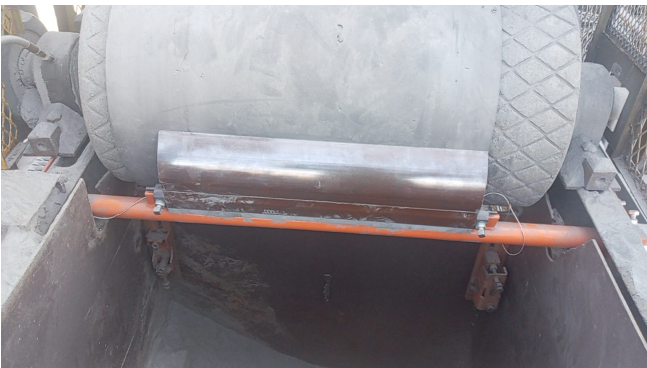
Martin® QC1+™ Cleaner HD with Constant Angle Radial Pressure (CARP) technology
