# PROBLEM SOLVED™ PAPER

**SOLUTION:** Martin® QC1™ HD & SQC2™ Mini Scraper

**TITLE:** QC1™ HD and SQC2™ Mini Cleaner Delivered Reliable Belt Cleaning.

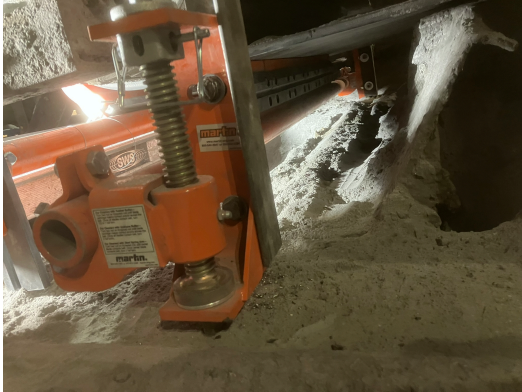
Installation of Martin QC1™ HD to improve fugitive material under the belt.

Following a detailed on-site inspection, Martin Engineering France recommended a complete belt cleaning solution for a reversing conveyor. The system comprised one Martin® QC1™ HD primary belt cleaner and two Martin® SQC2™ Mini secondary belt cleaners, selected to suit bidirectional operation. The QC1™ HD primary cleaner was installed at the head pulley to remove the majority of carryback. Its heavy-duty curved urethane blade delivers consistent cleaning on wide belts at moderate speeds while accommodating belt reversal and mechanical splices. Fast one-pin blade replacement enables safe maintenance, reduced downtime, and improved reliability. The SQC2™ Mini cleaners removed remaining fines and cleaned the belt more effectively.

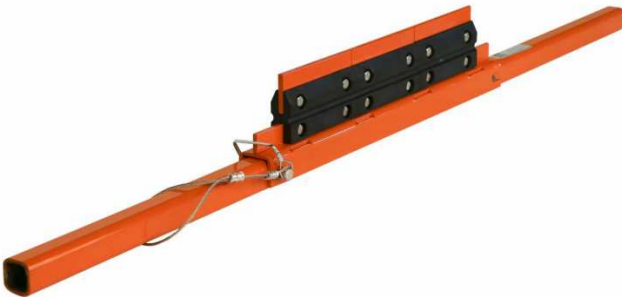
SQC2™ Mini Secondary Belt Cleaner

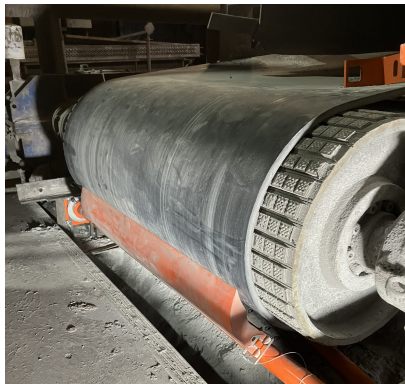
The Patented "CARP" Constant Angle Radial Pressure design keeps a tight seal on the belt.
