PROBLEM SOLVED™ PAPER

SOLUTION: CleanScape® Primary Cleaners

TITLE: CleanScape® :The Optimal Solution for Space-Constrained Applications

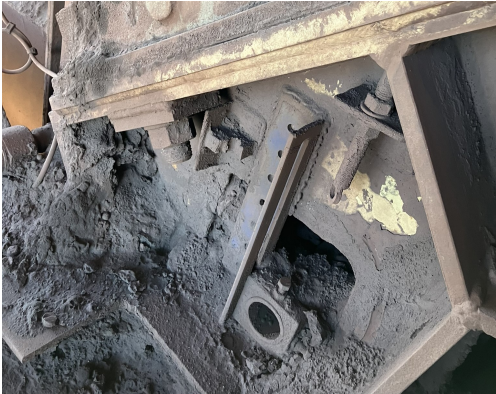
Material spillage demanded frequent manual clean-ups, driving up labor costs and posing serious safety risks.

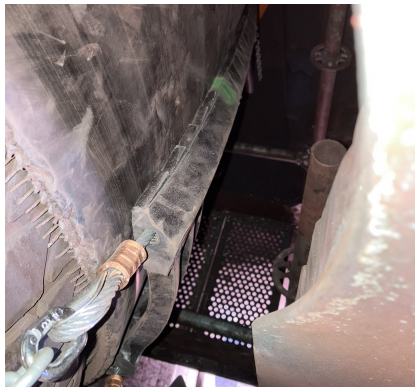
CleanScape® installed in minimal space, ensures low wear on both the belt and the cleaner

To address the issue of material spillage, Martin Engineering's expert team, in collaboration with a trusted partner, proposed the installation of the CleanScape® HD Primary Cleaner. Given the space constraints within the chute, the CleanScape was the ideal solution due to its simple installation and minimal space requirements. The CleanScape cleaner ensures low wear on both the belt and the cleaner, prolonging their effective service life. CleanScape's tungsten carbide tips are completely corrosion-resistant, making it durable even in harsh environments. The cleaner requires minimal maintenance and comes with stainless steel installation kits for added durability. Additionally, it is suitable for use with reversible belts, enhancing its versatility.

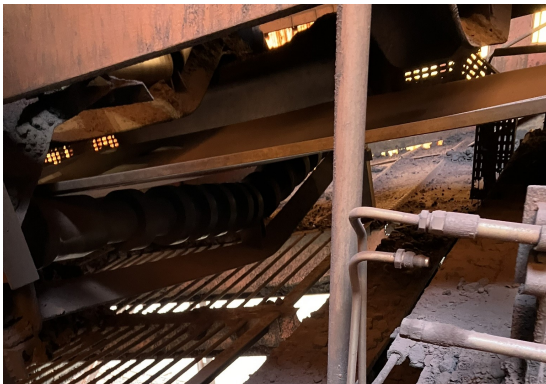
CleanScape® Primary Cleaner effectively reduced the material spillage and associated operational challenges.

The results were overwhelmingly positive, with the plant reporting a significant reduction in manual cleaning frequency. The CleanScape® Primary Cleaner proved to be the optimal solution for this space-constrained application and is highly effective in eliminating spillage, thus addressing all the associated operational challenges. With less material accumulating under the belt, wear on the conveyor system measurably decreased, which has greatly enhanced the longevity of the conveyor system. Following the successful performance of the first installation, a second unit has been fitted on a main conveyor belt feeding a blast furnace.
