PROBLEM SOLVED™ PAPER

INDUSTRY: Coal

LOCATION: Witbank, Mpumalanga, South Africa

TITLE: Solving costly conveyor issues with Martin Engineering's cleaning system

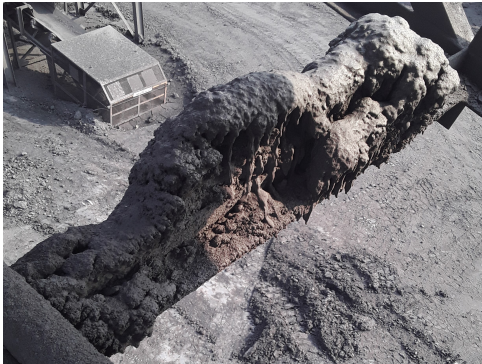
Excessive Spillage under the structure

A leading provider of advanced coal processing solutions, serving the coal mining industry in Mpumalanga, South Africa, was facing significant challenges at one of its discard and processing plants due to an inefficient conveyor cleaning system on a critical belt. The challenges stemmed from both improper installation and lack of maintenance, resulting in severe chute blockages, carryback, and spillage under the conveyor structure. The poorly installed scrapers caused material to accumulate, blocking the chute and impeding the flow. This led to operational inefficiencies, increased maintenance time, and heightened safety risks. Neglecting regular maintenance further aggravated the problem, as the cleaning system deteriorated over time without any adjustments or improvements.

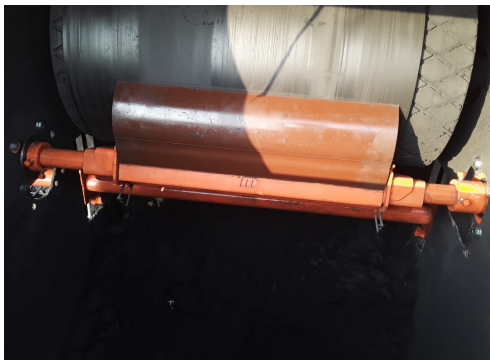
QB1™ Cleaner HD installed at the head pulley

An expert Martin Engineering engineer recognized the critical need for an effective cleaning system by installing both a primary and secondary cleaner. Installed on the head pulley, the Martin® QB1™ Cleaner HD was specifically chosen for its ability to provide reliable cleaning close to the belt's discharge point. Complementing the primary scraper, the SC16 secondary cleaner was installed to deliver additional cleaning further down the belt, effectively capturing any residual material on the return side. Using both primary and secondary belt cleaners offers a comprehensive cleaning solution crucial for maximizing conveyor efficiency. This dual approach ensures thorough cleaning, minimizes carryback, and reduces maintenance needs.

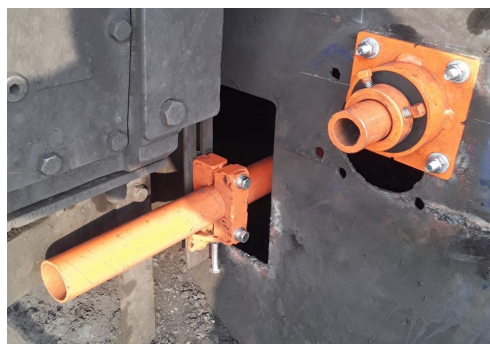
Martin® SC16 Secondary Cleaners installed
