PROBLEM SOLVED™ PAPER

SOLUTION: Martin® Torsion V-Plow

INDUSTRY: Cement

LOCATION: Cimento Elizabeth in Paraiba, Brazil

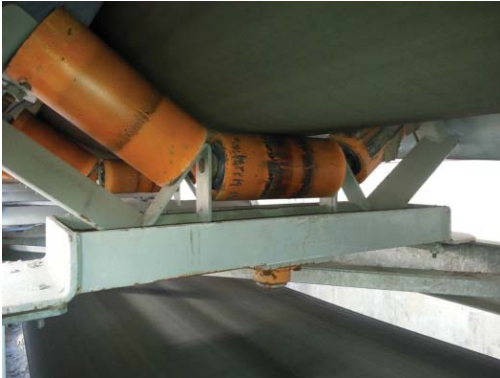
The Cimento Elizabeth plant in Paraiba, Brazil was experiencing fugitive material on a conveyor.

The Cimento Elizabeth plant in Paraiba, Brazil manufactures cement products for a variety of applications, including formulations for harsh service environments, fast-drying concrete and high-strength materials for precast components. The company was experiencing fugitive material on the non-carrying side of the conveyor that carries 1000 TPH of limestone from the mine. The spillage would collect on the underside of the belt during its return run, and the material became trapped between the head pulley and the belt. The problem caused premature wear of the belt, as well as misalignment, and had the potential to damage the tail pulley, as well.

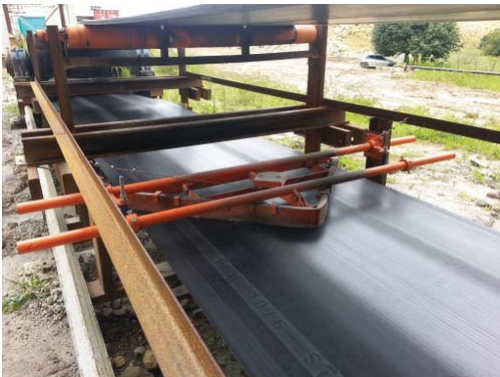
Cimento Elizabeth officials report that they are extremely satisfied with the Martin Engineering solution.

The 900 meter (2,953 foot) belt is now running at its designed speed of 1.6 m/s (5'3"/s), with the V-Plow removing fugitive material before it can reach the tail pulley. The company has greatly extended the life of the belt, which cost an estimated R\$800 per meter to replace. Cimento Elizabeth officials report that they are extremely satisfied with the Martin Engineering solution, and they feel confident that the belt is being protected and the misalignment problem has been resolved. They no longer need to remove trapped material at the pulley, which delivers further savings from reduced maintenance and downtime.
