# PROBLEM SOLVED™ PAPER

**SOLUTION:** Martin® Multi Valve Air Cannon

**INDUSTRY:** Cement

**LOCATION:** A Cement Plant in Panama

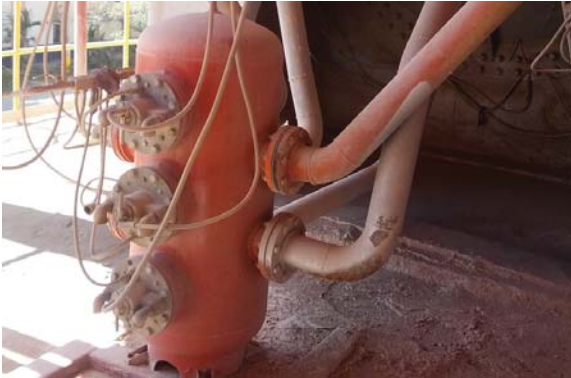
*The workers at a cement plant in Panama were running out of space around their preheater.*

Previously, at a cement plant in Panama, workers were experiencing some difficulties achieving their volume needed due to the preheater's spoon. The issue developed because of the number of air cannons needed to keep the material flowing, was limiting the physical space. The plant realized they needed to address the problem and find a solution that would fulfill the primary function of promoting material flow, but also optimizing space.

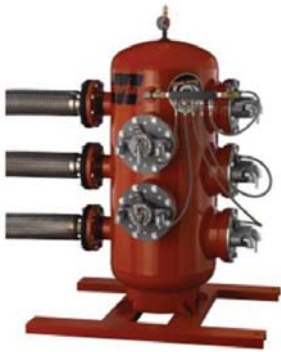
*The Martin® Multi Valve Air Cannon improves flow at five discharge points.*

To eliminate the problem, Martin recommended the installation of the Martin® Multi Valve Air Cannon which has an advanced valve design with up to five independent valves housed in a single tank. This unique design gives five points of application in a single container, which provided a solution to the space problems presented at the plant. The cannon was installed in the preheater's spoon to provide even more physical space to the area.

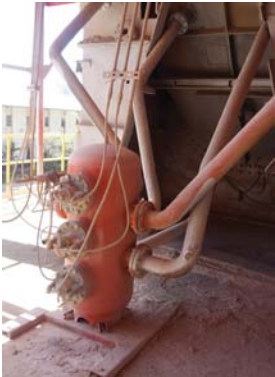
The installation of the Martin® Multi Valve Air Cannon resulted in greater access to the preheater's spoon. The customer is happy with the change and now has better access to the preheater and is better able to keep the area clean. The maintenance process has also improved because now there is a single cannon and in a more accessible location. The staff at the plant was fully satisfied, which led to the purchase of 2 additional cannons. The 2nd cannon was installed in the smoke chamber for better accessibility and ease in inspections. The 3rd cannon was installed in the upstream pipeline, to check the north wall of the preheater tower. The plant is expected to purchase another air cannon soon for another area of the plant.
