# Ambitious quarrying outlook

Vol.8 ISSUE No.1. January/February 2020

# Göltas Cemento opts for modernised belt apron conveying

Two companies in Turkey and East China have both updated their conveyor systems to achieve greater efficiency and ease of maintenance. **Liam McLoughlin** reports

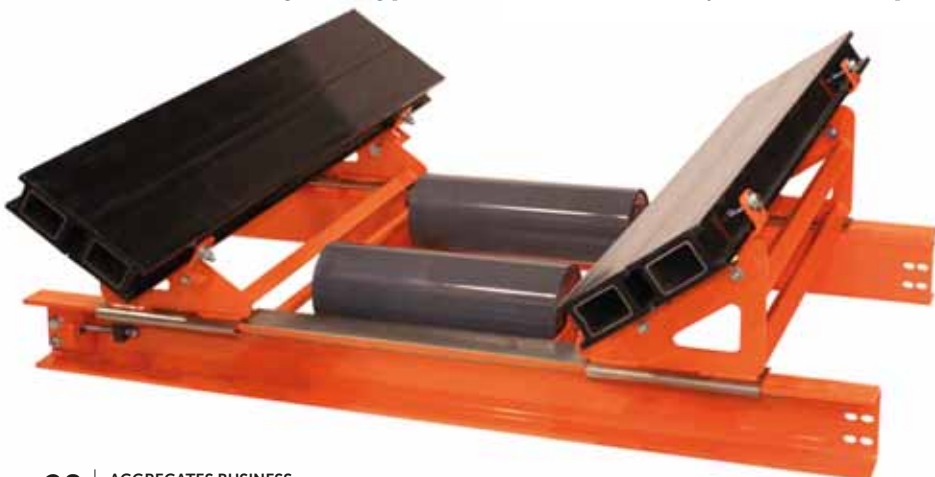
**LEFT:** Track-mounted designs allow components to slide in and out easily for maintenance

To reduce maintenance time and labour, improve safety and extend equipment life, operators should consider track-mounted impact cradles and belt support cradles. Located under the skirtboard and mounted with rugged steel assemblies, the cradles feature large impact-absorbing UHMW polymer 'box bars' engineered with smooth surfaces that the belt can slide across with little friction or belt wear. These assemblies can be pulled out by a single worker and – working safely from outside the conveyor and using only a single tool – the box bars can be simply removed and flipped in a matter of minutes to double the service life.

Along the cargo path in the settling zone and beyond, retractable idlers support the belt and maintain the trough angle. Exposed to the punishing environment, gritty dust and extreme weather, rollers can seize over time. Often set closely together in the loading zone to avoid belt sag, slide-out/slide-in roller frames permit workers to perform idler service outside of the belt plane without the need to raise the belt or remove adjacent idlers.

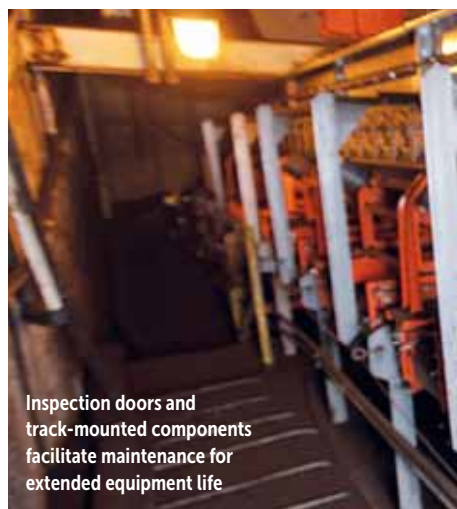
Inspection doors and track-mounted components facilitate maintenance for extended equipment life

Since installation, Martin Engineering says that spillage around the loading zones is under control and dust emissions have been drastically reduced. Operators report that a considerable drop in equipment failure rates has resulted in a substantial increase in productivity. Contributing to the success was workers' ability to easily inspect and service components by sliding them out and servicing them outside of the conveyor.
