REDUCE CONVEYOR MAINTENANCE TIME THROUGH BETTER ACCESS

DANIEL MARSHALL OF MARTIN ENGINEERING DISCUSSES WAYS TO LOWER THE POTENTIAL FOR DOWNTIME ON CONVEYOR SYSTEMS BY IMPROVING ACCESS TO THEM.

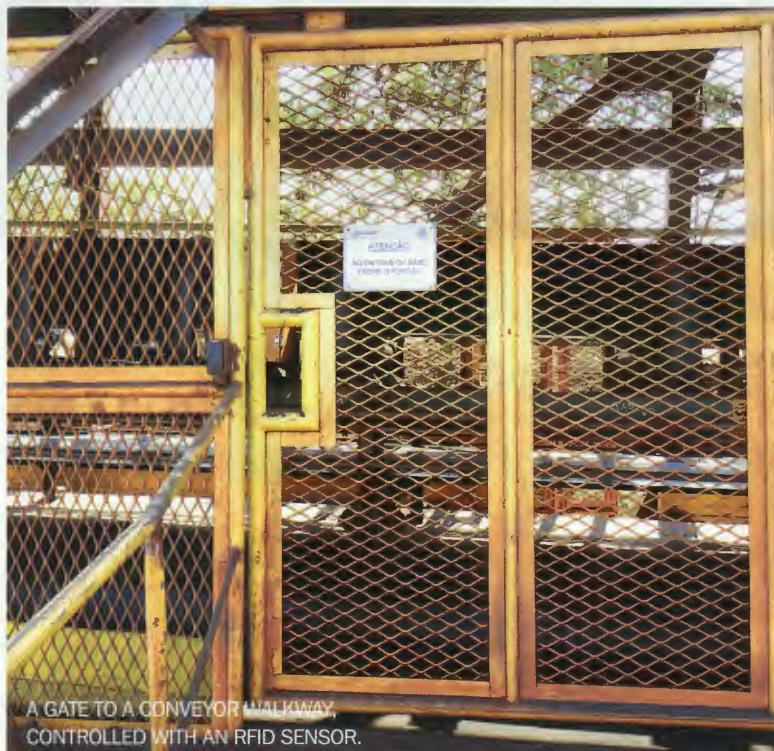
A GATE TO A CONVEYOR WALKWAY, CONTROLLED WITH AN RFID SENSOR.

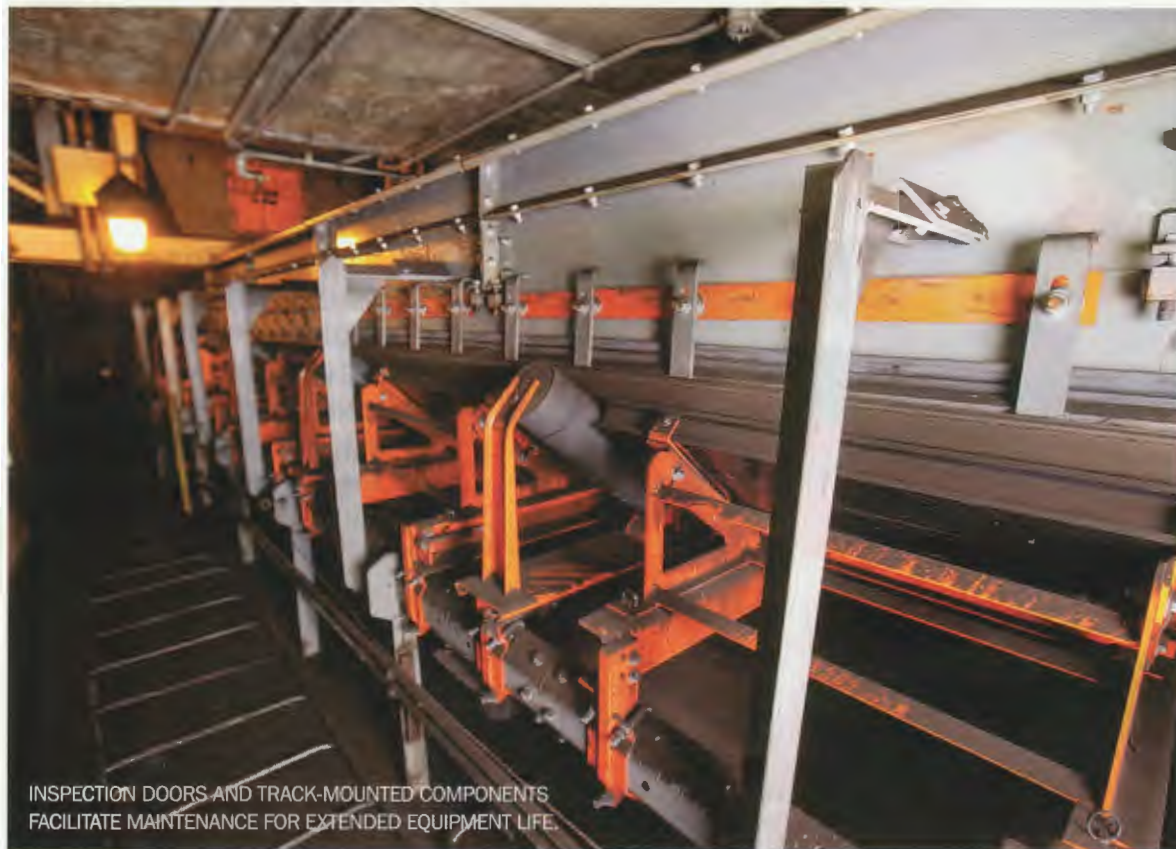
INSPECTION DOORS AND TRACK-MOUNTED COMPONENTS FACILITATE MAINTENANCE FOR EXTENDED EQUIPMENT LIFE.

workers to crouch or crawl under the system or even enter a confined space to inspect it or perform maintenance, which can result in serious injuries. Inspection of the system needs to be fast, easy and safe.

Small inspection doors – either solid or grated – can allow several observation points. Larger doors can offer access points with ample space for service of specific wear parts.

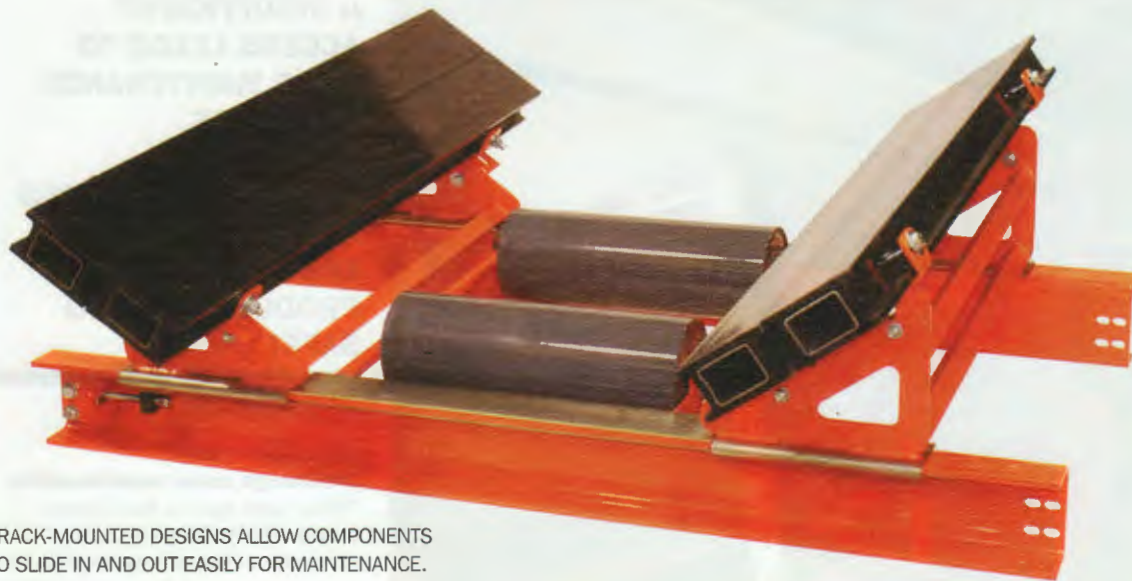
TRACK-MOUNTED DESIGNS ALLOW COMPONENTS TO SLIDE IN AND OUT EASILY FOR MAINTENANCE.

To reduce maintenance time and labor, improve safety and extend equipment life, operators should consider track-mounted impact cradles and belt support cradles.

and mounted with rugged steel assemblies, the cradles feature large impact-absorbing UHMW polymer “box bars” engineered with smooth surfaces that the belt can slide across with little friction or belt wear.

These assemblies can be pulled out by a single worker and – working safely from outside the conveyor and using only a single tool – the box bars can be simply removed and flipped in a matter of minutes to double the service life.

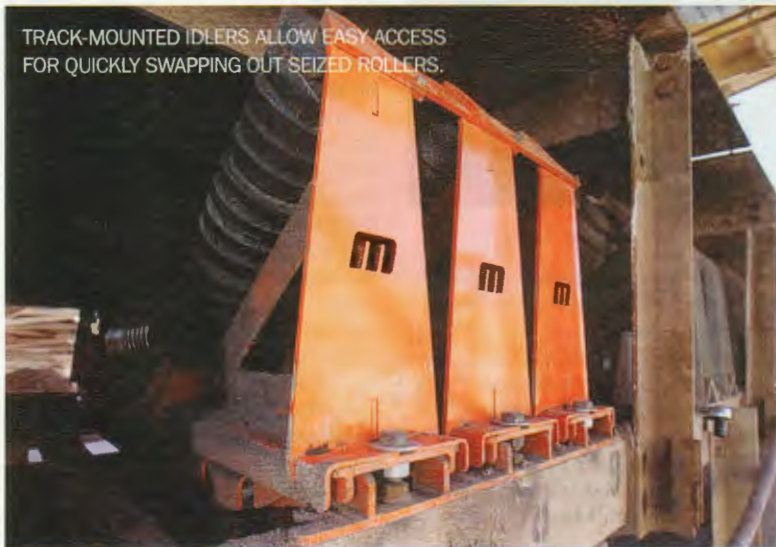
TRACK-MOUNTED IDLERS ALLOW EASY ACCESS FOR QUICKLY SWAPPING OUT SEIZED ROLLERS.

settling zone and beyond, retractable idlers support the belt and maintain the trough angle.

Exposed to the punishing environment, gritty dust and extreme weather, rollers can seize over time.

Often set closely together in the loading zone to avoid belt sag, slide-out/slide-in roller frames permit workers to perform idler service outside of the belt plane without the need to raise the belt or remove adjacent idlers.

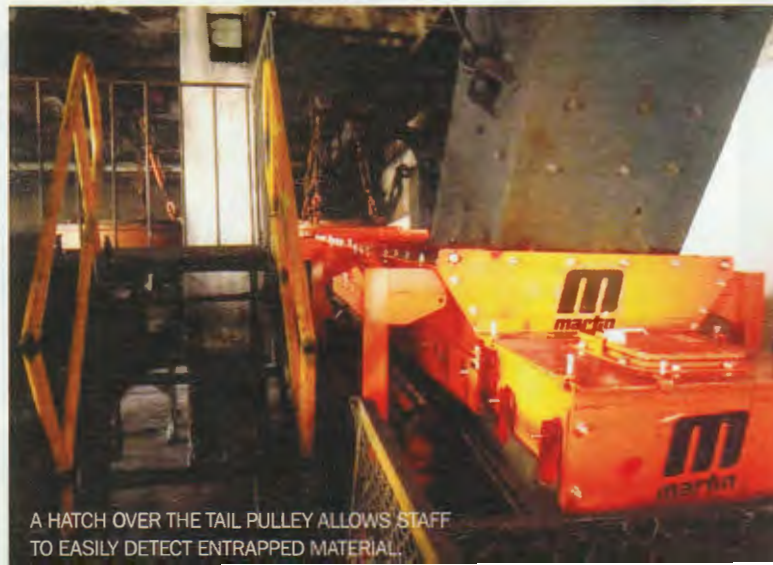
A HATCH OVER THE TAIL PULLEY ALLOWS STAFF TO EASILY DETECT ENTRAPPED MATERIAL.

Inadequate impact control led to spillage becoming entrapped between the belt and tail pulley, damaging them both.
