# BIOMASS

# REDUCE CONVEYOR MAINTENANCE TIME THROUGH BETTER ACCESS

Improved conveyor access can significantly reduce maintenance time and prevent injuries.

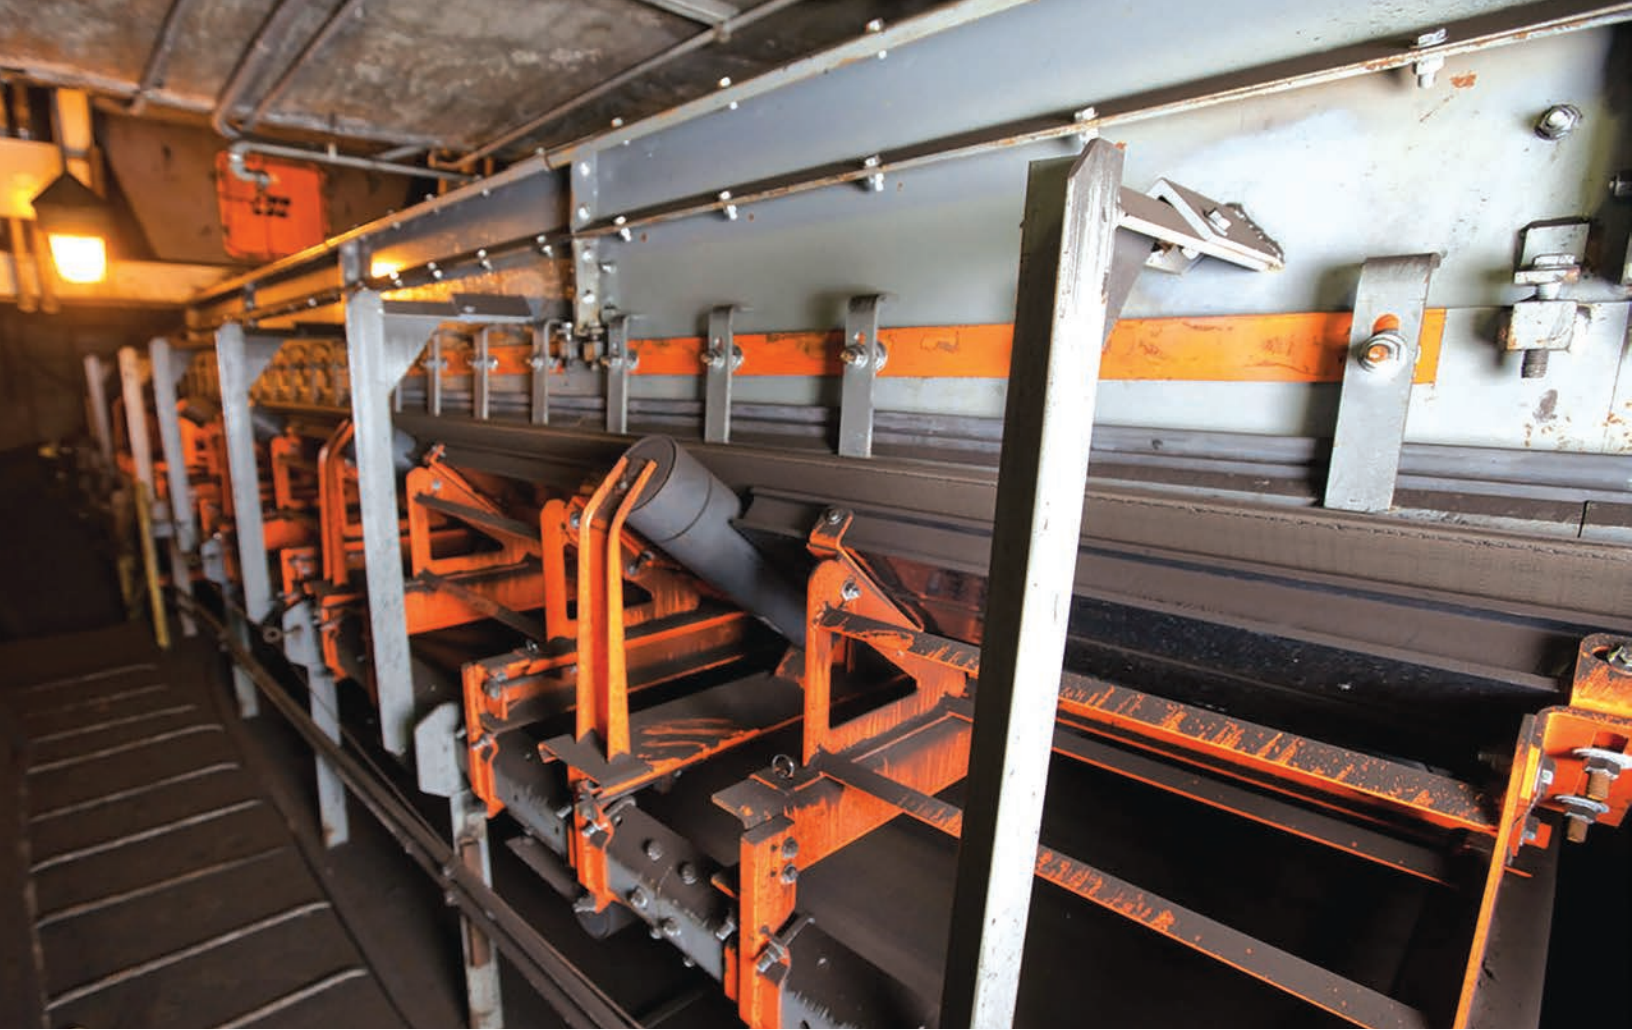
Inspection doors and track-mounted components facilitate maintenance for extended equipment life.  
PHOTO: MARTIN ENGINEERING

To reduce maintenance time and labor, improve safety and extend equipment life, operators should consider track-mounted impact cradles and belt support cradles. Located under the skirtboard and mounted with rugged steel assemblies, the cradles feature large, impact-absorbing, ultra-high-molecular-weight polymer “box bars” engineered with smooth surfaces that the belt can slide across with little friction or belt wear. These assemblies can be pulled out by a single worker, safely from outside the conveyor. Using only a single tool, the box bars can be simply removed and flipped in a matter of minutes to double the service life. Along the cargo path in the settling zone and beyond, retractable idlers support the belt

and maintain the trough angle. Exposed to the punishing environment, gritty dust and extreme weather, rollers can seize over time. Often set closely together in the loading zone to avoid belt sag, slide-out/slide-in roller frames permit workers to perform idler service outside of the belt plane without the need to raise the belt or remove adjacent idlers.

A tight seal is the key to preventing fugitive dust from leaving any chute. Current setups often require workers to crouch or crawl under the system, or even enter a confined space to inspect it or perform maintenance, which can result in serious injuries. Inspection of the system needs to be fast, easy and safe. Small inspection doors, either solid or grated, can allow several observation points. Larger doors can offer access points with ample space for service of specific wear parts.
