# Knock-Knock on Conveyor Idlers

## Ausrichtung von Tragrollen an Gurtförderern

► C. Goldbeck, Martin Engineering, Neposet, USA

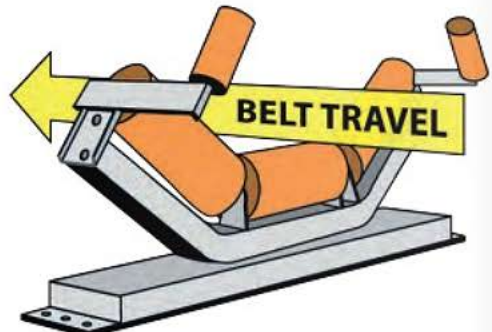
Figure 2: Tracking idler (all photos and graphics by Martin Engineering Company, Neposet, USA)

Unfortunately, to accommodate limited space availability, tracking idlers (► Fig. 2) typically have short sensing arms. This requires a fairly large belt displacement to create a small movement of the idler. While these designs tend to improve tracking, there are limits to how much correction they can deliver, and short sensing arms can actually pinch a belt if the idler pivots too far.

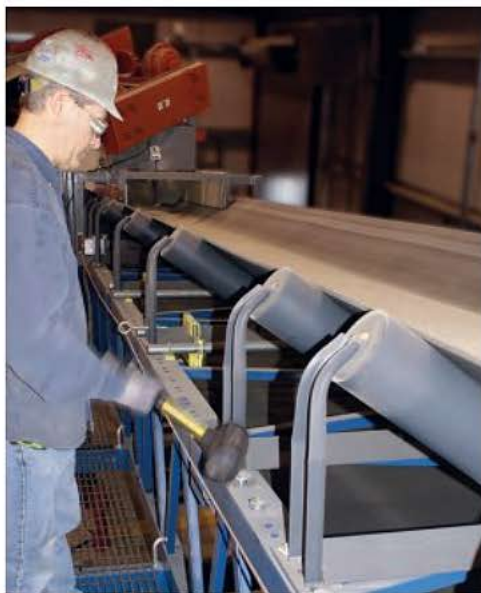
Figure 1: "Knocking" an idler with a mallet to change its position

Many operators have realized that pivoting an idler is a quicker and more effective way to steer a belt. This common approach is called "knocking an idler," striking it with a hammer to move it slightly and realign the belt (► Fig. 1).

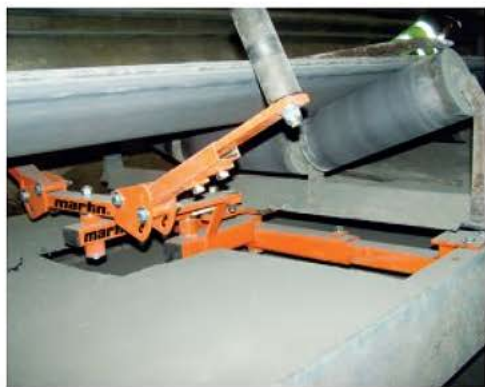
Figure 3: Multi-Pivot Trainer for the load-carrying run

To overcome the limitations of existing belt alignment devices, Martin Engineering has invented and patented a Multi-Pivot Belt Tracker (► Fig. 3), which employs sensors, pivoting idlers and geometry to align a wandering belt. The sensors avoid pinching the belt, and the engineered geometry amplifies any detected misalignment to create a greater pivot.

Multi-Pivot Belt Trainers use longer arms than other designs, positioning the guide rolls further from the pivot roller, as well as closer to the belt edge. The closer proximity allows guide rolls to sense very slight misalignments and make immediate corrections. Rather than waiting for a powerful mistracking force, the longer arms require considerably less pressure to move the pivot roller. The result is better correction with no

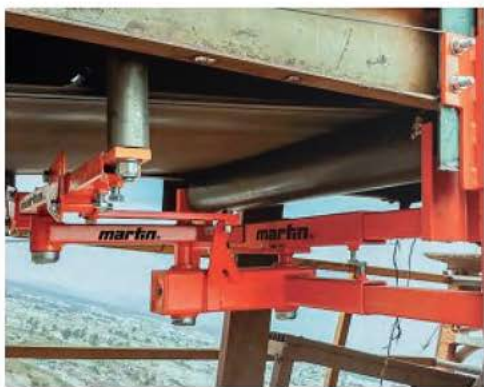
Figure 4: Multi-Pivot Trainer for the return run

pinch points and less wear on conveyor and tracking equipment, for a longer and more efficient service life. Specific designs are available for both the load-carrying belt path and the return run (► Fig. 4).

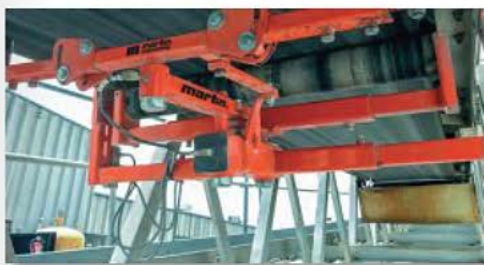
Figure 6: The return side Martin Tracker lifts the belt slightly for appropriate contact

Martin technicians pinpointed the problem areas on each of the conveyor belts and offered an economical solution that utilized modern belt tracking technology where it was needed. Across the eight conveyors, the technicians recommended installing 28 Martin® Trackers™ (► Figs. 5 and 6) Many of the units control the belt return, but there are also upper trackers strategically placed in problem areas.
