Coal Age®

SEALED AND DELIVERED

External skirting mitigates dust, spillage and downtime

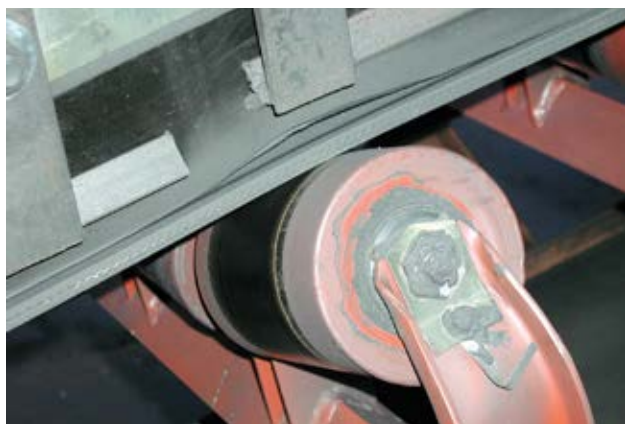
Figure 1 — Scalping occurs when trapped material forms a high-pressure area between the roller and the skirt.

- Scalloping occurs when trapped material forms a high-pressure area between the roller and the skirt, causing excessive wear on the sealing system. [Fig. 1]
- Grooves can be created along the entire length of the belt under the skirt. [Fig. 2]

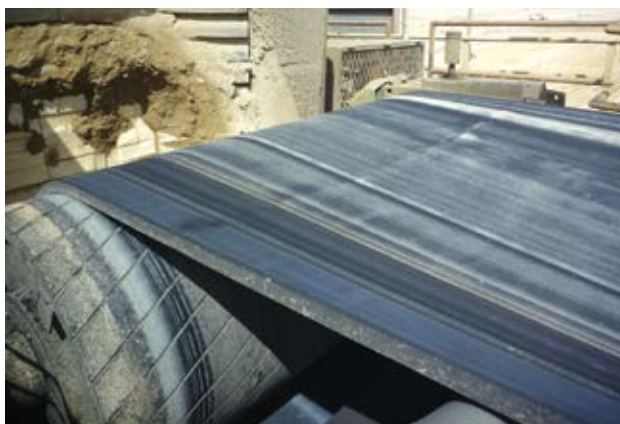
Figure 2 — Grooves can be created along the entire length of the belt under the skirt.

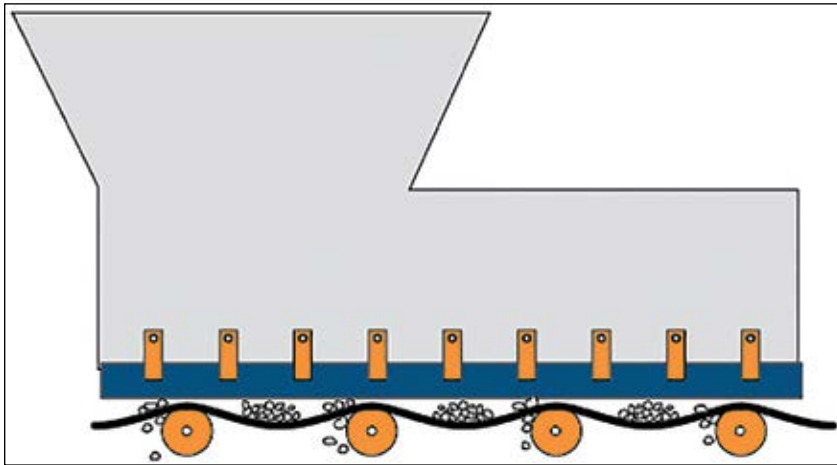
Figure 3 — Gaps, spillage and entrapment are not always apparent to the naked eye.

Regardless of the belt tension provided by the takeup pulley, small amounts of belt sag will occur between the skirt and belt, creating a space for fugitive dust to escape or material to become entrapped. [Fig. 3] This is avoided by using impact cradles or edge support rather than rollers in the loading zone for a more consistent belt plane through the settling zone. By creating a consistent belt plane, the straight edge of the skirt is able to retain a tight seal.

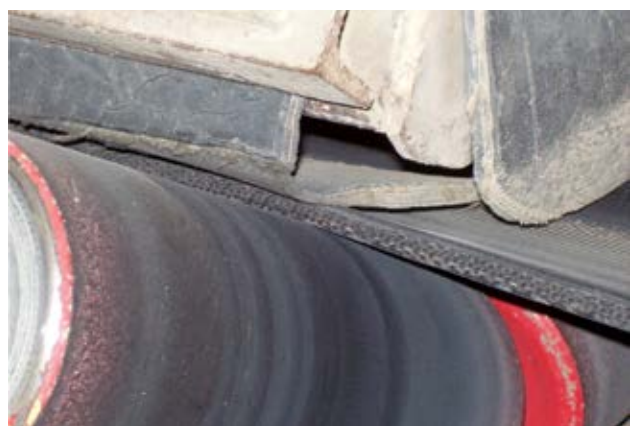
Figure 4 — Old belting used as a lay-in seal traps material between the seal and belt.

A self-adjusting interior skirt features an L-shaped system with an outside assembly — similar to the self-adjusting skirt — with an inward extension under the wear liner that rides on the belt closer to the cargo to increase the range of tolerance for belt mistracking. Old belting should never be used for sealing, as the fabric will trap abrasive fines and wear grooves in the belt. [Fig. 4] Even with a deflector style wear liner, cargo will get between the seal and belt, and the pressure of the load will create wear unless the bulk material is totally non-abrasive.

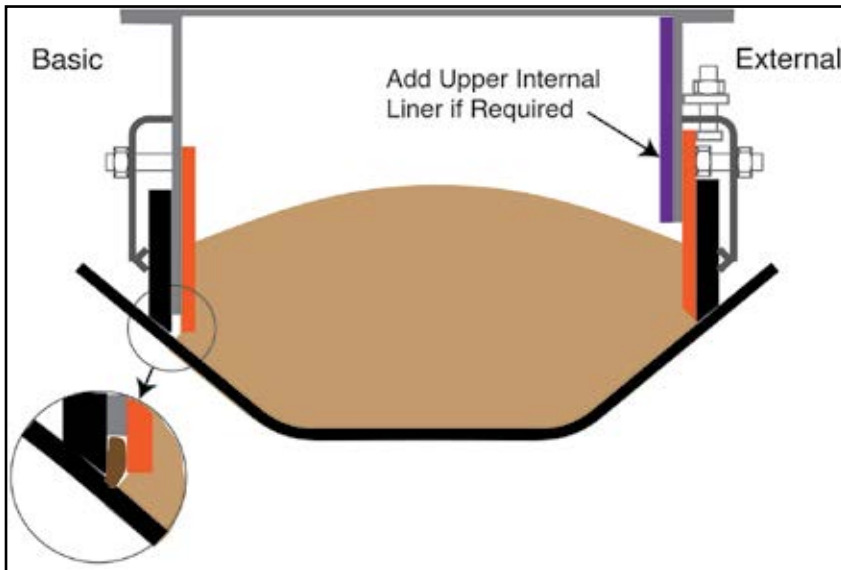
Figure 5 — At left: conventional external seal and internal wear liner can result in entrapment. At right: external seal and external wear liner system eliminates the gap.

The internal wear liner and external skirt configuration has been the industry standard for decades. It offers a safer and more adjustable solution for skirting, as it is typically held tightly against the skirtboard using an adjustable clamp system that can be accessed from outside the chute. However, the internal design [Fig. 5] can allow some material buildup in the gap between the wear liner and the skirtboard, depending on the size of the aggregate.

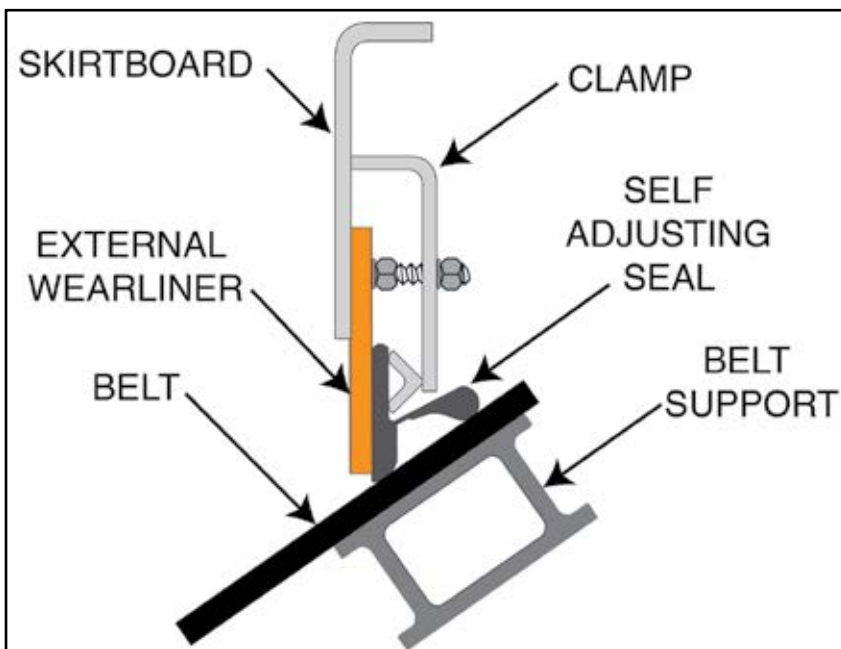
Figure 6 — External wear liner and dual self-adjusting seal with belt support is considered the state of the art.

External wear liner and skirting configurations place both pieces of equipment outside the chute wall. [Fig. 6] If not originally supplied, this may require some restructuring of the chute, extending installation time. Placing the skirt seal and wear liner outside of the chute makes it easier for workers to perform adjustments more frequently and safely, resulting in a better seal on the belt and less material entrapment, while eliminating the need for confined space entry. Without confined space entry, the external design requires minimal tools to inspect, adjust or replace, and in most cases these tasks can be performed by a single worker.

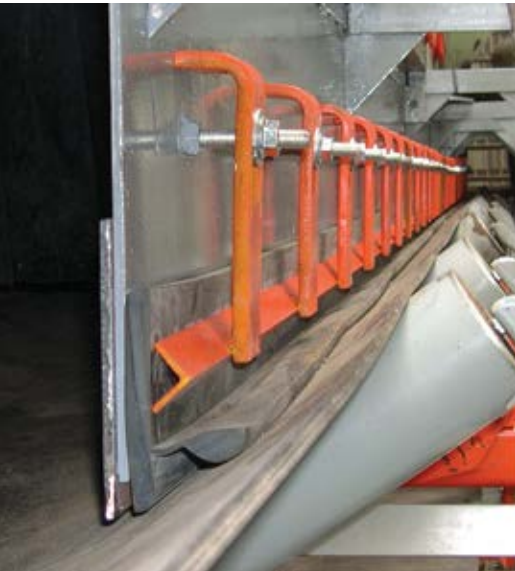
Figure 7 – The external configuration redesigns the chute for more effective sealing.

Managers invited Martin Engineering to examine the issue and offer solutions. After thorough inspection, technicians installed wear liners, double skirting and upper/lower belt trackers. [Fig. 7] The wear liner protects the wall, while the double skirting forms a seal that rides lightly on the belt, keeping fines from escaping. The wear liner and skirts are externally mounted for safe and easy maintenance. To maintain a true belt path, technicians installed upper and lower tracking technology and closely spaced 35° idlers for belt support that slide out for easy one-person maintenance. To protect the tail pulley, a plow was installed on the inside of the belt return to deflect fugitive material.
