Volume 271 · Number 4

July-August 2023

THE COST OF SPILLAGE

SEALED CHUTE COMPOSITION

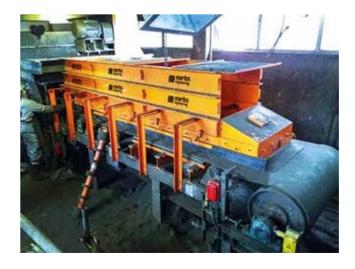
Figure 1: With the proper enclosure design, dust volumes can be lowered to below regulatory levels.

If left uncontained, fugitive material in the form of dust and fine particle spillage will increase labor costs for cleanup, foul equipment, potentially encapsulate the belt and pose a serious safety hazard.[Figure 1] A dirty and dusty environment also discourages workers from doing regular maintenance on the problem area and negatively affects morale.

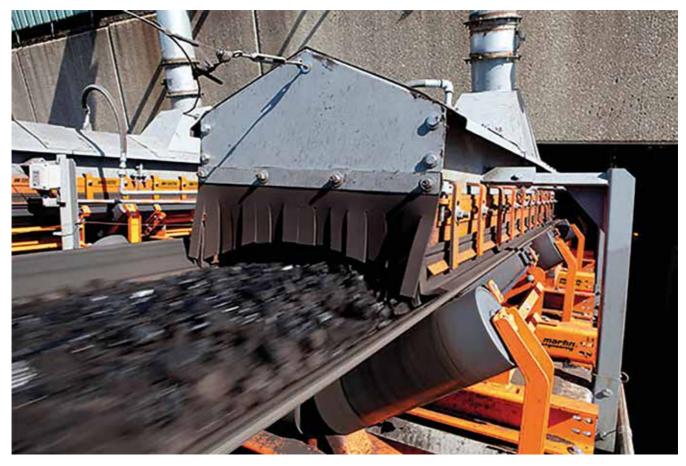
Figure 5: The reconfigured conveyor controls emissions for improved safety and easier maintenance.

dust bags to contain emissions and spillage throughout the settling zone. Strategically placed belt trackers maintain belt alignment along the entire path. Heavy-duty primary and secondary cleaners that can be pulled out for easy service were installed at the discharge zone to reduce carryback and promote safer blade replacement. The entire system was designed with innovative safety features and ease of maintenance in mind. Each of the components works together to deliver a comprehensive bulk handling solution that promotes efficiency and a safer workplace. [Figure 5]
