# DRY CARGO *international*

ISSUE NO. 257 MAY 2022

# Cement plant solves belt drift using highly responsive tracking equipment

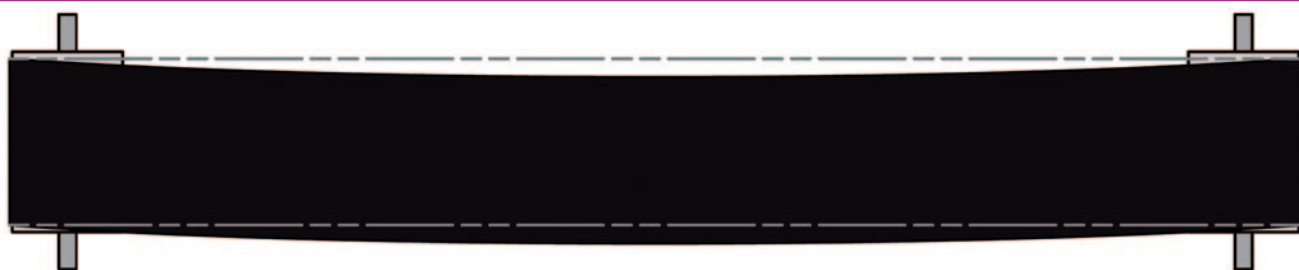
Figure 1 – Camber can happen in the manufacturing process, and belts should be inspected prior to installation  
(© 2022 Martin Engineering).

Second, technicians suspected some potential manufacturing flaws of the belt attached to the limestone conveyor. If the belt isn't precisely engineered or properly stored, it can bow or camber. [Fig.1] This might have contributed to the tracking and belt damage issues.

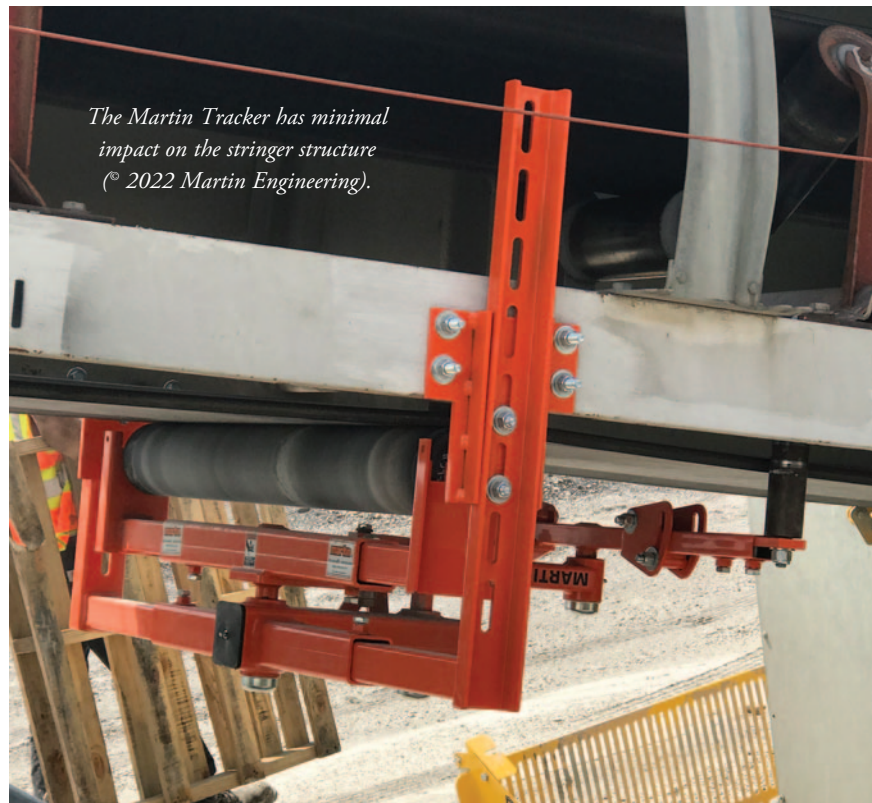
Figure 2: a tracker pivots against the mistracking, using the force and weight of the belt to redirect it.

Utilizing innovative multiple-pivot, torque-multiplying technology, the Martin® Tracker™ has two sensing arms that extend out to either side of the conveyor with rollers at the tip, which smoothly ride the edges of the belt. The sensing arms detect slight variations in alignment and use the force of the belt to immediately pivot the position of the troughed idlers against the misalignment with equal force, thus returning the belt to its intended path. [Fig.2]

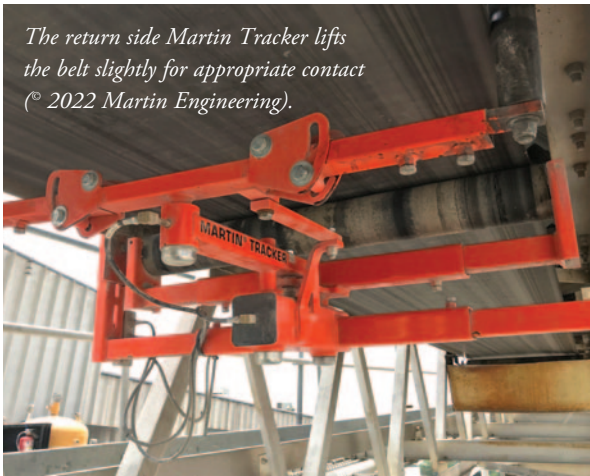
*The return side Martin Tracker lifts the belt slightly for appropriate contact (© 2022 Martin Engineering).*

The lower trackers have a flat roller with a polyurethane coating. Raised slightly above the belt plane, the roller acts partly as support with just enough downward

force from the belt for the polyurethane to grip the belt and return it into alignment.
