EFFICIENT PLANT

New conveyor loading zone cleans up work environment and eliminates shutdowns.

Keep Fugitive Material In Its Place

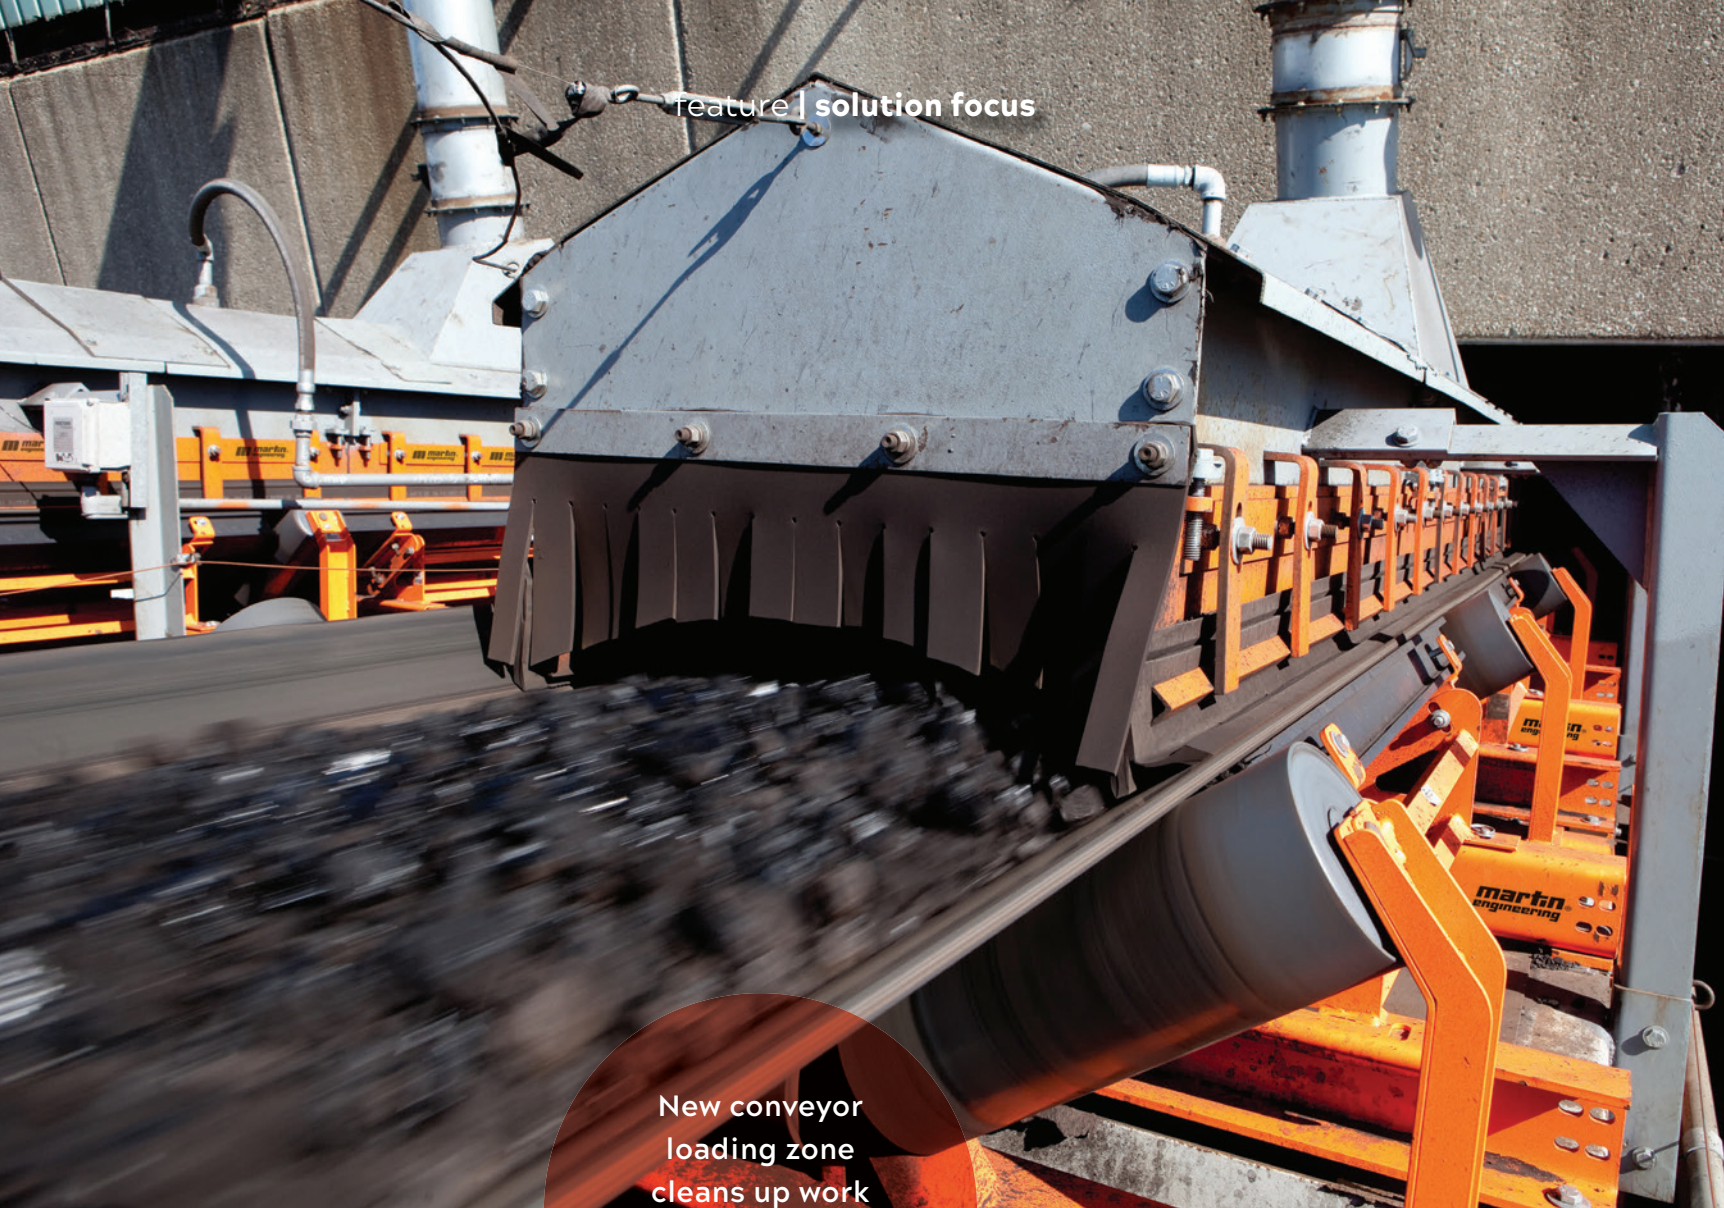
Left. The reconfigured conveyor controls emissions for improved safety and easier maintenance.

Martin impact cradles were installed to center the material and promote belt health, while slider cradles improved performance and safety by sliding out for external maintenance. The project also included skirt-ing and dust bags to contain emissions and spillage throughout the settling zone. Strategically placed belt trackers align the belt along the entire path. Heavy-duty primary and secondary cleaners slide in and out for service and were installed at the discharge zone to reduce carryback and promote safer blade replacement.

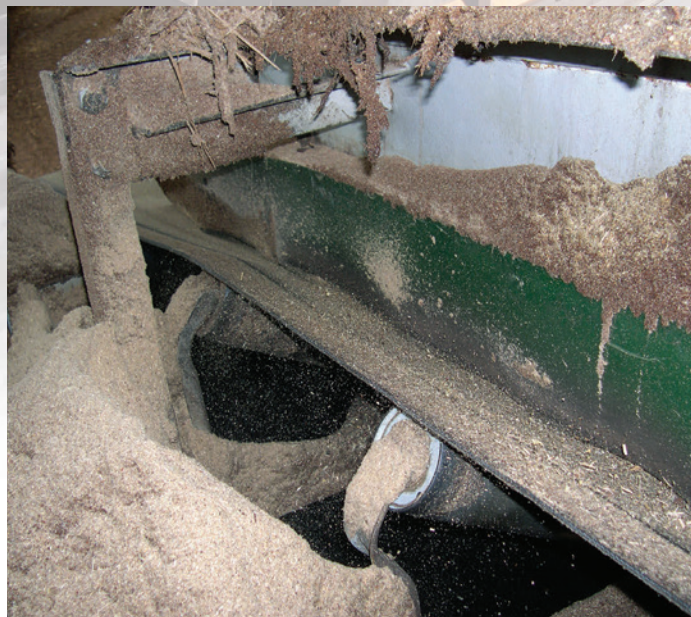
Right. Dust accumulation on rolling components can cause abrasive damage and premature failure.

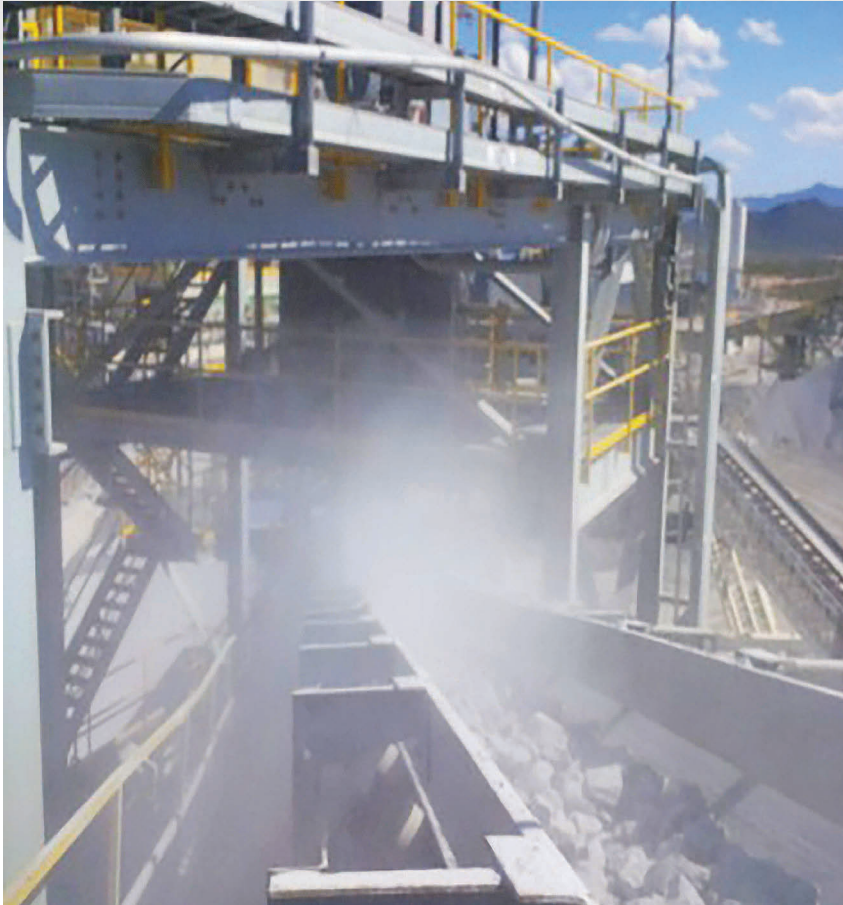
Raw bulk material drops onto a moving conveyor belt, creating dust and spillage.
