Global efforts to improve efficiencies in recycling

Whilst ambitions for a circular economy continue to gain momentum, uncertain market conditions make it increasingly difficult to turn a profit in the recycling business. So, squeezing maximum efficiency from recycling plant operations has become essential, writes Reiner Fertig of Martin Engineering.

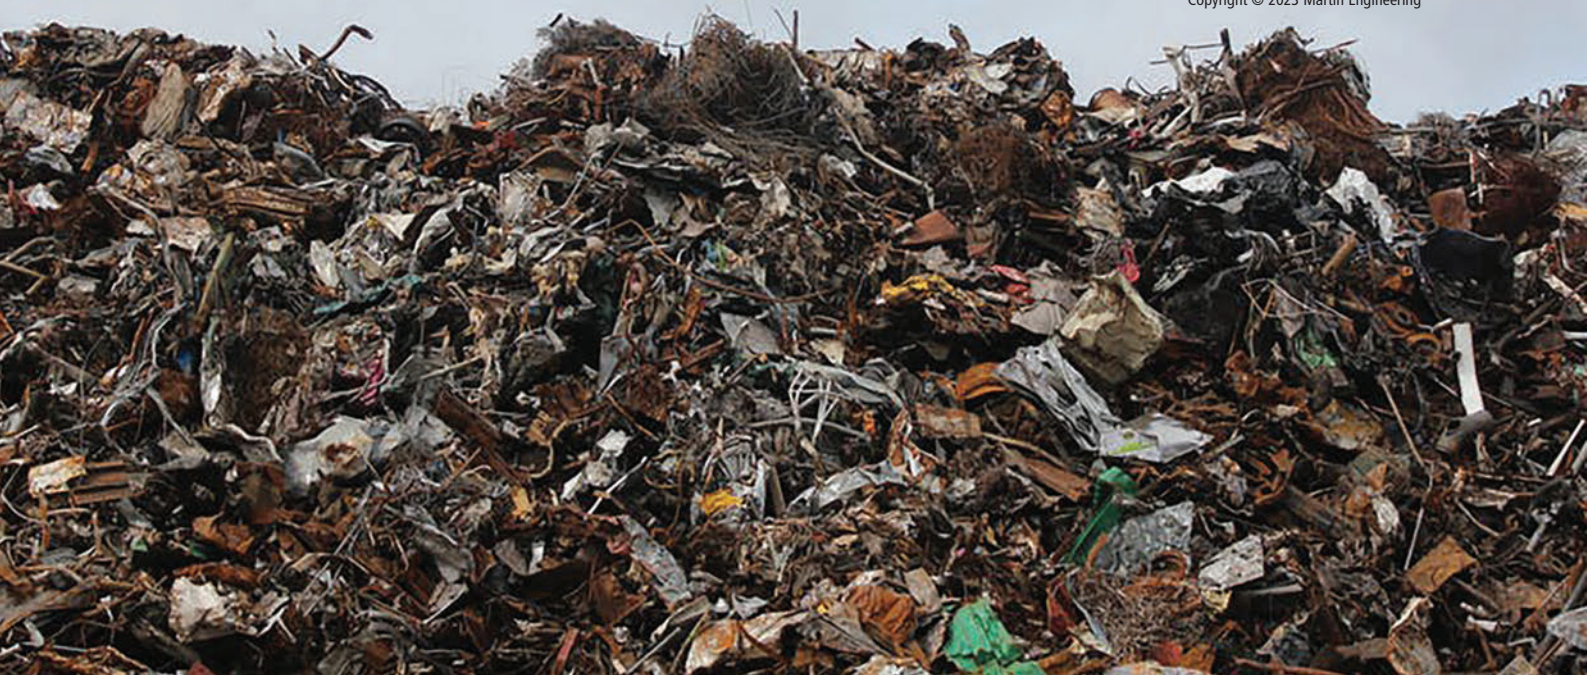
Metal recycling is key to a circular economy, but processing has to stack up economically as well as environmentally

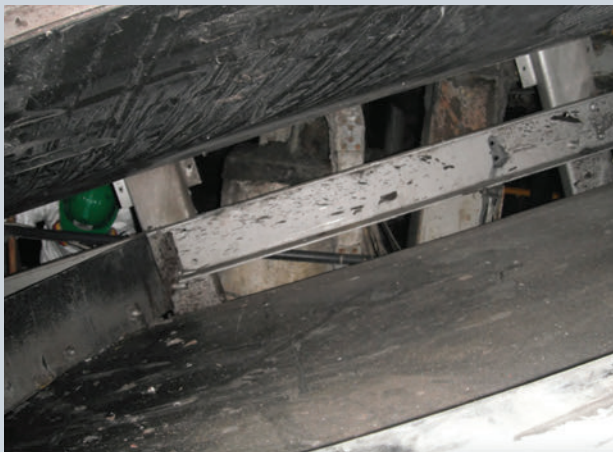
Enertec's conveyor belt suffered from impact damage and misalignment.
Copyright © 2023 Martin Engineering

However, their main conveyor belt suffered from continual impact damage and misalignment as a result of heavy batteries dropping onto it. Smaller batteries (such as motorcycle batteries) tended to rebound out of the loading chute because the conveyor belt lacked an effective support system.

Some of the batteries ran down the back of the chute, which caused damage to the conveyor belt and also to the tail pulley. And others fell down the sides, getting stuck between the chute and the conveyor and accumulating over time. In addition to this problem, the lack of proper support meant that significant vibration was being transmitted to the nearby weighbridge.

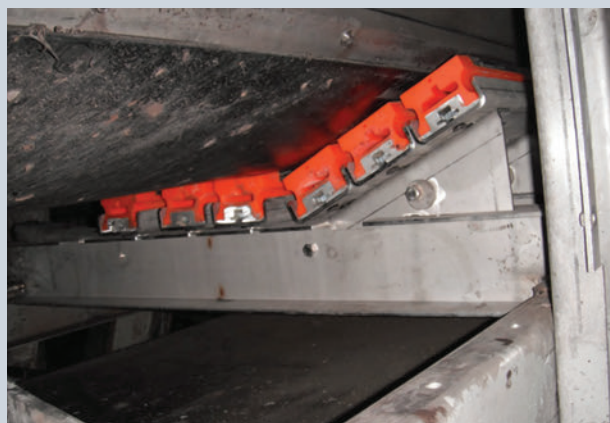
Martin's Impact Cradle absorbs the force of falling materials and objects to prevent damage to the belt and structure and eliminates any belt sag.
Copyright © 2023 Martin Engineering

Following examination from technicians at Martin Engineering, the solution came with the installation of an Impact Cradle positioned under the belt conveyor loading zone beneath the chute. The Impact Cradle absorbs the force of falling objects and materials to prevent damage to the belt

and surrounding structure. It eliminates any belt sag and is designed to minimise any bounce-back from the initial impact with the belt.

Like many of Martin's installations the cradle was custom-manufactured to meet Enertec specific requirements – in this case that meant it had to be made from stainless steel to resist attack from the corrosive acids in the electrolyte solution of the batteries they recycle. Following installation, the problems of misalignment and impact damage were corrected and Enertec recorded fewer production problems and lower maintenance costs.

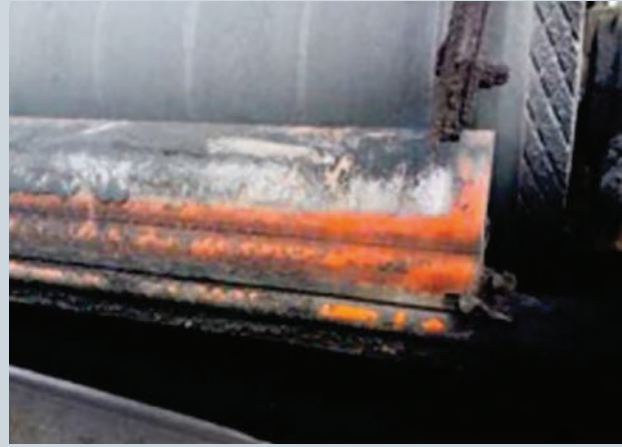
Martin blades' patented design creates a tight seal, flows easily over splices and maintains cleaning performance through all stages of blade life. Copyright © 2023 Martin Engineering

After a thorough inspection that included Martin's unique Walk the Belt™ assessment, Martin Engineering representatives determined that a QC1™ Cleaner HD STS was the right solution to clear the belt of adhered carryback. Using the patented Martin® Spring Tensioner HD STS with a polyurethane blade formed in the "CARP" (Constant Angle Radial Pressure) design, the blade creates a tight seal on the belt, runs easily over mechanical splices and maintains cleaning performance through all stages of blade life. Mounted on a sturdy stainless steel mandrel, the blade cartridge is serviced without confined space entry with a simple one-pin operation, making replacement a safe and simple procedure.

The result was improved belt cleaning efficiency and reduced airborne dust. Operators observed that considerably more material was discharging directly into the chute as intended, with significantly less carryback than they had ever experienced. Due to the reduction of fine material being held in cracks and divots on the return side of the belt, there was less dust that could become airborne, leading to an immediate improvement in plant air quality.
