Controlling Fugitive Dust Emissions on Limestone Conveyor Transfer Point

By Dave Harasym - UK Sales Manager, Martin Engineering

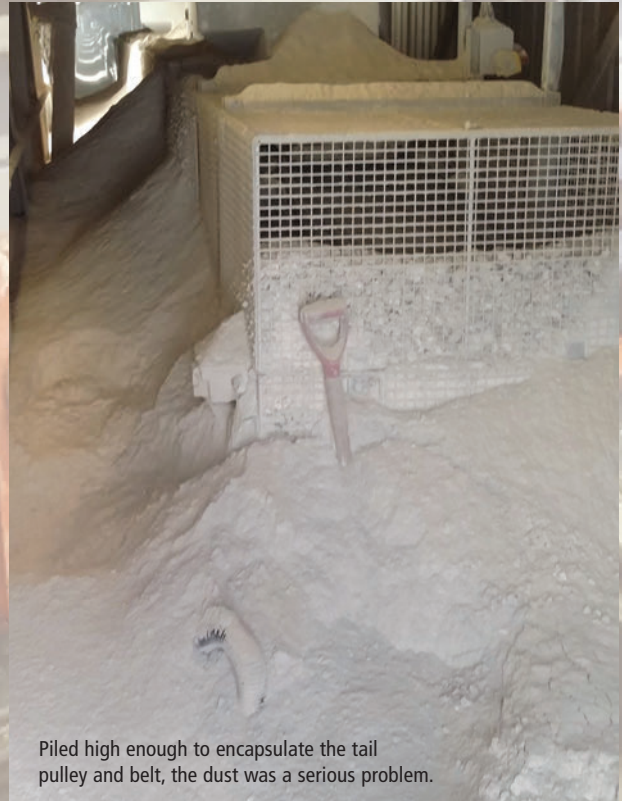
Piled high enough to encapsulate the tail pulley and belt, the dust was a serious problem.

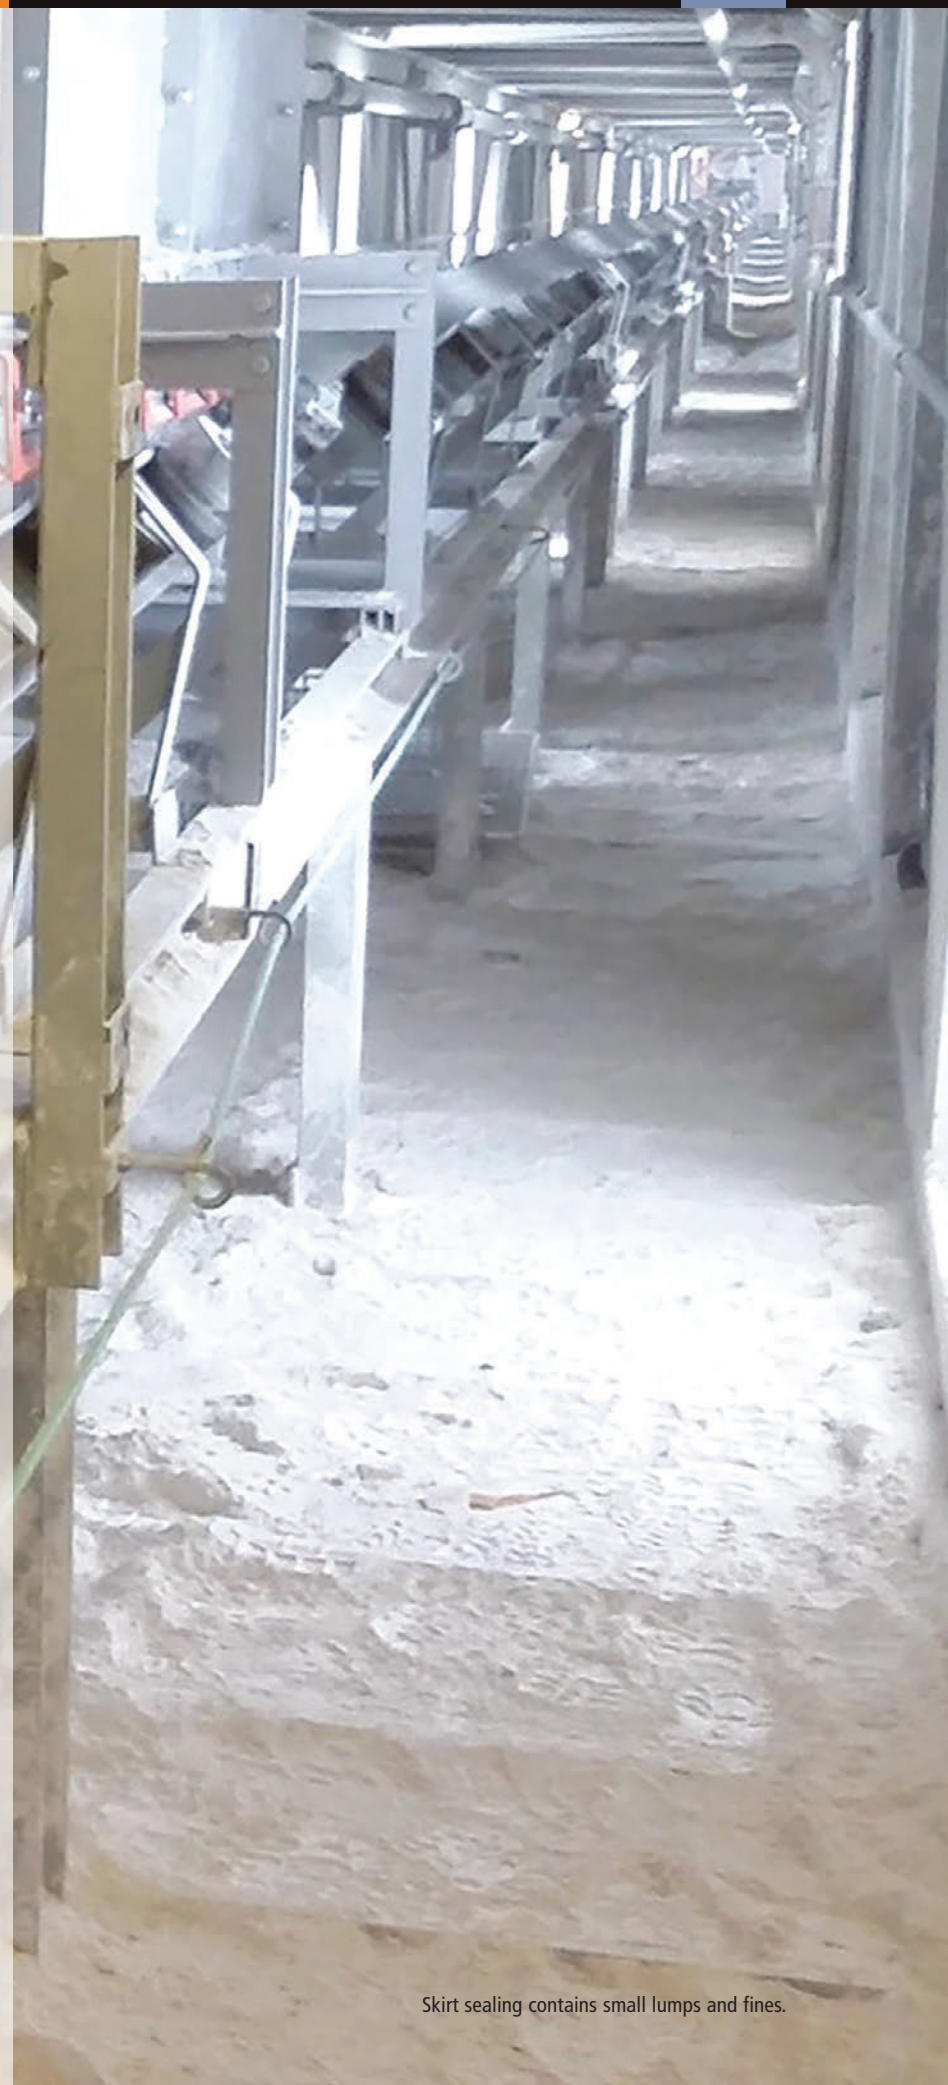
Skirt sealing contains small lumps and fines.

Placed flush with the wear liner on the outside of the chute, the ApronSeal includes a primary and secondary sealing strip with a dual-sided elastomer construction made of 70 durometer EPDM rubber composite for its low abrasion index characteristics. The primary strip holds a tight seal on the belt to trap fugitive dust and contain it within the cargo flow. The self-adjusting secondary seal rides smoothly on the belt alongside the rigid primary strip to provide an extra dust seal. Once the contact area of the sealing strip has worn down, workers merely loosen the mounting brackets, slide the strip out and flip it over, doubling its wear life.

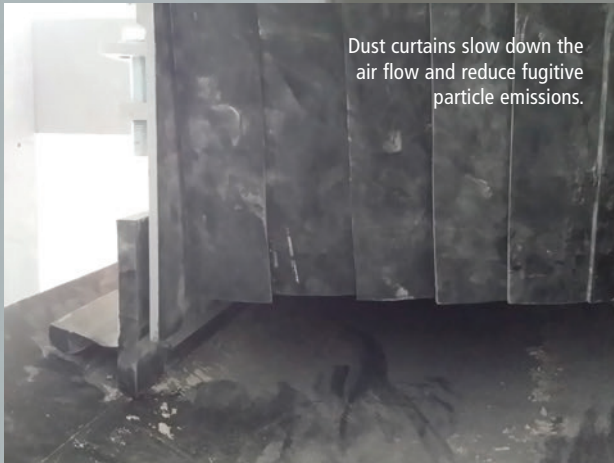
Dust curtains slow down the air flow and reduce fugitive particle emissions.

Following the loading zone, several dust curtains stop dust from escaping out of the end of the chute by trapping it within the settling zone. Previously, the mechanical dust filtration systems had been unable to handle the sheer volume of particulate matter, so the filters clogged quickly and created a maintenance issue, causing the units to be abandoned. With the units operational again, technicians cleaned the area and replaced the filters. Combined with the new chute design, the systems are able to effectively filter any overflow of dust.

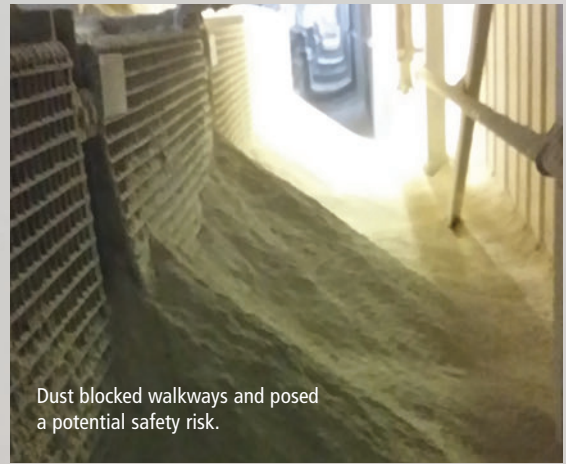
Dust blocked walkways and posed a potential safety risk.
