BULK TERMINALS

A CLEAN WINNER

Dave Mueller, conveyor products manager, Martin Engineering, explains why CleanScrape offers a low maintenance and reliable conveyor belt cleaner, providing up to four times the equipment life of conventional cleaners

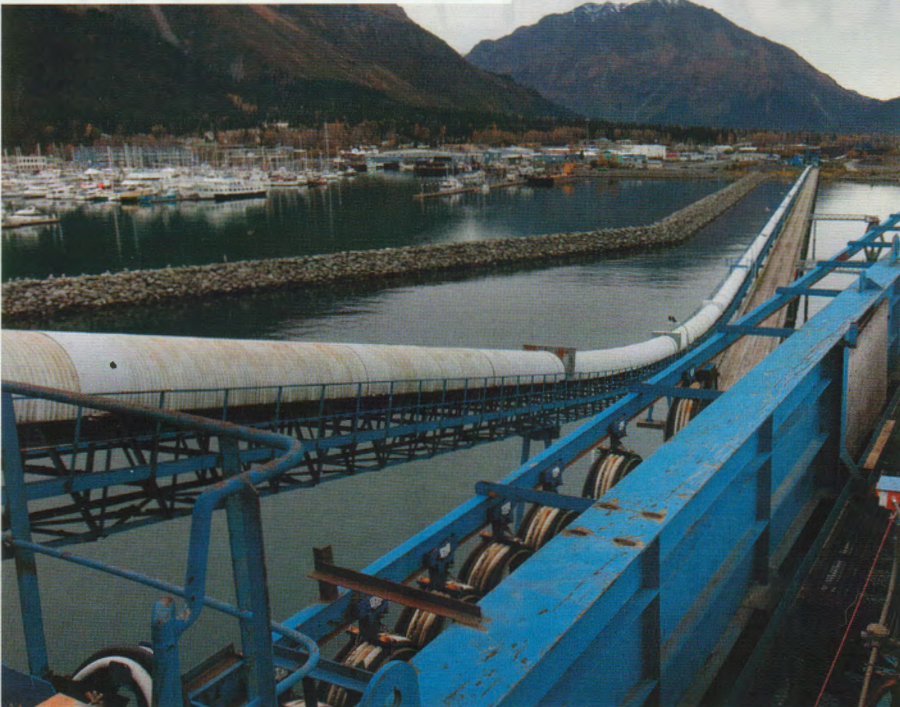
TALL CONVEYOR SYSTEMS AT PORTS AND TERMINALS CAN POSE A SAFETY CHALLENGE FOR MAINTENANCE. ALL PHOTOS © Ó MARTIN ENGINEERING 2023

Ports and terminals employ stacker conveyors, tripper conveyors, and some of the tallest conveyor discharge points in the world to load the cargo holds of massive dry bulk carriers. If the belts of these tall conveyors are not adequately cleaned, material can cling to the belt and drop off on the return, causing spillage and dust to spread over a wide area.

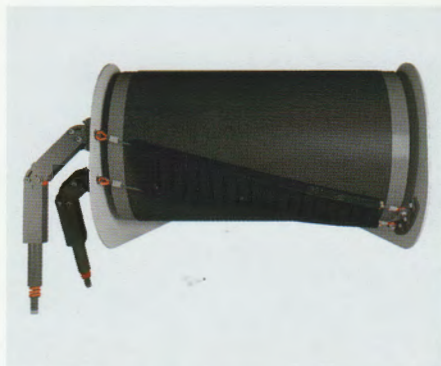
CLEANSCAPE'S INNOVATIVE DESIGN TAKES UP LESS ROOM THAN SOME OTHER PRIMARY CLEANERS

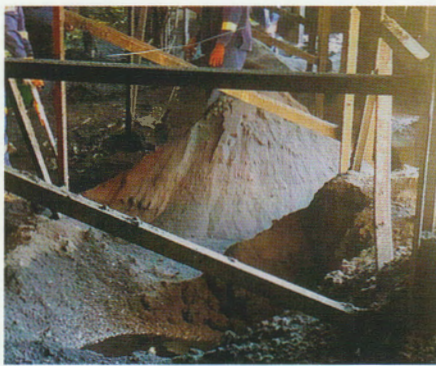
SPILLAGE ALONG THE SYSTEM BECAME A COSTLY ISSUE TO ADDRESS.

Transnet Port Terminal at Richards Bay is one of South Africa's largest ports. Eight of its conveyors transporting raw materials such as magnetite, chrome, coal, chloride and zircon were experiencing excessive spillage at the discharge zones. Fines were adhering to the 1,350mm to 1,500mm belts causing carryback to spill along the belt path, pile underneath the system and spill out into walkways.

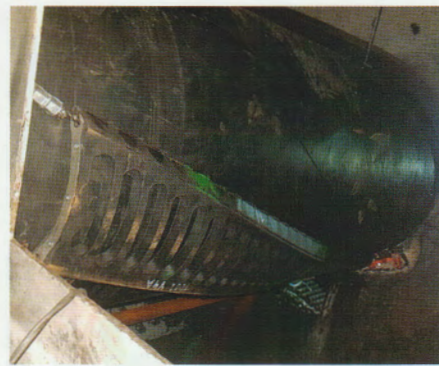
THE CLEANSCAPE RUNS NEARLY THE ENTIRE WIDTH OF THE BELT AND PULLEY

Installed diagonally across the discharge pulley, the CleanScrape forms a three-dimensional curve beneath the discharge area that conforms to the pulley's shape, covering drum diameters from 300-2,000mm and belt widths from 400-3,000 mm with belts speeds up to 7.5 m/s.
