# Engineered for workplace safety

Byron Allen, Service Technician at Martin Engineering highlights a case study in hot clinker transfer point design

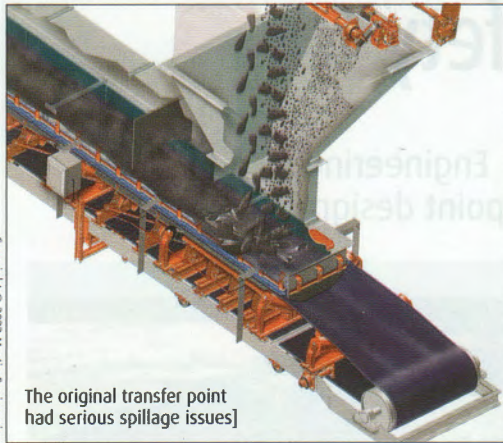
The original transfer point had serious spillage issues

Several issues contributed to safety concerns. The original transfer point from the pan conveyor to the tripper had some problems with sealing. Hot fines would spill out the sides and collect on the walkway around it. In addition, backups in the transfer chute often stopped production until they could be cleared.

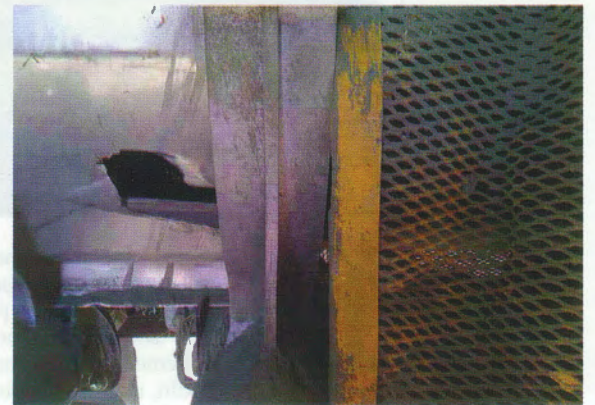
The large hole and the warped grate indicate the extreme heat emitted by the system

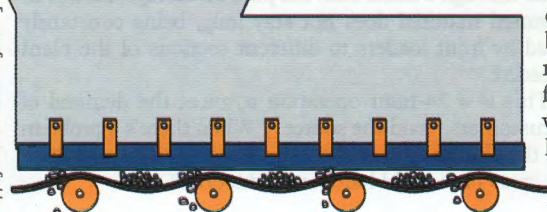
Poor belt support allowed fugitive material to collect on idlers, causing premature failure.

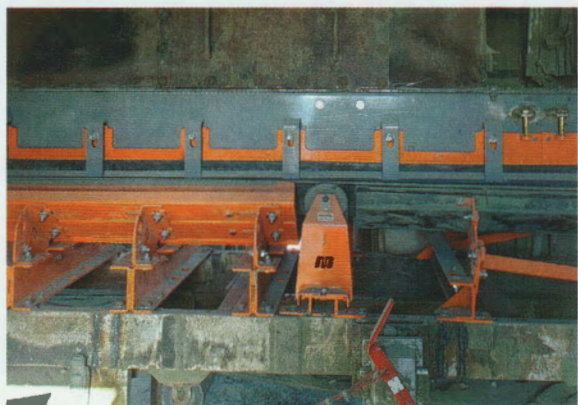
Integrated modular components work

The team installed a new enclosure with an impact cradle, external wear liner, apron seal skirting, track-mounted idlers, support cradles and dust curtains. These components work together as a total solution to improve belt loading, reduce spillage and dust, and minimize impact damage to the belt.

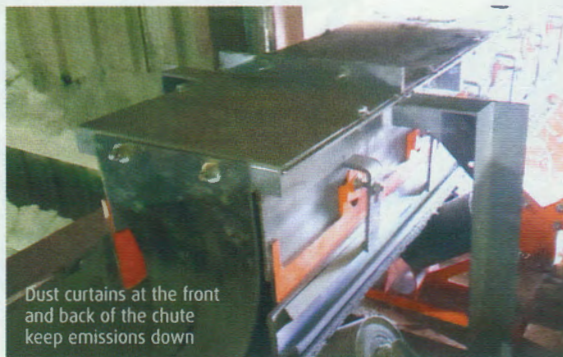
Dust curtains at the front and back of the chute keep emissions down

Dust curtains at both ends of the chute control the turbulent airflow created by the loading process, minimizing the escape of fugitive material at either end of the chute. By controlling airflow, material settles faster on the belt and more product is retained.
