Catch and release

During cement production, the proper loading and distribution of material on a conveyor at the point where the cargo touches the belt are linked to long-term system health, as well as workplace safety and process efficiency. Referencing a plant project in Texas, USA, where dust and spillage posed a potential risk to workers, Martin Engineering highlights the importance of efficient conveyor transfer design.

■ by **Dan Marshall**, *Martin Engineering, USA*

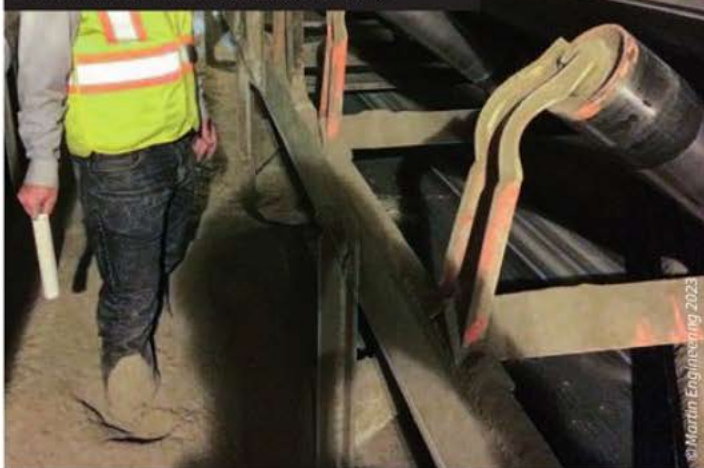
Proper conveyor transfer design will help mitigate many of the issues that lead to downtime, including dust spillage

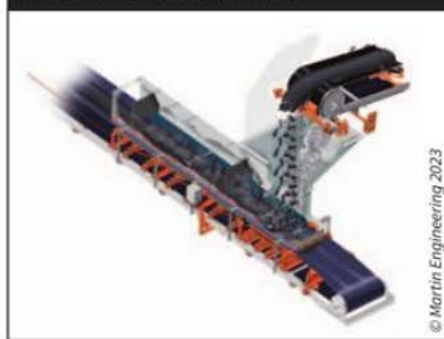
Modern loading zone design has elements that focus on safety for both personnel and equipment

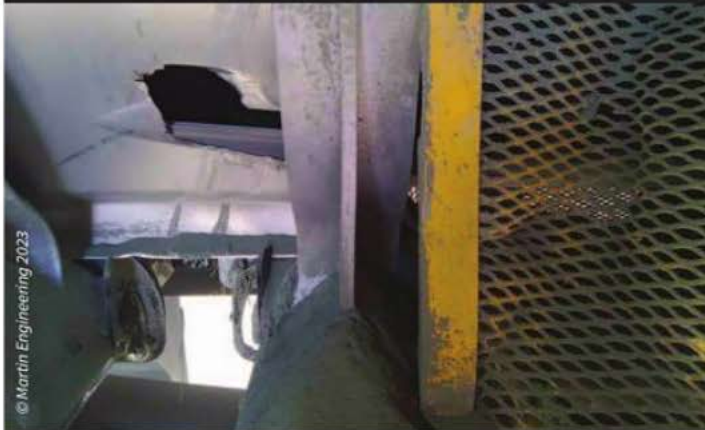
The large hole and the warped grate indicate the extreme heat emitted by the system

Several issues contributed to safety concerns. The original transfer point from the pan conveyor to the tripper had some problems with sealing. Hot fines would melt the steel of the enclosure and spill out the sides, collecting on the walkway around it. In addition, back-ups in the transfer chute often stopped production until they could be addressed. Manually clearing a clogged transfer chute carried the possibility of direct contact with the hot material, so a trained employee wearing high-heat PPE used an air lance or CO₂ blasting device to perform the cleaning, leading to longer downtime.

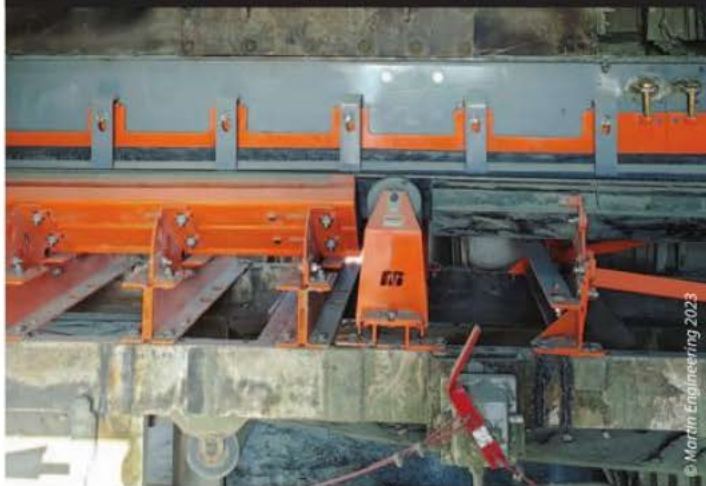
Integrated modular components work together for maximum performance

Martin Engineering was invited to offer solutions. The team installed a new enclosure with an impact cradle, external

wear liner, apron seal skirting, track-mounted idlers, support cradles and dust curtains. These components work together as a total solution to improve belt loading, reduce spillage and dust, and minimise impact damage to the belt.
