Mining engineering

Improving conveyor transfer point performance in hard rock mines

by R. Shields

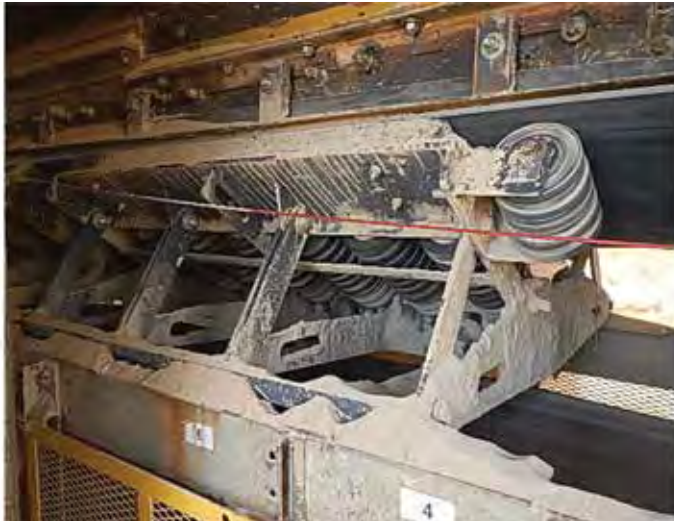
Dust and spillage created a maintenance burden and potential safety hazard for the mine's Conveyor B.

“There’s a long material fall going to the secondary crusher, and that creates a huge disturbance in the material flow,” explained Wayne Maita, crusher operations/fixed plant maintenance superintendent for the Rochester Mine. “We were seeing a lot of dust and spillage in that area. It not only affected the air quality and presented a potential safety risk from accumulated material on floors and structures,

Coeur officials also noticed belt damage occurring as a result of fugitive material. As material escapes, it accumulates on idlers and other components, often creating friction points that contribute to excessive wear and premature failure. These wear issues create immediate costs such as belt replacement and seized bearings.

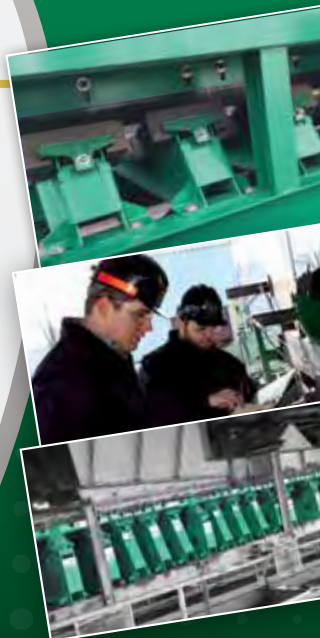
Impact cradles absorb the force of the falling load, yet slide in and out for easy service.

A set of five combination cradles (impact cradles with rollers under the center of the belt) were then installed to absorb the impact of the falling load, while minimizing friction and belt wear. These cradles feature steel-reinforced impact bars on adjustable wing supports to match standard trough angles of 20°, 35° or 45°. But rather than the full trough of support bars that appear on a true impact cradle, these combination cradles replace the center bars with an impact idler roll. This design delivers a flat surface for an effective edge seal at the belt edge but minimizes the friction of having sliding bars all the way across the belt. Eccentric cams built into the supports also provide 5° of wear adjustment, so the alignment between wings and idlers can be customized for a precise fit to provide effective transfer point sealing.

These combination impact cradles employ a track-mounting concept that allows the components of the cradle — the two wings and the center roller — to slide easily in and out of position to allow maintenance or replacement. These modular components are then light enough to be removed by one person, without requiring heavy lifting equipment.

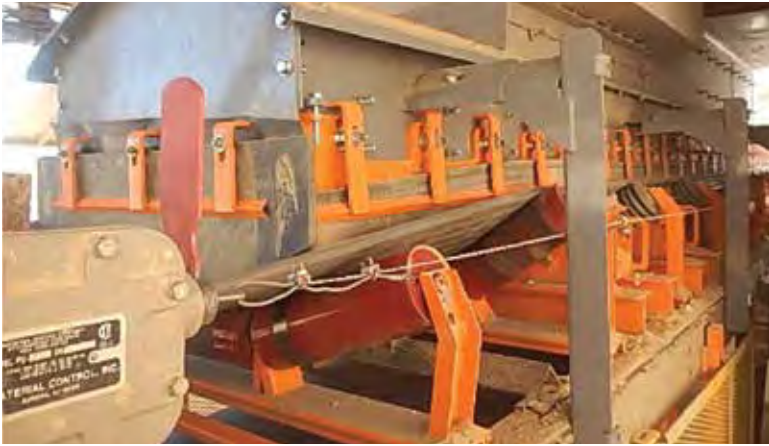
The modular chute wall allows easy installation of skirtboard and stilling zone components to manage dust.

The old transfer point chute structure was replaced with 12.2 m (40 ft) of modular chute wall. The new construction incorporated a tail-sealing box and integrated dust curtains. A chromium carbide overlay on the inside of the chute protects the new containment system from intermittent high cargo depths on the conveyor.

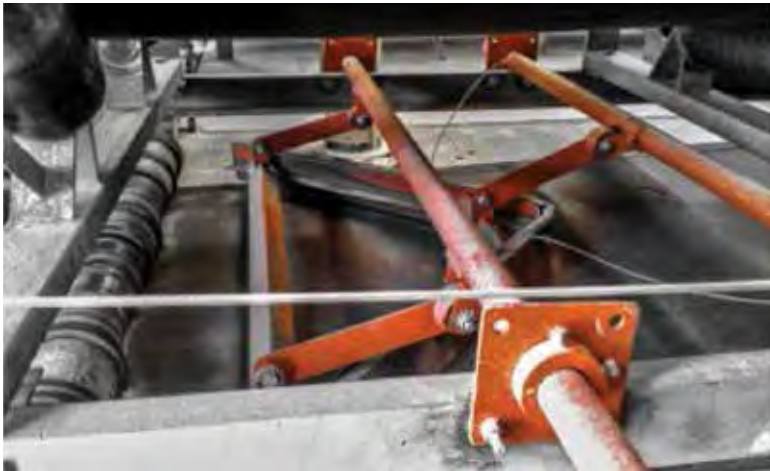
The V-plow features a spring-loaded suspension to rise and fall with fluctuations in belt tension and travel.

A final belt protection mechanism is a V-plow installed at the tail pulley. This plow fights the potentially damaging effects of lumps of fugitive material carried into the tail pulley on the return side of the belt.

The V-plow is engineered with a unique spring-loaded suspension system that allows the plow to rise and fall with fluctuations in belt tension and travel. The V-plow is attached to the conveyor frame with dual steel crossbars bolted to the conveyor frame a few feet from the tail pulley. Three torsion arms adjust independently, maintaining consistent pressure for effective cleaning in all stages of blade wear.

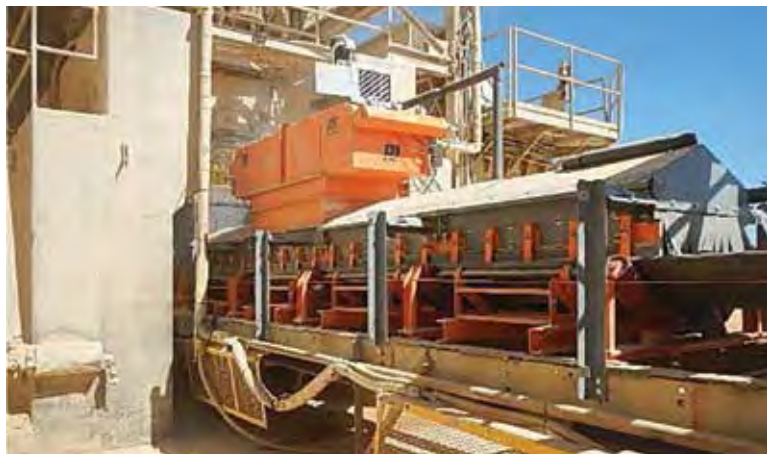
The integrated air cleaner is an independent unit positioned directly at a dust generation point.

To complete the containment system, technicians also installed an integrated air cleaner, which contains a suction blower, filtering elements and a filter-cleaning system. Instead of a centrally located unit connected to dust generation points via ductwork, this small air cleaner is incorporated into the dust generation point itself. The particles are not extracted, but are instead collected within the enclosure and periodically discharged back into the material stream. Unlike large central dust collection systems, the integrated approach employs a smaller, independent unit directly at

The integrated air cleaner contains a self-cleaning system that removes material from the filters using a pulse of compressed air. As material is captured by the filters, it agglomerates against the filter media. When the filter media is pulsed with a backwash of compressed air, the material will fall. If it is agglomerated, it will fall back into the material stream. The pulse system alternates pulses to each filter element. When one filter is being pulsed, the adjacent filter is still drawing air and gathering dust. If a pulsed particle is too small to drop out of the air stream on its own accord, it will be pulled into an active filter.

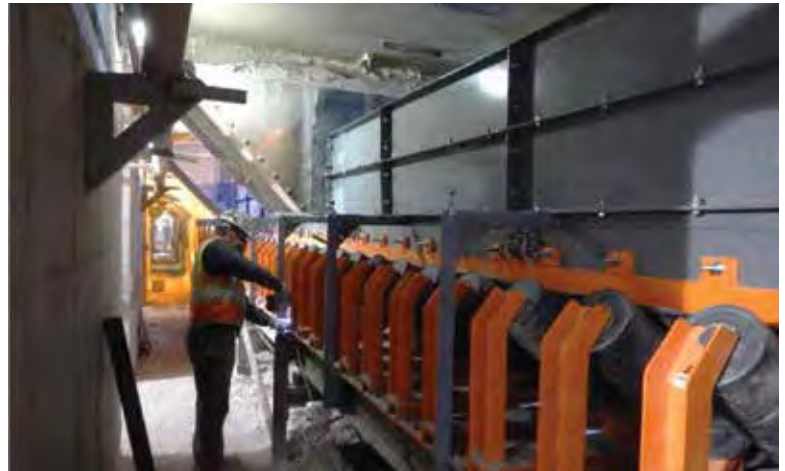
At an Arizona copper mine, a transfer point project included the installation of a taller chutewall to form a stilling zone to allow airborne dust to settle.

A second portion of the project included the installation of modular chute wall extensions that raised the overall height of the skirtboard to a total of 914 mm (36 in.). This additional height creates a stilling zone, which allows airborne
