Reduce conveyor maintenance time through better access; Innovative design for efficiency

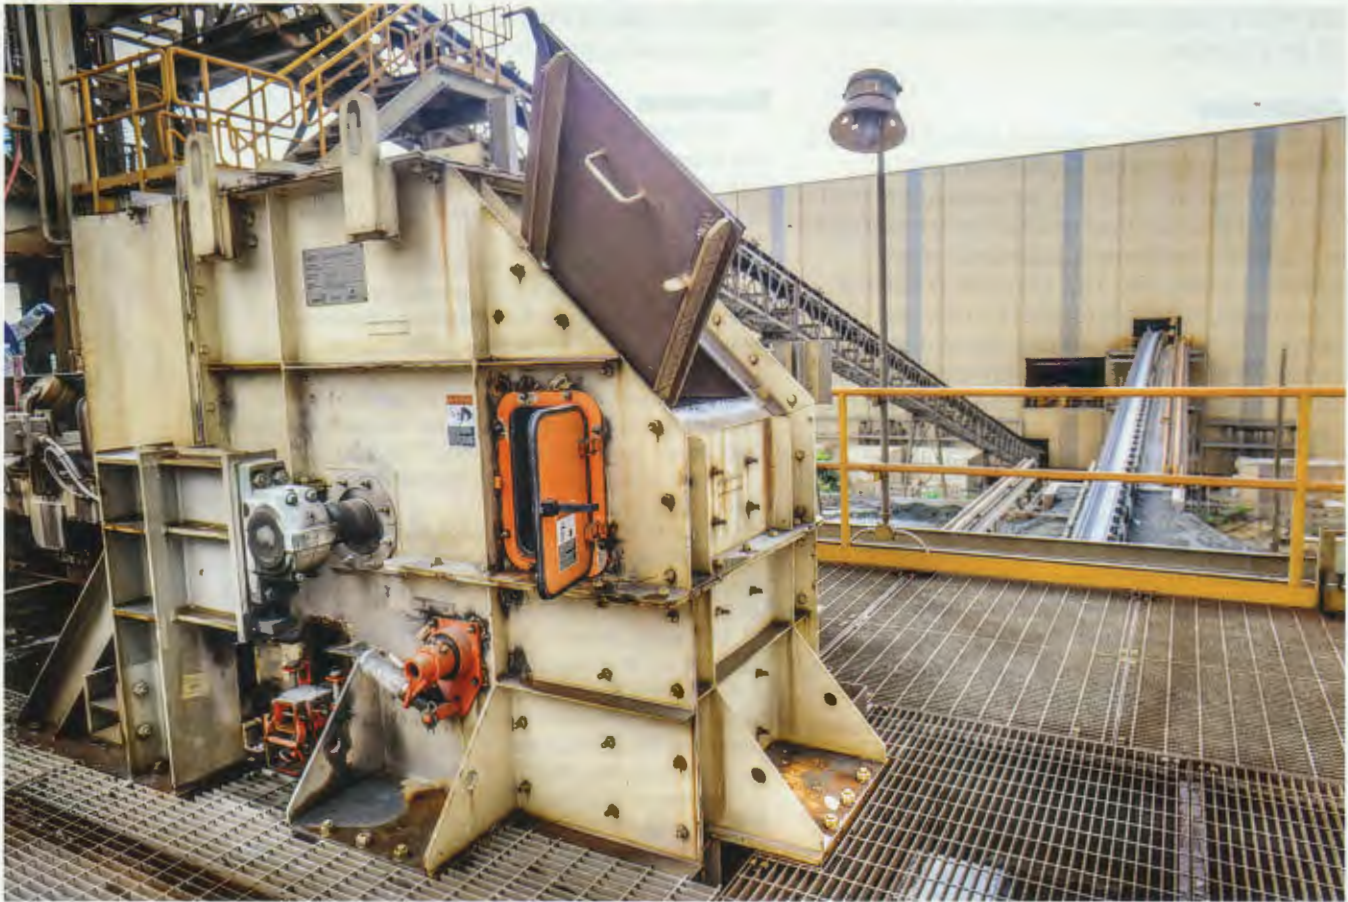
Access can mean observation points, entry doors and workspace for service.

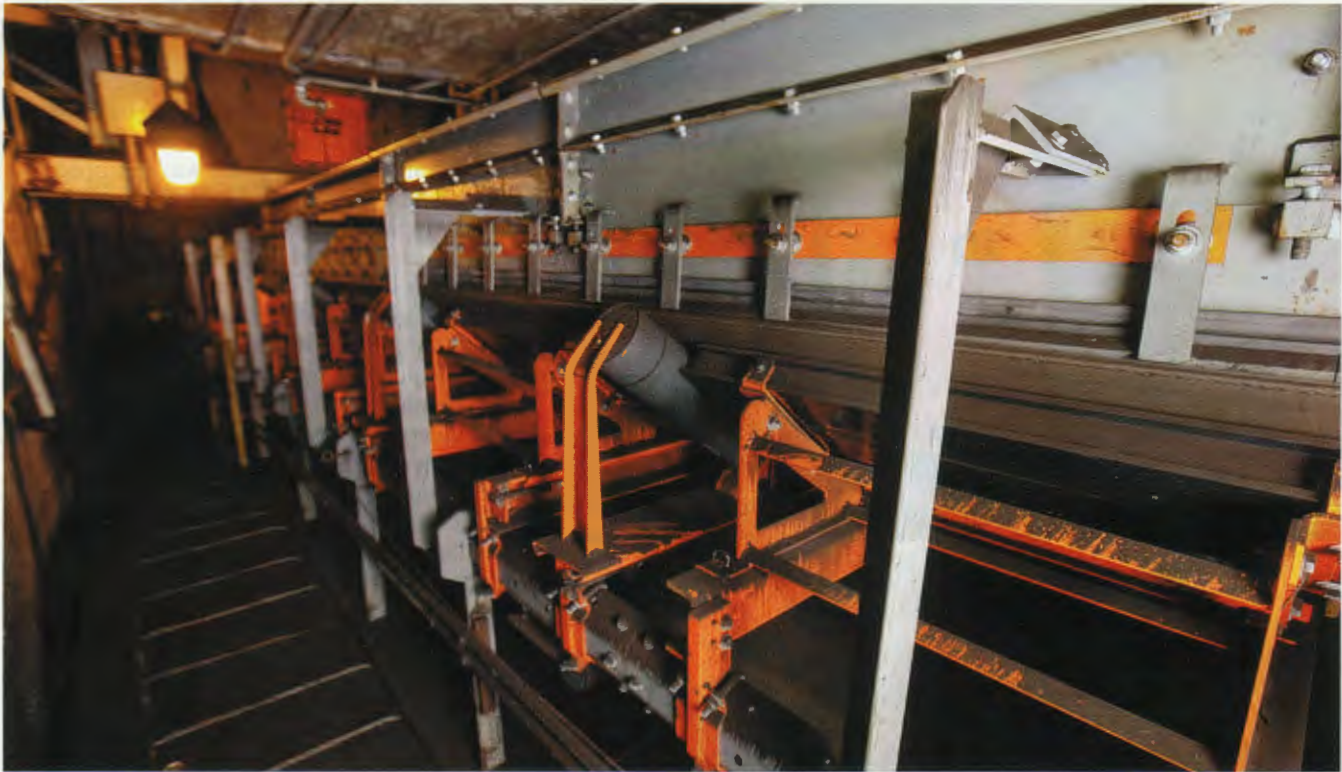
Inspection doors and track-mounted components facilitate maintenance for extended equipment life.

A tight seal is the key to preventing fugitive dust from leaving any chute. Many current setups require workers to crouch or crawl under the system or even enter a confined space to inspect it or perform maintenance, which can result in serious injuries. Inspection of the system needs to be fast, easy and safe. Small inspection doors — either solid or grated — can allow several observation points. Larger doors can offer access points with ample space for service of specific wear parts.

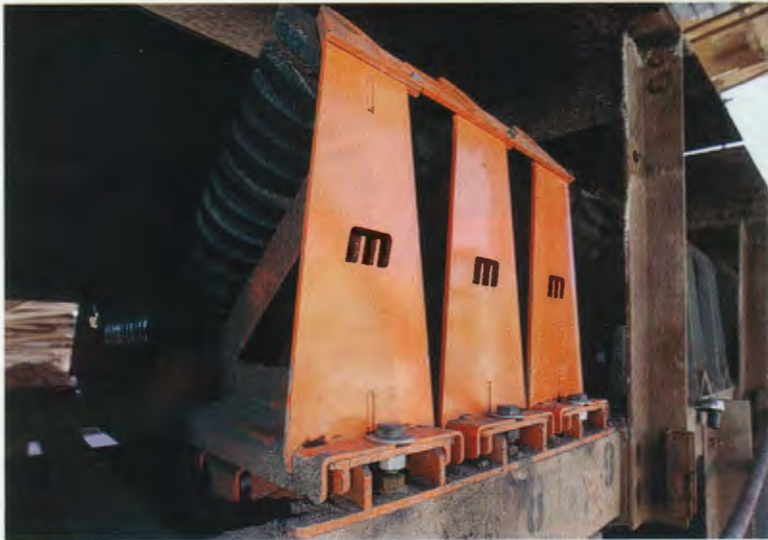
Top: Track-mounted idlers allow easy access for quickly swapping out seized rollers.

Along the cargo path in the settling zone and beyond, retractable idlers support the belt and maintain the trough angle. Exposed to the punishing environment, gritty dust and extreme weather, rollers can seize over time. Often set close together in the loading zone to avoid belt sag, slide-out/slide-in roller frames permit workers to perform idler service outside the belt plane without the need to raise the belt or remove adjacent idlers.

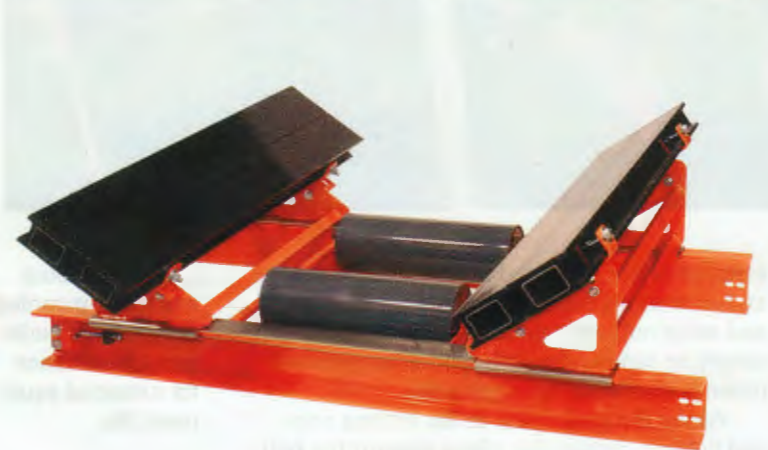
Below: Track-mounted cradle allows components to slide in and out easily for maintenance.

To reduce maintenance time and labor, improve safety and extend equipment life, operators should consider track-mounted impact cradles and belt support cradles. Located under the skirtboard and mounted with rugged steel assemblies, the cradles feature large impact-absorbing UHMW polymer box bars engineered with smooth surfaces that the belt can slide across with little friction or belt wear. These

assemblies can be pulled out by a single worker and — working safely from outside the conveyor and using only a single tool — the box bars can simply be removed and flipped in a matter of minutes to double the service life.
