MINING & QUARRY WORLD

No Joke: Knock-Knock on conveyor idlers

CONVEYOR BELT ALIGNMENT

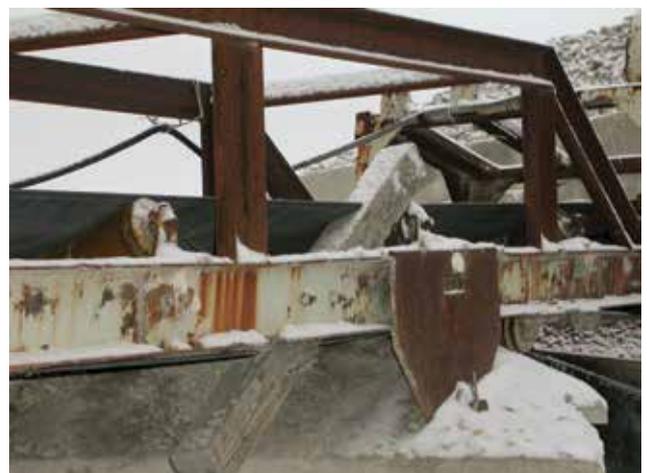
Wooden block intended to limit belt wander.

A wide variety of circumstances can lead to mistracking, and operators have tried many things to correct the alignment. Some have elected to place an obstacle such as a block of wood in the belt path, so it won’t travel too far out of line. This occasionally improves the situation, but more often it’s just temporary and the belt will eventually slice through the obstacle.

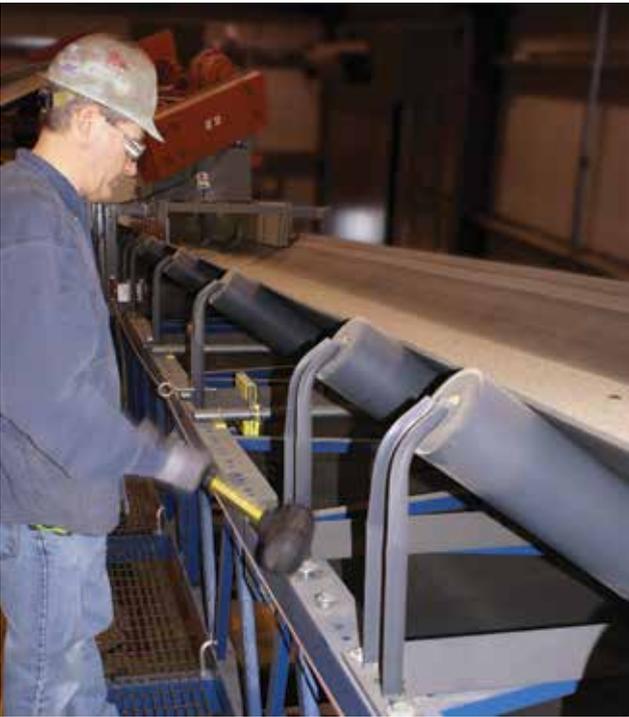
“Knocking” an idler with a mallet to change its position.

Many operators have realised that pivoting an idler is a quicker and more effective way to steer a belt. This common approach is called “knocking an idler,” striking it with a hammer to move it slightly and realign the belt.

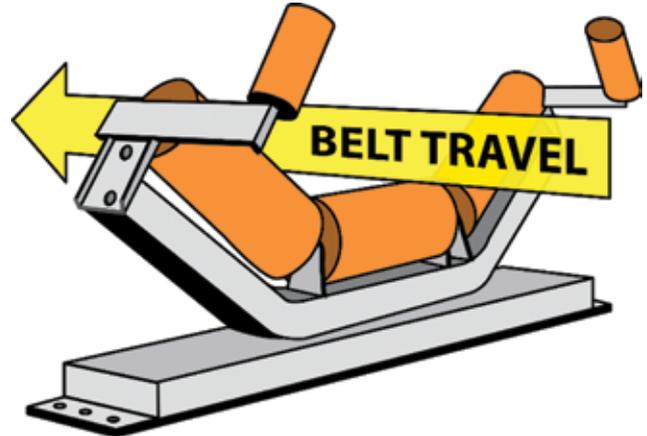
Tracking idler.

“While these mechanisms can improve a belt that’s consistently off-center in one direction, they do not react to dynamic belt movement, meaning that they don’t correct intermittent belt wander,” Marshall continued. “To combat such changing conditions, engineers designed the tracking idler. Unlike the edge correction approach, the device senses belt movement in either direction, and pivots the idler slightly to steer the belt back into position. It doesn’t apply a great deal of force to the edges, which can damage a belt and splices. When the belt is running true, it remains centered, and when it senses a misaligned condition, it gently corrects the belt.”

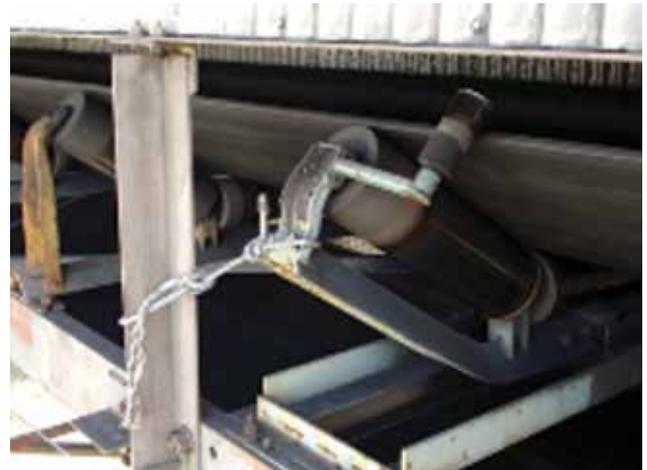
A tracking idler tied off to limit its travel.

Unfortunately, to accommodate limited space availability, tracking idlers typically have short sensing arms. This requires a fairly large belt displacement to create a small movement of the idler. While these designs do tend to improve tracking, there are limits to how much correction they can deliver, and short sensing arms can actually pinch a belt if the idler pivots too far. To combat this, some operators choose to “tie off” a tracking idler to limit its movement. While the practice can help preserve the belt, it doesn’t address significant mistracking.

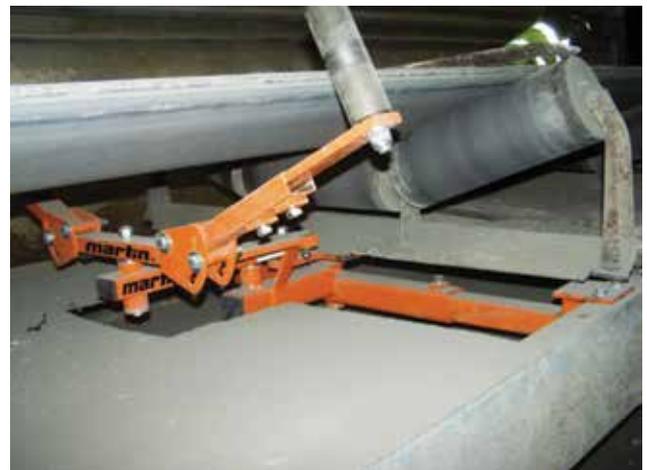
Multi-Pivot Trainer for the load-carrying run.

To overcome the limitations of existing belt alignment devices, Martin Engineering has invented and patented a Multi-Pivot Belt Tracker, which employs sensors, pivoting idlers and geometry to align a wandering belt. The sensors avoid pinching the belt, and the engineered geometry amplifies any detected misalignment to create a greater pivot.

Multi-Pivot Belt Trainers use longer arms than other designs, positioning the guide rolls further from the pivot roller, as well as closer to the belt edge. The closer proximity allows guide rolls to sense very slight misalignments and make immediate corrections. Rather than waiting for a powerful mistracking force, the longer arms require considerably less pressure to move the pivot roller. The result is better correction with no pinch points and less wear on conveyor and tracking equipment, for a longer and more efficient service life. Specific designs are available for both the load-carrying belt path and the return run.

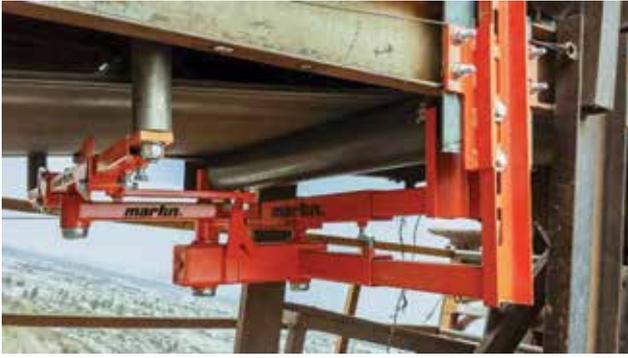
Multi-Pivot Trainer for the return run.

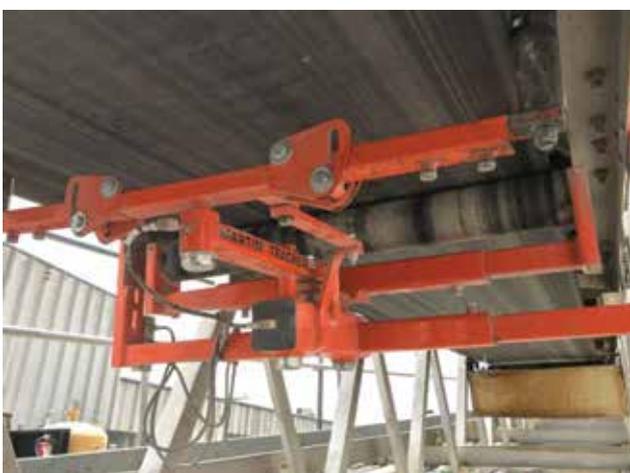
The return side Martin Tracker lifts the belt slightly for appropriate contact.

Three critical areas on the conveyor required tracking: the exit of the settling zone, the entrance to the feed mill and along the return path. A lower tracker placed along the belt path and near the loading zone ensures the belt is aligned as it hits the tail pulley to promote centered loading. An upper troughed tracker at the settling zone exit reinforces a straight belt path as it travels the length of the system.
