Sealed and Delivered: External Skirting Mitigates Dust, Spillage and Downtime

by Dave Mueller / Product Manager,
Martin Engineering

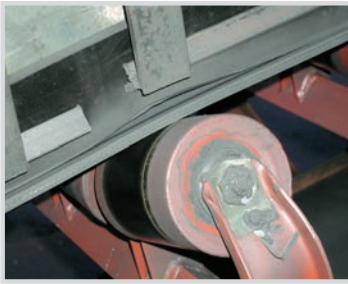
Scalloping Grooves can be created along the entire length of the belt under the skirt.

Scalloping occurs when trapped material forms a high-pressure area between the roller and the skirt, causing excessive wear on the sealing system.

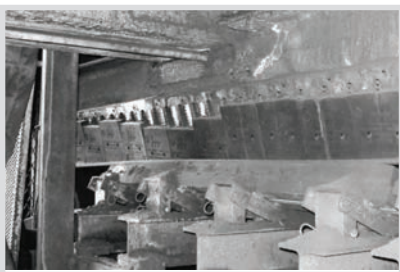
Sectional skirting can wear unevenly, causing gaps and increased maintenance.

Segmented vertical sealing systems use a series of interlocking sealing blocks installed outside the skirtboard on special mounting plates. The interlocking blocks can be manually moved downward, but resist upward movement. However, since some wear disproportionately to others, they are difficult to adjust accurately (leading to scalloping) and are easily over-adjusted (causing premature wear to the seals and belt). Gaps caused by material being forced between the blocks make them prone to material entrapment and leakage of dust and fines.

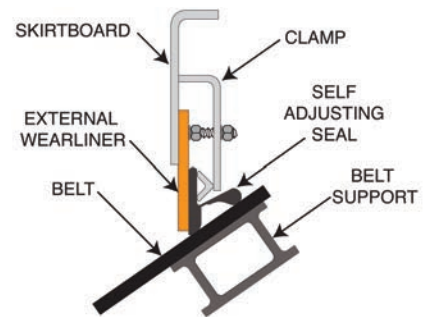
External wear liner and dual self-adjusting seal with belt support is considered the state of the art.

External wear liner and skirting configurations place both pieces of equipment outside the chute wall. If not originally supplied, this may require some restructuring of the chute, extending installation time. Placing the skirt seal and wear liner outside of the chute makes it easier for workers to perform adjustments more frequently and safely, resulting in a better seal on the belt and less material entrapment, while eliminating the need for confined space entry.

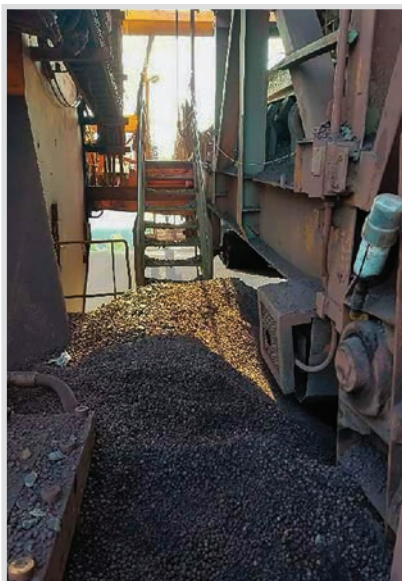
Cluttered stairs and walkways created a workplace hazard.

A port terminal in Indiana handling petroleum coke (petcoke) was experiencing excessive spillage, tail pulley fouling and belt tracking issues on a transfer point from a stacker/reclaimer boom leading from a cargo ship to a conveyor system. When hitting the belt, the light, chalky substance spilled out the sides of the chute and piled onto the floor, creating a walkway hazard. This required workers to be reassigned from other duties several times per month to

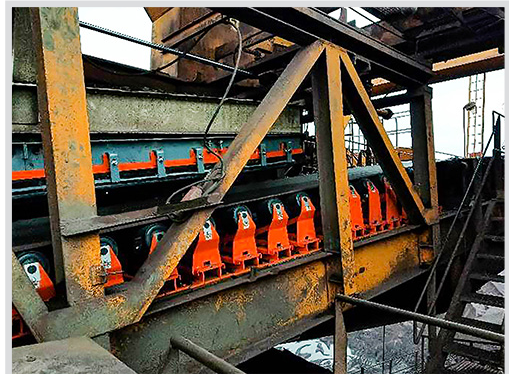
The external configuration redesigns the chute for more effective sealing.

Managers invited Martin Engineering to examine the issue and offer solutions. After thorough inspection, technicians installed wear liners, double skirting, and upper/lower belt trackers. The wear liner protects the wall, while the double skirting forms a seal that rides lightly on the belt, keeping fines from escaping. The wear liner and skirts are externally mounted for safe and easy maintenance. To maintain a true belt path, technicians installed upper and lower tracking technology and closely spaced 35° idlers for belt support that slide out for easy one-person maintenance. To protect the tail pulley, a plow was installed on the inside of the belt return to deflect fugitive material.
