# MODERN QUARRYING

# IMPACTS OF CONVEYOR SAFETY

The effect of the 2020 pandemic on the bulk material handling industry has been profound in both production and operations, but what impact did it have on safety? By Jerad Heitzler, training manager at Martin Engineering.

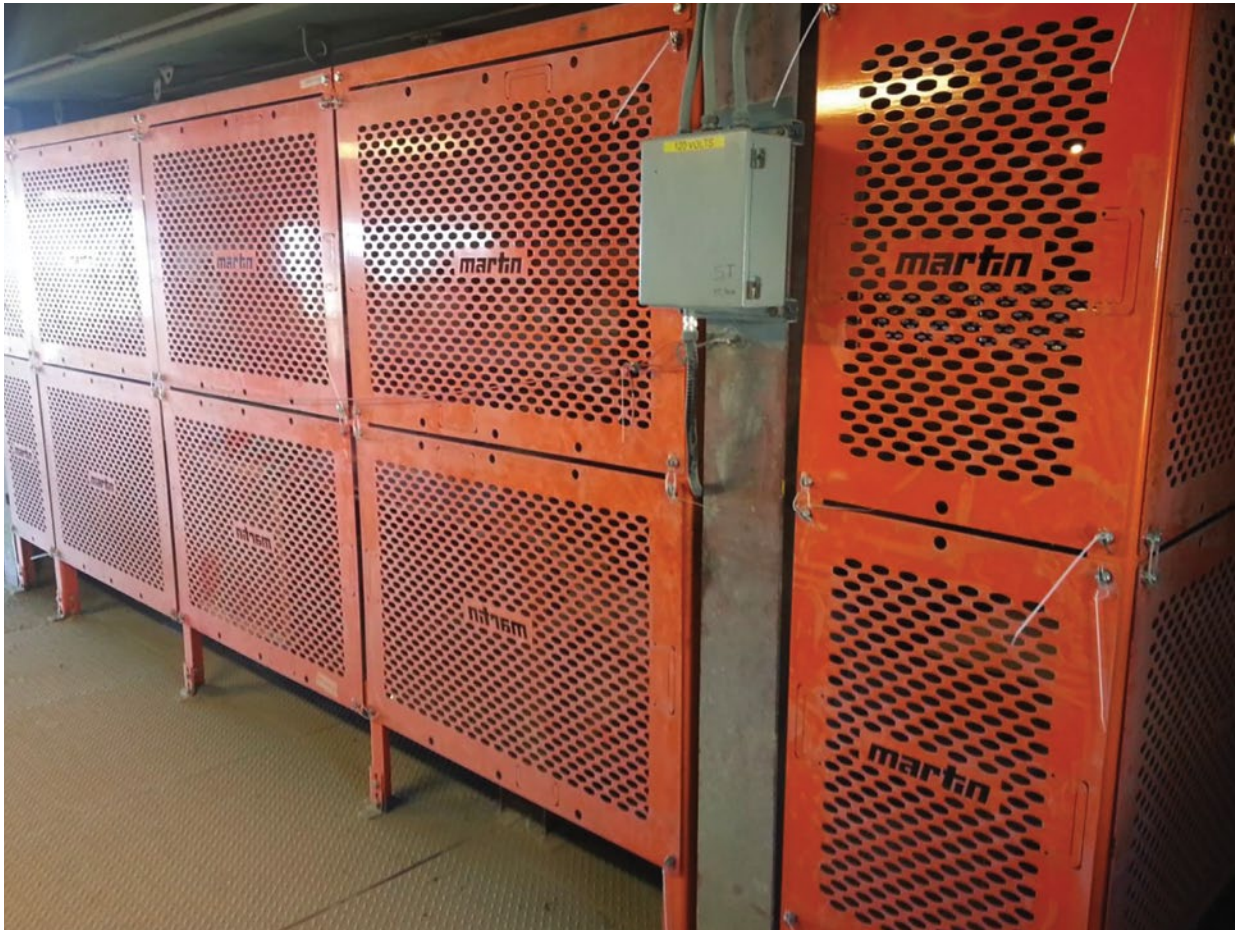
Guarding restricts access and may require a specific procedure to unlock.

There were several details left out of the public report. One is the presence of guarding around the belt, which prevents limbs and objects from "breaking the plane" of the system. The "plane" is the line (generally indicated by the outside of the stringer) that, once crossed, becomes a hazard for this type of incident. Guarding is designed with mesh that prevents incidental contact but allows for inspection. Often there is a procedure required to remove guarding, and in some cases, removal triggers an automatic shutdown of the system.

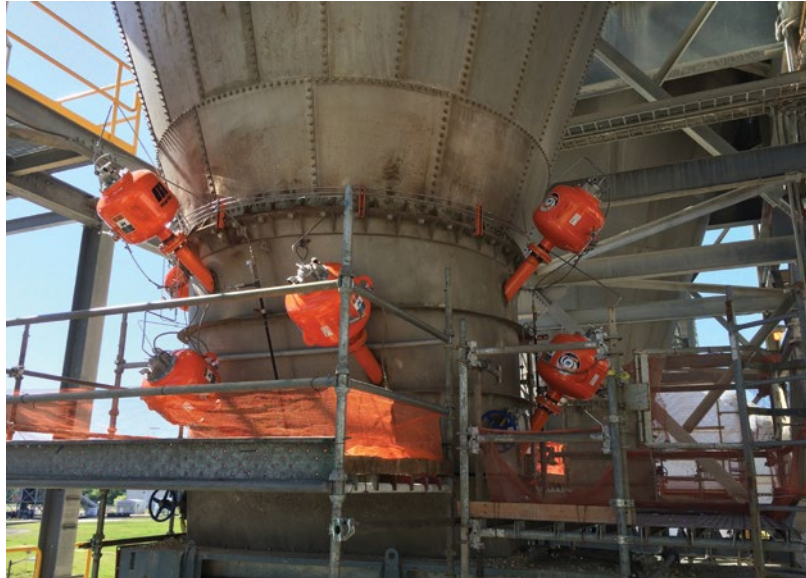
Air cannons are configured at a specific angle to enhance material flow.

Vibration at specified points agitates dust and fines that adhere to surfaces, preventing build-up that leads to clogging. Going one step further, air cannons use a forceful shot of pressurized air pointed toward the material flow to free build-up over wide areas of the vessel's surface. Air cannons not only prevent clogs but also promote the consistent flow of cargo through the process.
