# Sticky Storage

## Michigan Mine Recovers Silo Capacity And Product.

By Gregg Pickering

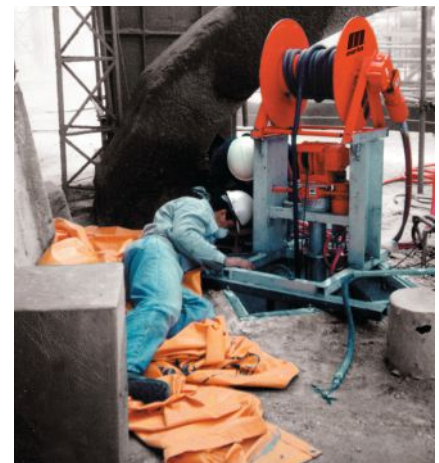
Effective silo cleaning requires trained technicians who can safely clean without damaging the vessel.

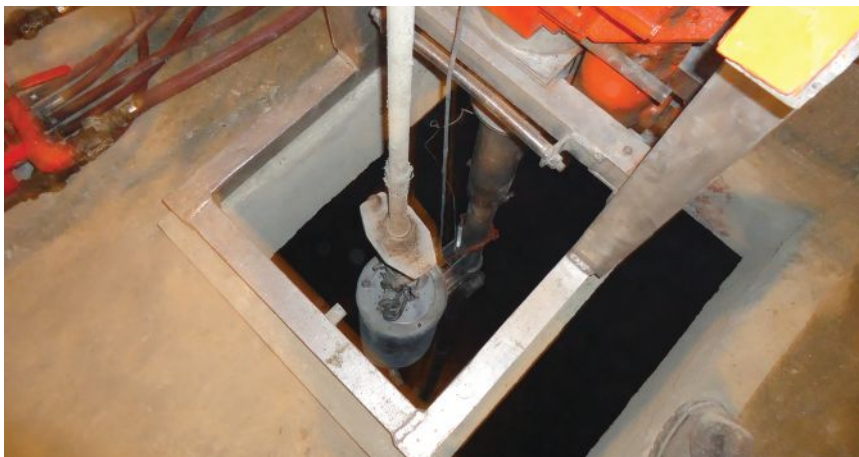
*The cleaning crew set up the whips outside of the access hatches.*

An experienced two-man crew set up two Martin HD (heavy-duty) Whip Busters at the top of the bins, outside of the access hatches. Powered by compressed air, the system can be equipped with a variety of whips, flails and cutting edges

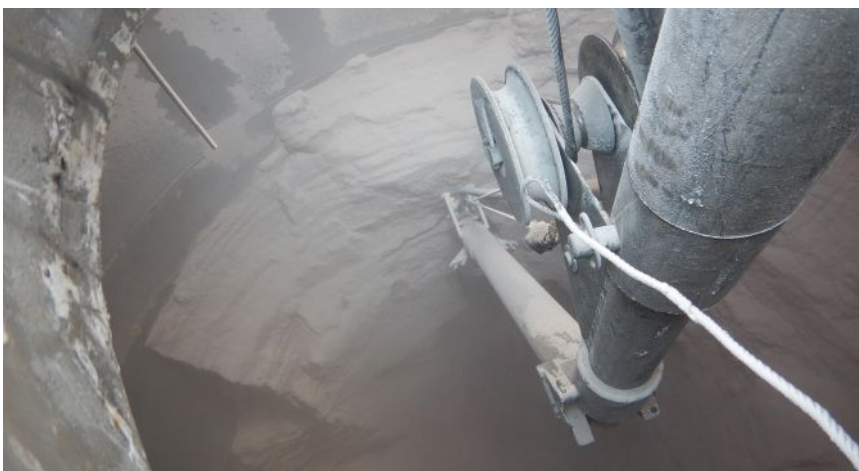
*Lowered into the silo from the access hatch, the device operates from the bottom up.*

Lowered into the silo from the access hatch, the device operates from the bottom up as the pneumatic cutting head delivers a powerful whipping action to dislodge even difficult materials. The extending arm and remote operation provide operators control over the whip head, allowing the team to completely clear dense material with no hang-ups on support bars and no confined space entry required to untie tangled equipment.

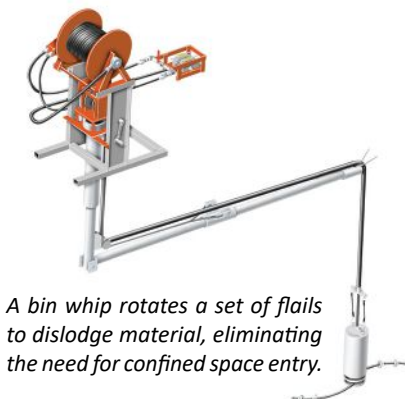
A bin whip rotates a set of flails to dislodge material, eliminating the need for confined space entry.

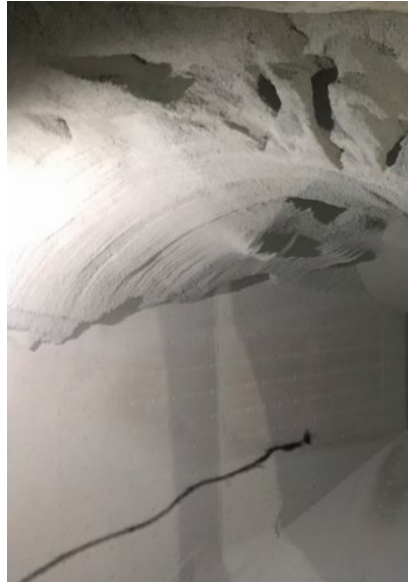
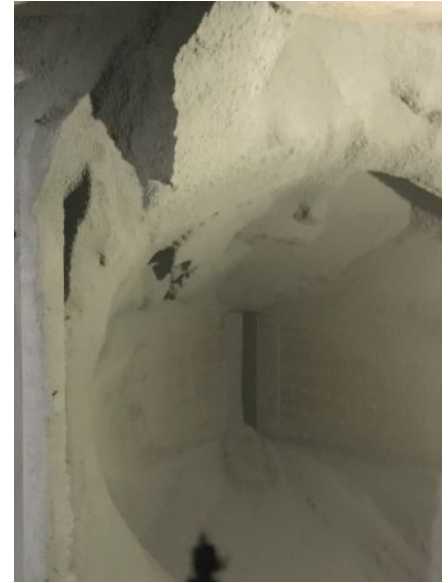
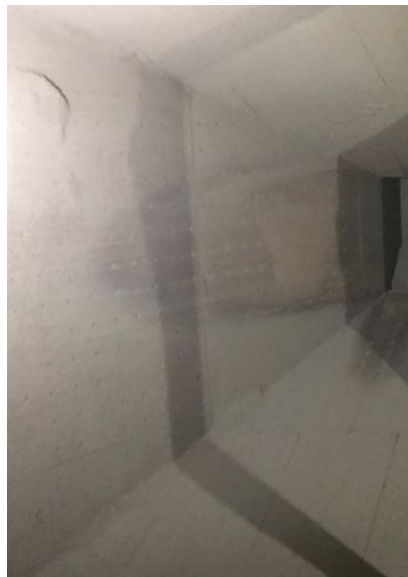
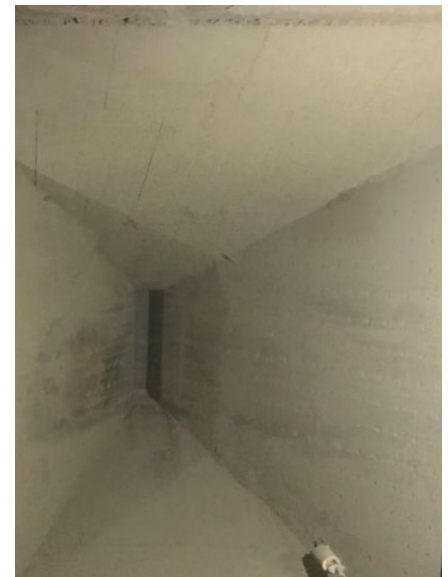
Roughly 30 ft. (9 meters) tall, each bin has two discharge feeders at the bottom, separated by a pant leg divider discharging onto the feeder belt. Lakomowski estimated that they were losing approximately 15% to 20% capacity of each bin from adhered material.

Before and After: looking downward into the vessel.

After the cleanouts were completed, operators reported that the bins are at 100% capacity and production has become more efficient as a result. The stringent 24-hour cleanout schedule reduced the timespan for the project, minimizing operational downtime and improving the return on investment (ROI).
