ROCK PRODUCTS®

Doing Away With Dust

A Singleton Birch Quarry Took Control of Fugitive Dust Emissions With a Combination of Experience and Technology.

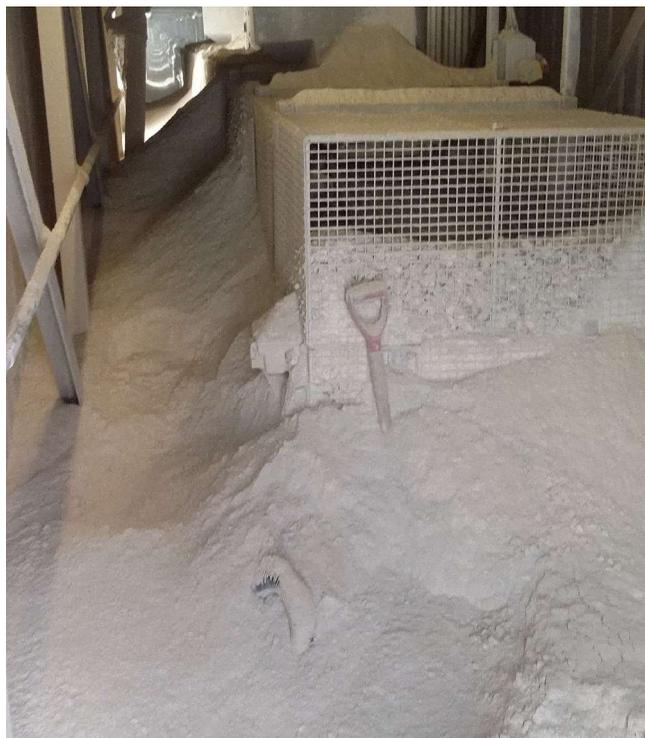
Piled high enough to encapsulate the tail pulley and belt, the dust was a serious problem.

Dust would quickly build up around the loading zone and encapsulate the tail pulley, eventually causing the belt to just slide over the built-up material rather than riding on the rollers, which fouled the return side of the belt and the face of the tail pulley. Fugitive material would travel freely throughout the long shaft, piling up and restricting access for maintenance workers to address these issues.

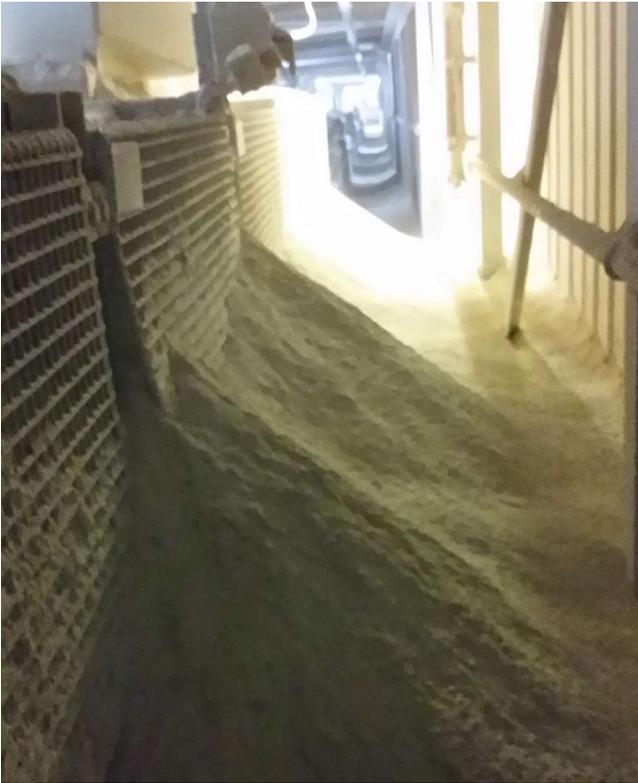
Dust blocked walkways and posed a potential safety risk.

Anyone entering the enclosed area was required to wear personal protective equipment (PPE), including breathing masks with respirators and hooded suits to protect against airborne particles. Workers first had to clear thigh-deep piles of dust from walkways and around the mainframe using the plant’s central industrial vacuum system, in order to access the conveyor for inspection and maintenance.

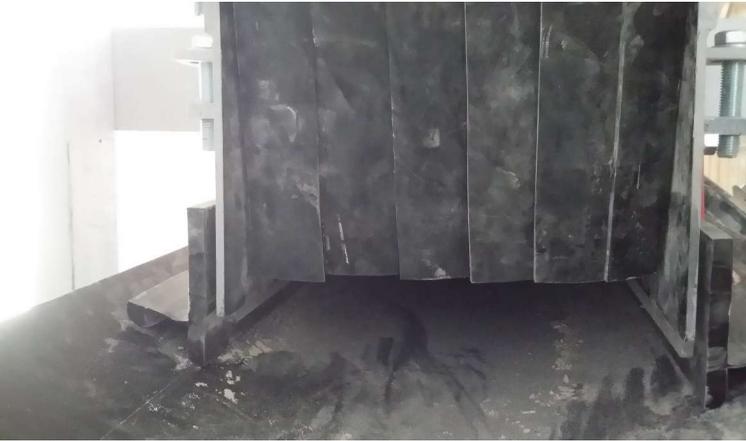
Dust curtains are set throughout the chute to slow air flow and reduce fugitive particle emissions.

Following the loading zone, several dust curtains stop dust from escaping out of the end of the chute by trapping it within the settling zone. Previously, the mechanical dust filtration systems had been unable to handle the sheer volume of particulate matter, so the filters clogged quickly and created a maintenance burden, causing the units to be abandoned. With the units operational again, technicians cleaned the area and replaced the filters. Combined with the new chute design, the systems are able to effectively filter any overflow of dust.

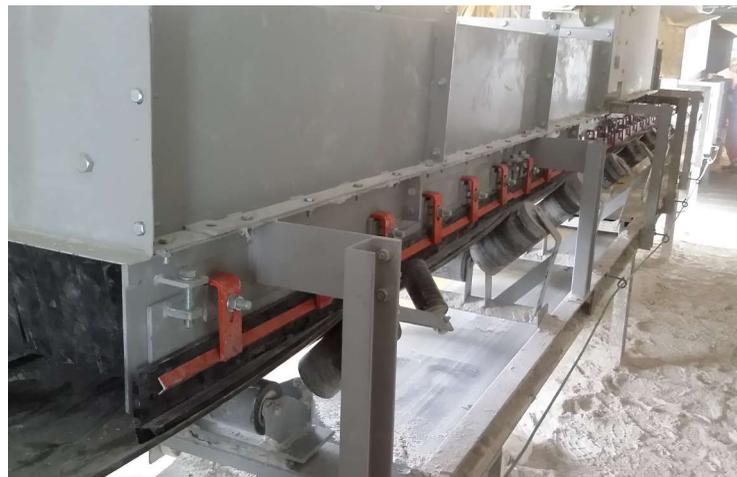
The EVO External Wear Liner helps prevent damage to the chute wall.

The new design raised the chute 102 mm (4 in.) from its previous position to accommodate the EVO External Wear Liner. Mounting brackets with jackscrews provide a secure mount, with precision adjustment of the wear liner to reduce spillage. The system closes the gap between the liner and the sealer, thus eliminating abrasion from trapped material without interfering with existing supports. When accompanied by the Double Sided ApronSeal skirting and clamps, the

The special mounting tabs allow the liner to be both adjustable and replaceable from outside the chute, requiring no confined space entry. Maintenance staff merely needs to loosen the mounting tabs and remove the wear liner, then slide the new one in. This reduces the replacement procedure to a fraction of the time and makes the operation significantly safer, with far less downtime.

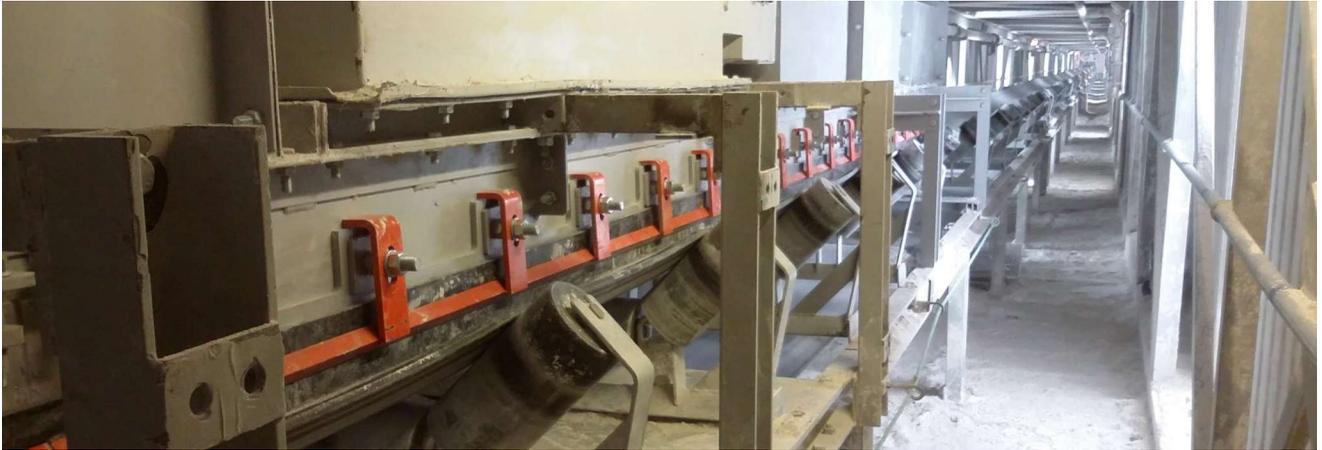
ApronSeal Skirting contains small lumps and fines.

Placed flush with the wear liner on the outside of the chute, the ApronSeal includes a primary and secondary sealing strip with a dual-sided elastomer construction made of 70 durometer EPDM rubber composite for its low abrasion index characteristics.

The primary strip holds a tight seal on the belt to trap fugitive dust and contain it within the cargo flow. The self-adjusting secondary seal rides smoothly on the belt alongside the rigid primary strip to provide an extra dust seal. Once the contact area of the sealing strip has worn down, workers merely loosen the mounting brackets, slide the strip out and flip it over, doubling its wear life.
