# Australian Mining safetowork

## From the outside

MARTIN ENGINEERING BREAKS DOWN ELIMINATING CHUTE ENTRY WITH AN EXTERNAL WEAR LINER.

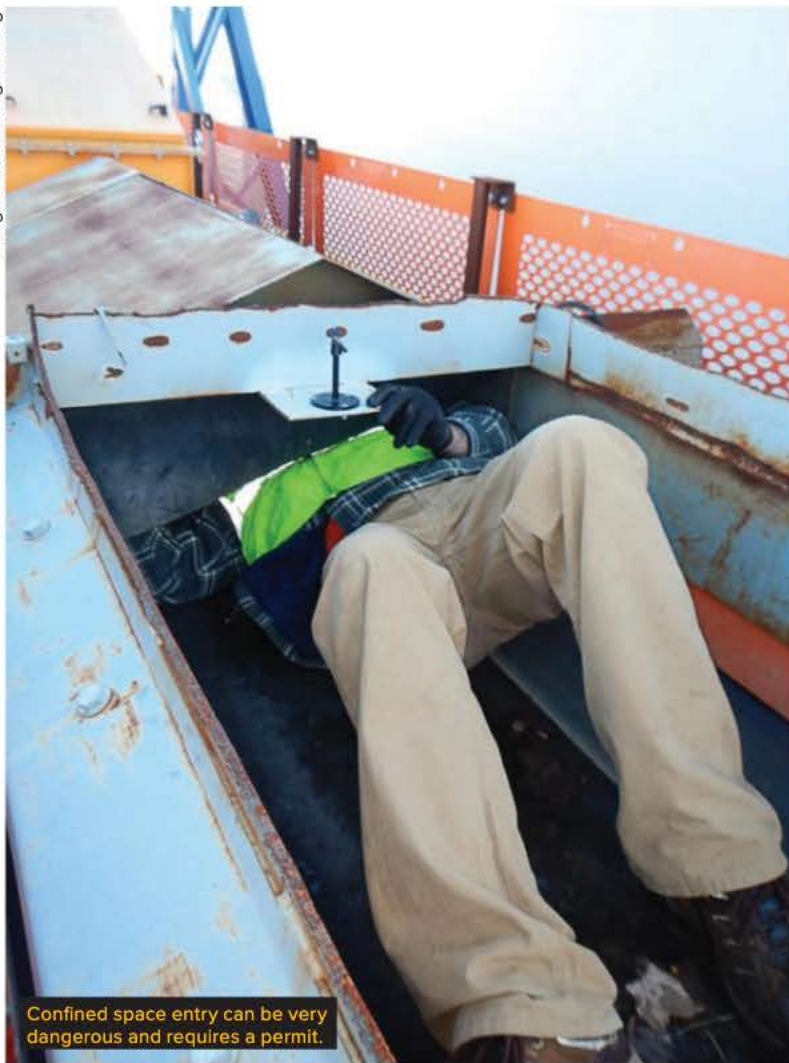
Confined space entry can be very dangerous and requires a permit.

When a conventional wear liner loses its edge, the replacement procedure is what operators describe as an undesirable maintenance assignment. The authorised entrant would go into the chute with a grinder to remove the welds and the sacrificial liner, which may have required a torch to cut away existing material.

Firstly, the liner can weigh more than 100kg, and when cut loose it can fall and endanger the people in the confined space of the chute.

Secondly, nearly any dust can be explosive under the right conditions, and having to grind or torch-cut the old liner introduces a spark or open flame. Some companies thoroughly wash out the chute prior to entry to avoid any chance of combustible particulates, making the job even more time-consuming.

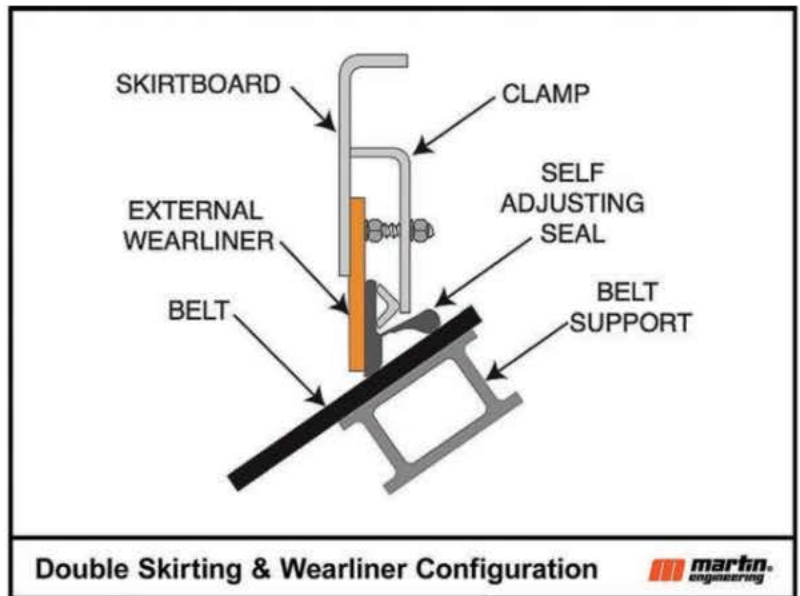
**Double Skirting & Wearliner Configuration**  
The external wear liner and skirting system improve safety, maintenance costs and equipment life.

An external liner can be installed and adjusted faster and easier, without the need for a grinder or torch, through the use of special mounting tabs.

Clips for bolting the liner are initially welded in place but do not require removal when the liner wears out. Since work is done from the outside, without any grinding sparks or torch flame, the hazard of explosive dust from tool usage is greatly reduced.

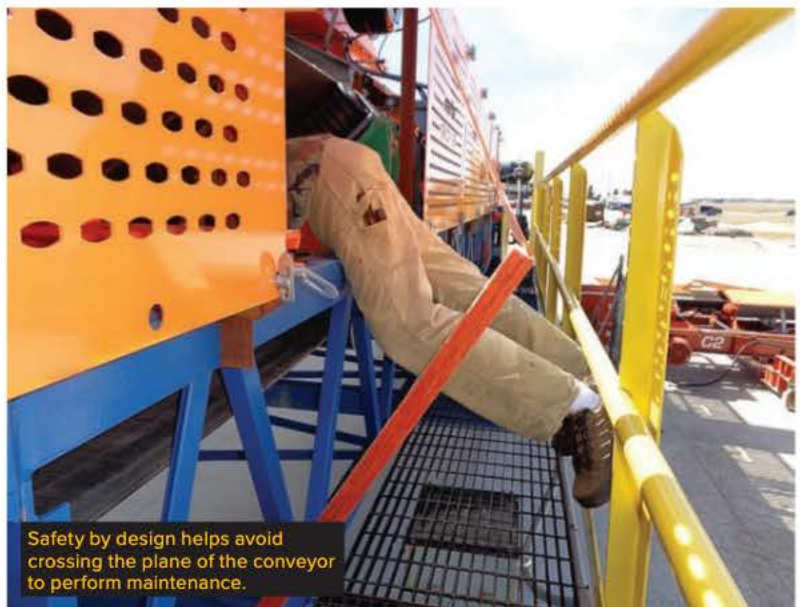
The managers invited Martin Engineering to examine the issue and offer solutions. After conducting a thorough 'walk the belt' procedure, technicians installed external wear liners, ApronSeal double skirting HD (heavy-duty), Trac-Mount idlers, upper and lower trackers, and a V-plow.

The wear liner protects the chute wall against punishing material, as the double skirting forms a seal that rides lightly on the belt, keeping fines from escaping. The wear liners and skirts are externally mounted for safe and easy maintenance, with no confined space entry required.

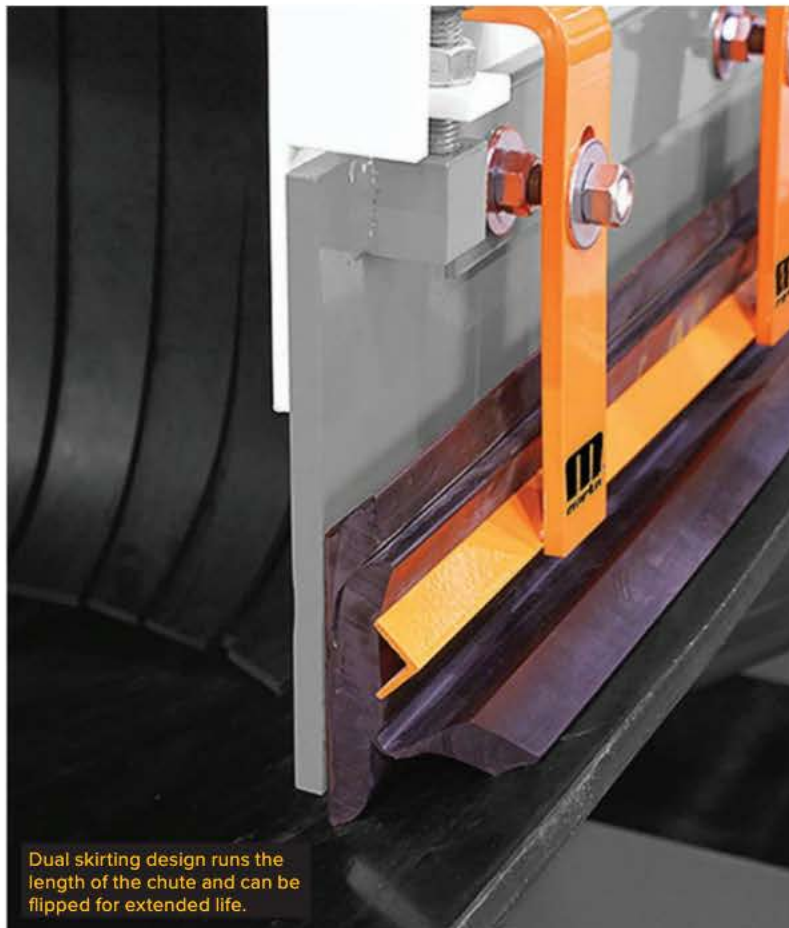
Dual skirting design runs the length of the chute and can be flipped for extended life.

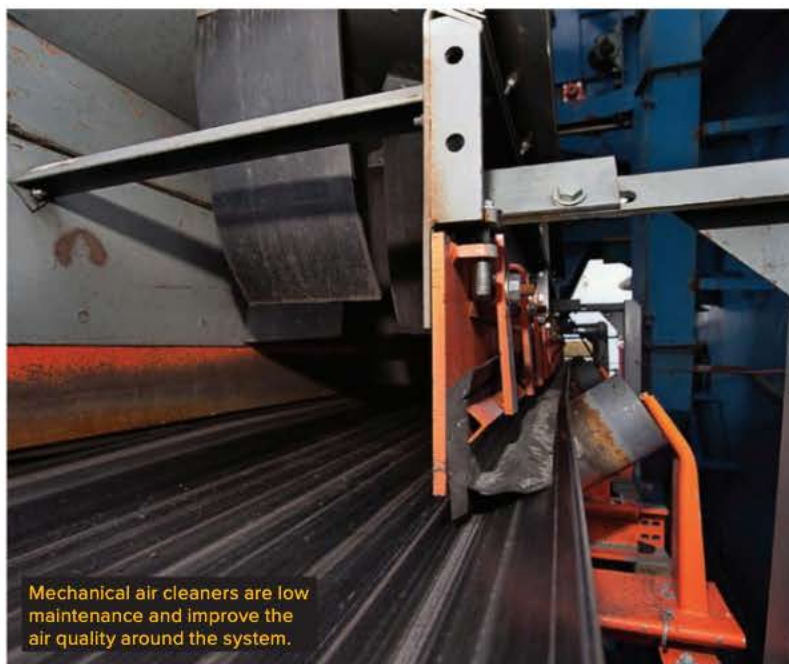
Mechanical air cleaners are low maintenance and improve the air quality around the system.
